WATER YEAR 2010
TRINITY RIVER RESTORATION PROGRAM
GEOMORPHIC AND RIPARIAN MONITORING—
A SUB-COMPONENT OF THE INTEGRATED HABITAT ASSESSMENT
PROJECT

Prepared for the Trinity River Restoration Program

Final Report, October 1, 2012

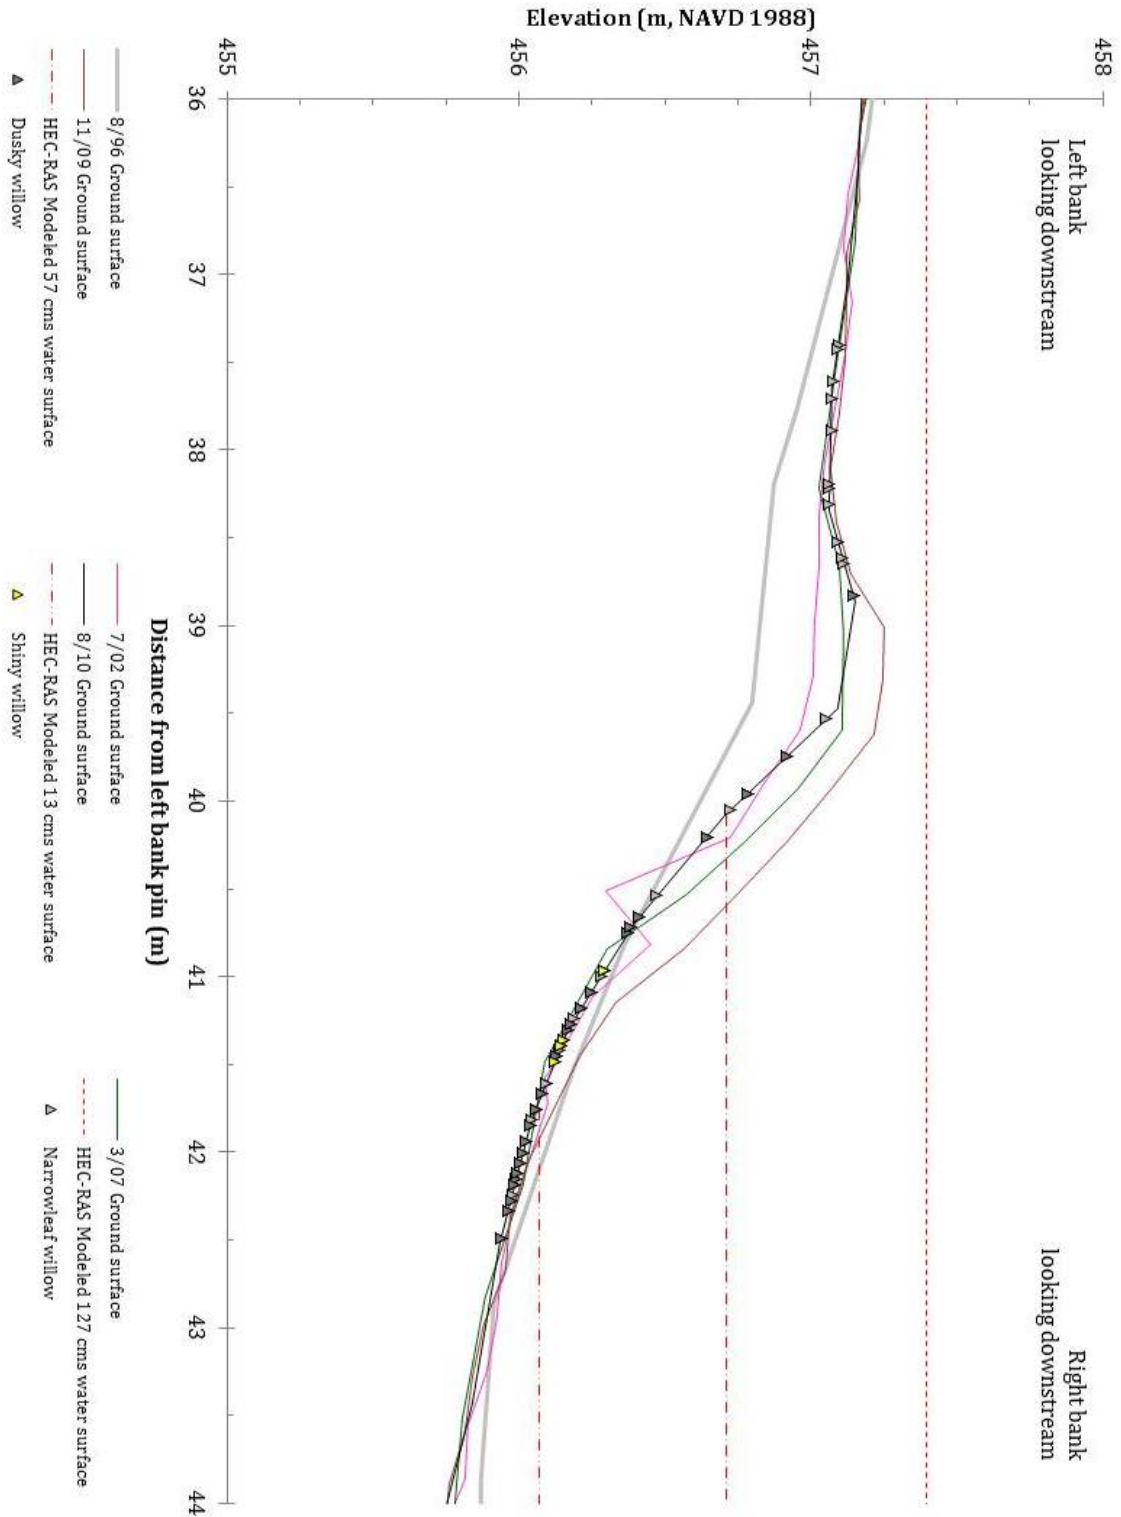
Figure 15. Pre-construction and post-construction topography at Bell Gulch Pilot Channel Rehabilitation Site XS 641+00, as well as re-formation of the riparian berm in relation to current hardwood locations.

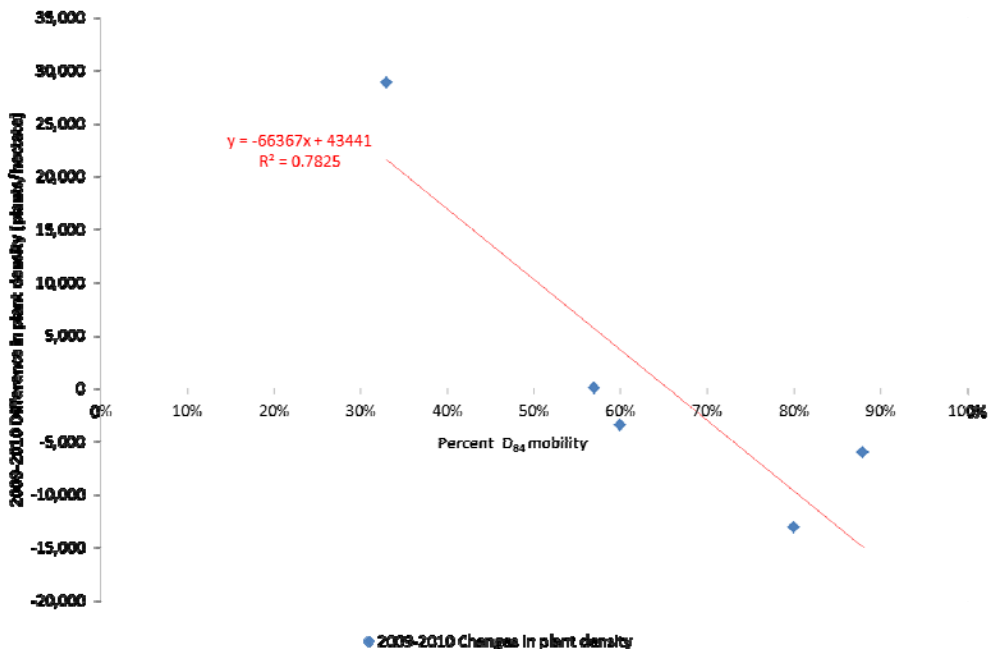
Figure 18. Plant density as a function of bed mobility. Mobility of the D_{84} can result in scour of riparian hardwood seedlings up to 0.50 cm diameter at root collar (DRC), or approximately 1-yr and younger plants.

Systemically (i.e., across all GRTS Panel 2 sites), 79% of riparian hardwoods <0.50 cm DRC (1-yr and younger) were scoured by the WY 2010 spring ROD release, thus supporting an underlying hypothesis of IAP Objective 5.2.1 (Table 2). As would be expected, plant density decreased as bed mobility increased (Figure 18). Although localized scour depths were more than sufficient to remove riparian hardwoods <0.50 cm DRC (1-yr and younger), scour depths were inconsistent throughout the sampled sites and therefore seedling scour was not achieved uniformly at each site. For instance, at Roundhouse XS 576+50, two scour chains occurred within the riparian encroachment risk zone. One chain showed a relative scour depth of $1.8 D_{84}$ and the other showed a relative scour depth of $0.2 D_{84}$. Spring ROD release flows were sufficient through much of the Project Reach to achieve seedling scour objectives at the low water edge. However, they were not 100% effective to scour all seedlings that established in WY 2010. The surviving seedlings will become a greater encroachment threat as they survive each subsequent year; therefore, the seedling scour objectives for a ROD Normal water year spring release were not entirely met.

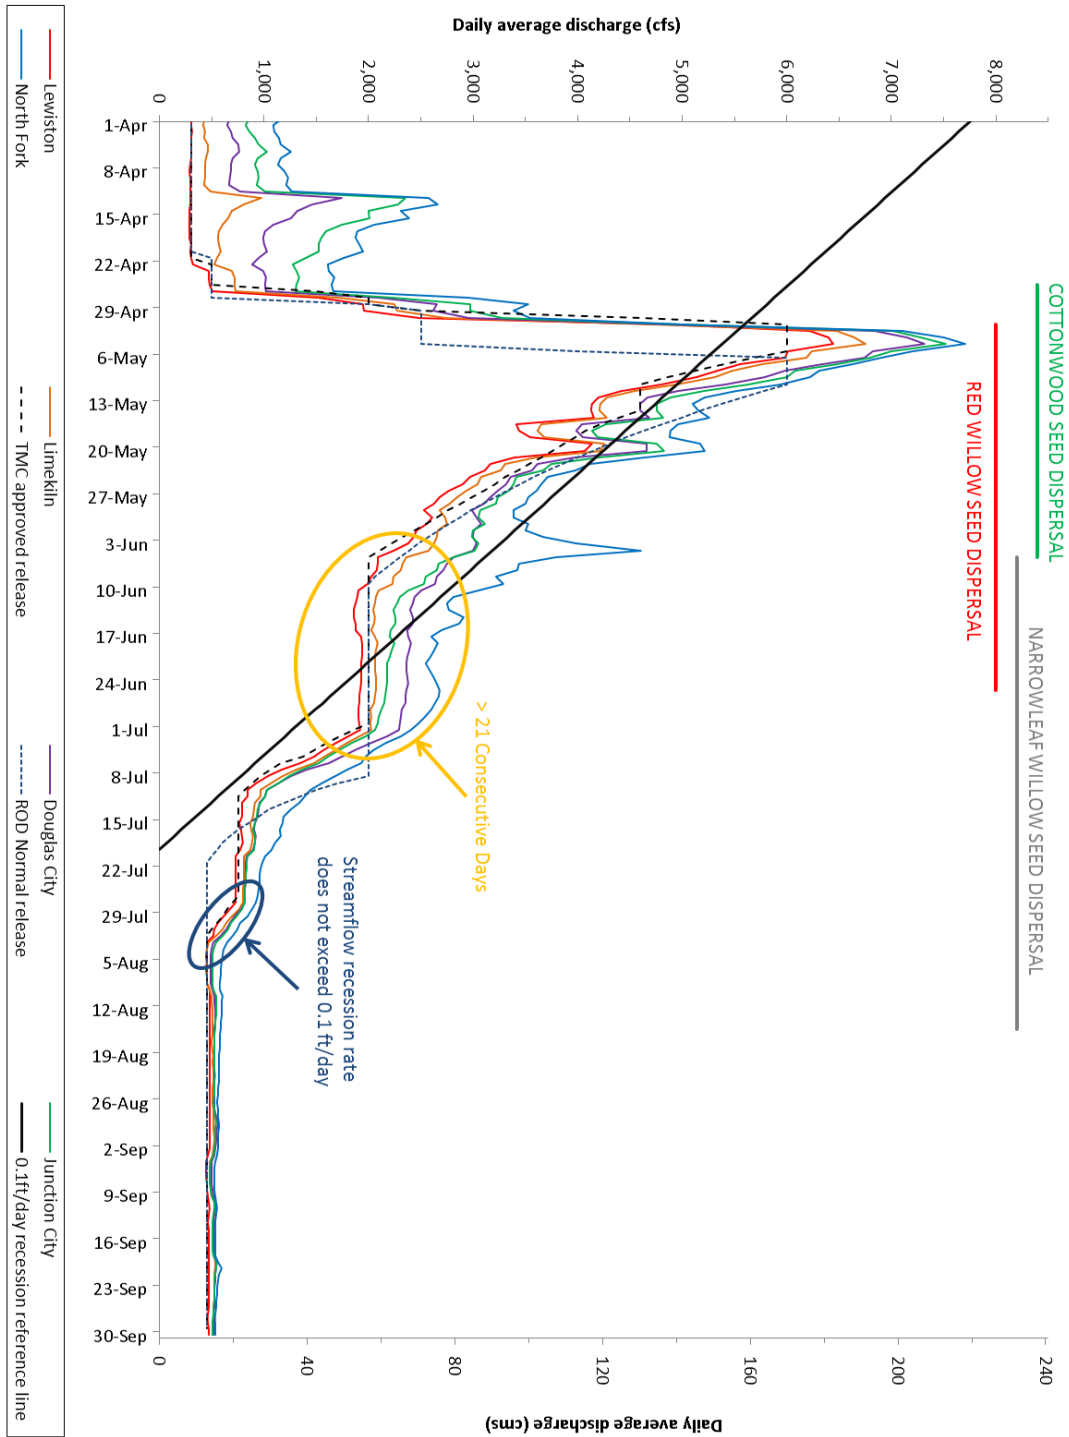
Figure 19. Daily average hydrographs at five gages between Lewiston Dam and the North Fork Trinity River, the recommended ROD release for a Normal water year, and the TMC approved release for WY 2010. Seed dispersal periods for black cottonwood, red willow, and narrowleaf willow are also shown, as are time periods where streamflow recession rates do not exceed 0.1 ft/day for at least 21 consecutive days.
