SEDIMENT YIELD STUDY  
GRASS VALLEY CREEK WATERSHED  
TRINITY COUNTY, CALIFORNIA

By  
JERALD M. CURRY  
September 1980

U.S. DEPARTMENT OF AGRICULTURE  
SOIL CONSERVATION SERVICE  
Davis, California

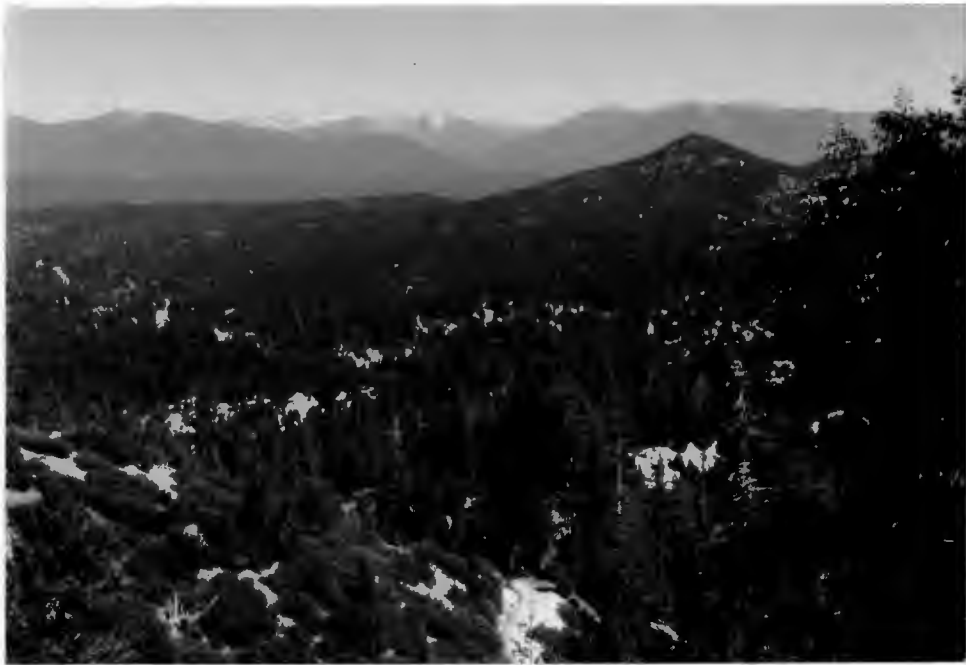
UPPER GRASS VALLEY CREEK WATERSHED  
VIEW FROM COUNTY LINE ROAD

The Grass Valley Creek watershed is mountainous with steep slopes and narrow V-shaped valleys. The drainage pattern is dendritic. Total relief of the watershed is 4,350 feet measured from the summit of Shoemaker Bally (EL. 5,950 ft.) to the mouth of Grass Valley Creek (EL. 1,600 ft.).

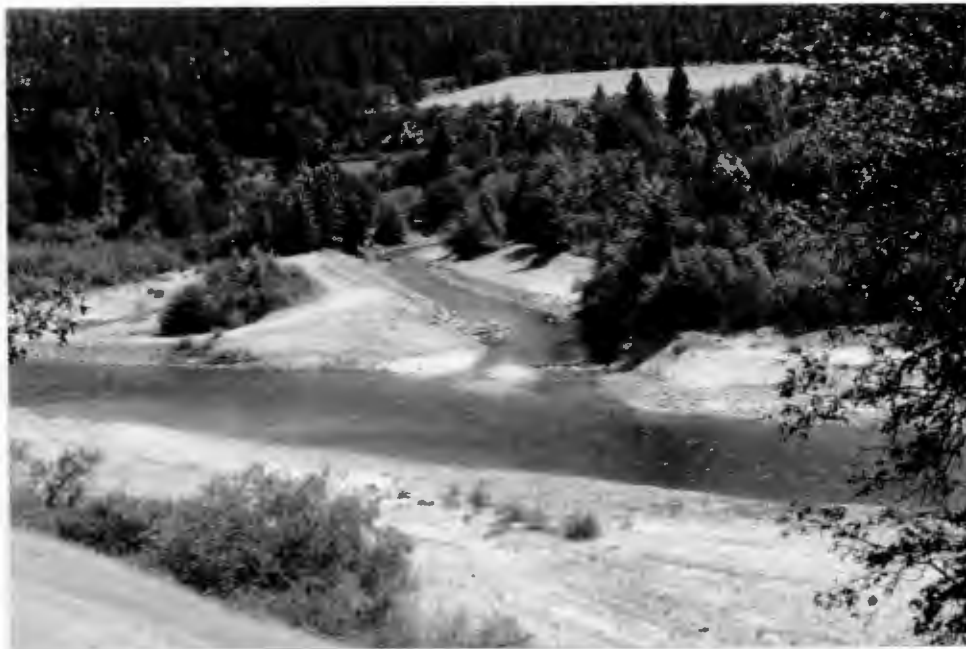
CONFLUENCE OF GRASS VALLEY CREEK  
AND TRINITY RIVER

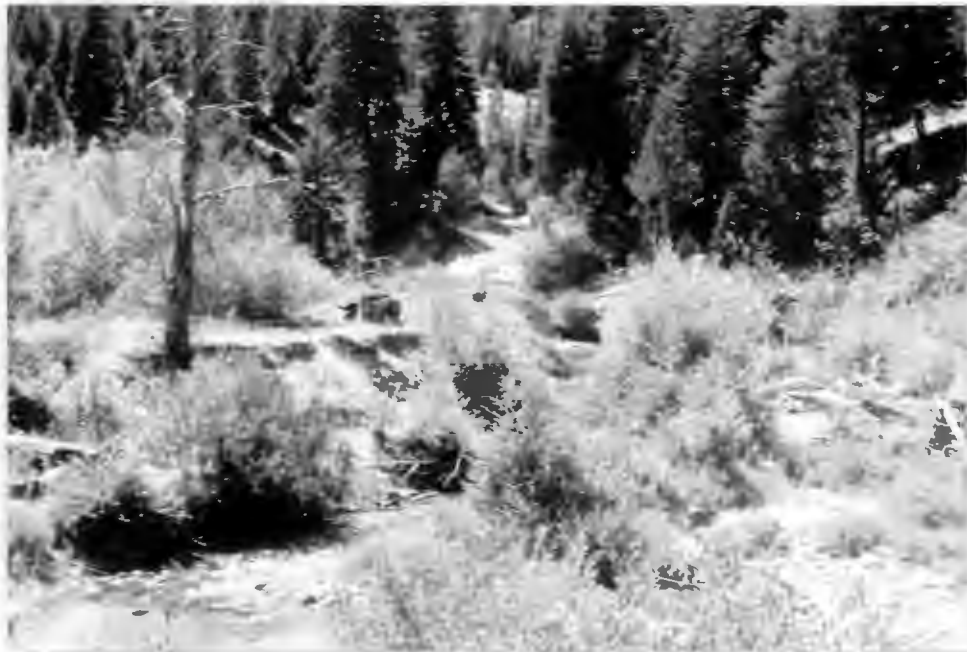
STREAMBANK EROSION ON GRASS VALLEY CREEK  
ABOVE BUCKHORN DAMSITE

There are approximately 270 miles of perennial and intermittent streams in the Grass Valley Creek Watershed. Stream miles were based on expansion of the Shasta Bally and Phillips Gulch 7½ minute quadrangle sheets. Sample reaches on the streams were observed in the field and studied on aerial photographs. Length, height and annual recession rate of the eroding stream

banks were noted. The recession rate over a period of years was determined by physical features on ground including tree roots, fence lines, etc. Approximately 65 percent of the banks are eroding to various degrees. The average erosion rate per stream mile is 35 tons. About 90 percent of the erosion is in areas with granitic soils.

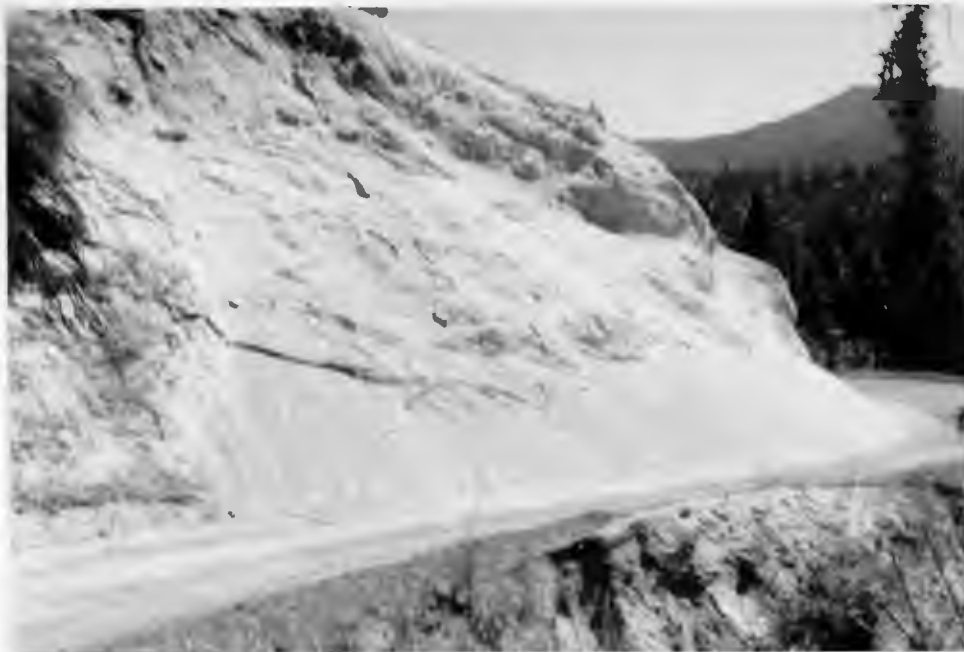
ROADBANK IN DECOMPOSED GRANITE  
BUCKHORN DAMSITE WATERSHED

Most of the road miles were driven or walked and erosion was observed in sample reaches. The method used and the data obtained by the State Division of Soil Conservation in 1968 was used primarily with some revisions. Various degrees of erosion are occurring on the roads and roadbanks. Roadbanks situated in the granitic materials are eroding at a fairly high rate. The exposed weathered granite slides down the steep banks and is deposited at the toe. This material is either removed by flows in the ditches or hauled away to disposal areas and then removed. Sheet and rill erosion caused by runoff flows is occurring on bare road surfaces in many cases.

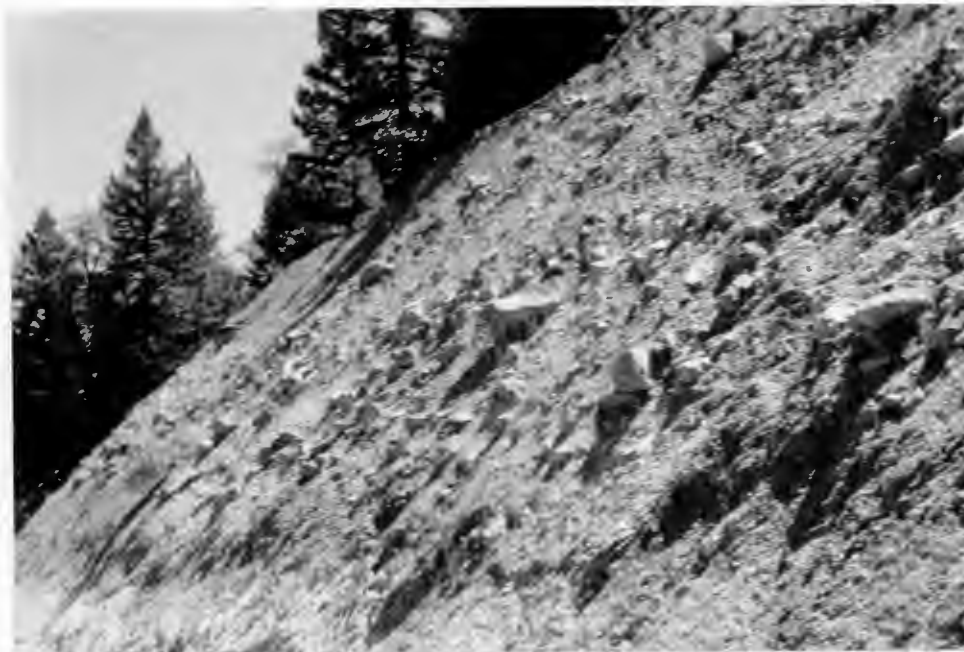
ROADBANK IN METAMORPHOSED SEDIMENTS  
ALONG HIGHWAY 299 BELOW FAWN LODGE
