*Arcata Fisheries Technical Report TR 2018-57*

## **Large Wood Placement At Channel Rehabilitation Sites By The Trinity River Restoration Program, 2005-2016**

Josh Boyce and Damon H. Goodman

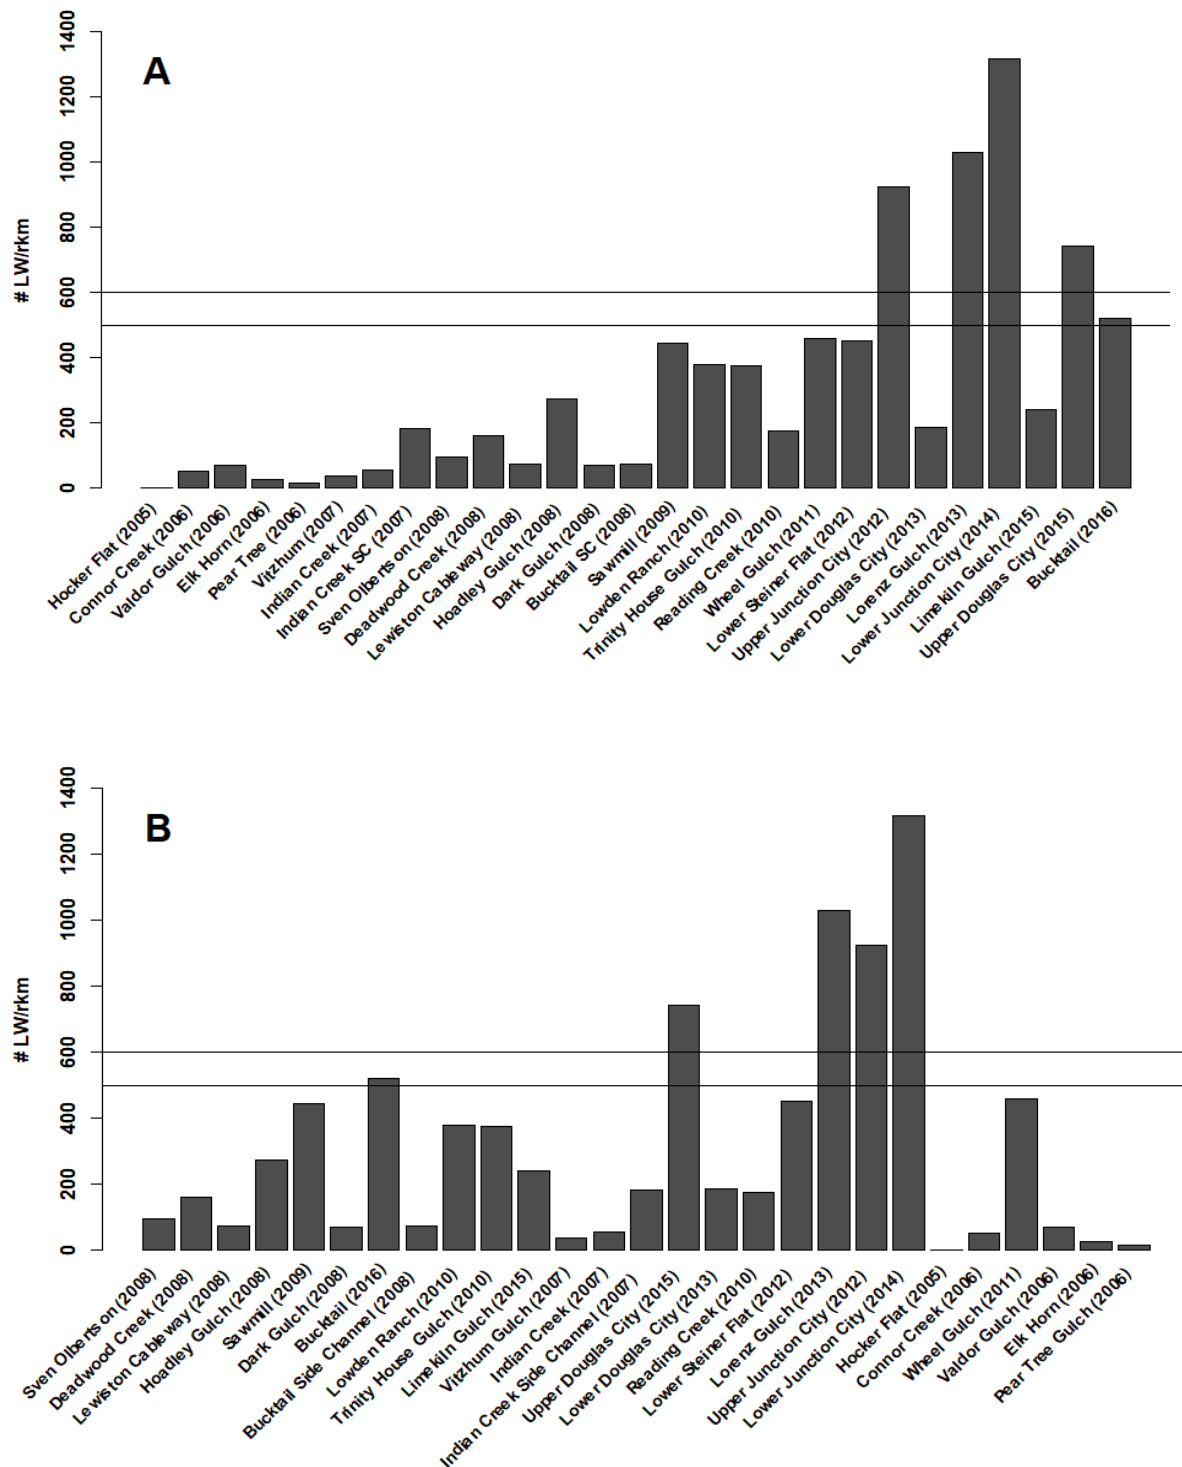
Figure 2. The total number of installed LW pieces per river kilometer for each rehabilitation site after construction. The lines indicate the range of Trinity River-specific recommendations for large wood loading (Cardno Entrix and CH2MHill, 2011). Sites are ordered chronologically (A) and longitudinally (B) from left to right with year of construction in parentheses.

A LW inventory was created from 2005-2016 for each rehabilitation site constructed by the TRRP with the exception of Hocker Flat, which did not include LW installations (Table 1). The total number of LW pieces placed per river kilometer at each rehabilitation site is displayed in Figure 2A and indicates a general increasing trend from 2006 (median=39, range=16-72) to 2016 (n=522). The longitudinal distribution of these data within the restoration reach are displayed from upstream to downstream for comparison (Figure 2B). One site (Bucktail) met the range (500-600 pieces LW/rkm) of LW loading recommended for the Trinity River by Cardno-Entrix and CHM2Hill (2011) and 4 sites exceeded this range (Upper and Lower Junction City, Lorenz Gulch, and Upper Douglas City). A total of 7,591 LW pieces (class I: n=3,320; class II: n=3,702; class III: n=569) have been placed in the restoration reach since 2006 (Appendix A, Table A1). Figure 3 provides a comparative example of the increase in LW loading by the TRRP between 2006 and 2014.

The LW inventory presented here clearly documents the increasing awareness by the TRRP of the importance of LW in riverine systems evidenced by the general increasing trend in the number of LW pieces per river kilometer over time (Figure 2A). Although five sites meet or exceed the range (500-600 pieces LW/rkm) of recommended LW loading for the Trinity River, there does not appear to be an effect of a particular TRRP design team on this metric. TRRP rehabilitation site designs are created by a series of multi-disciplinary teams or design teams from constituent partner organizations (see Appendix B for list of partner organizations). For instance, the Federal team designed Limekiln Gulch, with a relatively low density of LW pieces (240/rkm) and Lower Junction City, with the highest density (1,315 pieces LW/rkm). Similarly, Upper (743 pieces LW/rkm) and Lower (186 pieces LW/rkm) Douglas City were designed by the Hoopa Valley Tribe team. These results suggest that despite the overall increase in LW augmentation by the program, logistical constraints (e.g. LW availability or site access), the geomorphic context, site and/or feature specific objectives as well as budgetary considerations may influence the density of LW placed at particular rehabilitation sites.

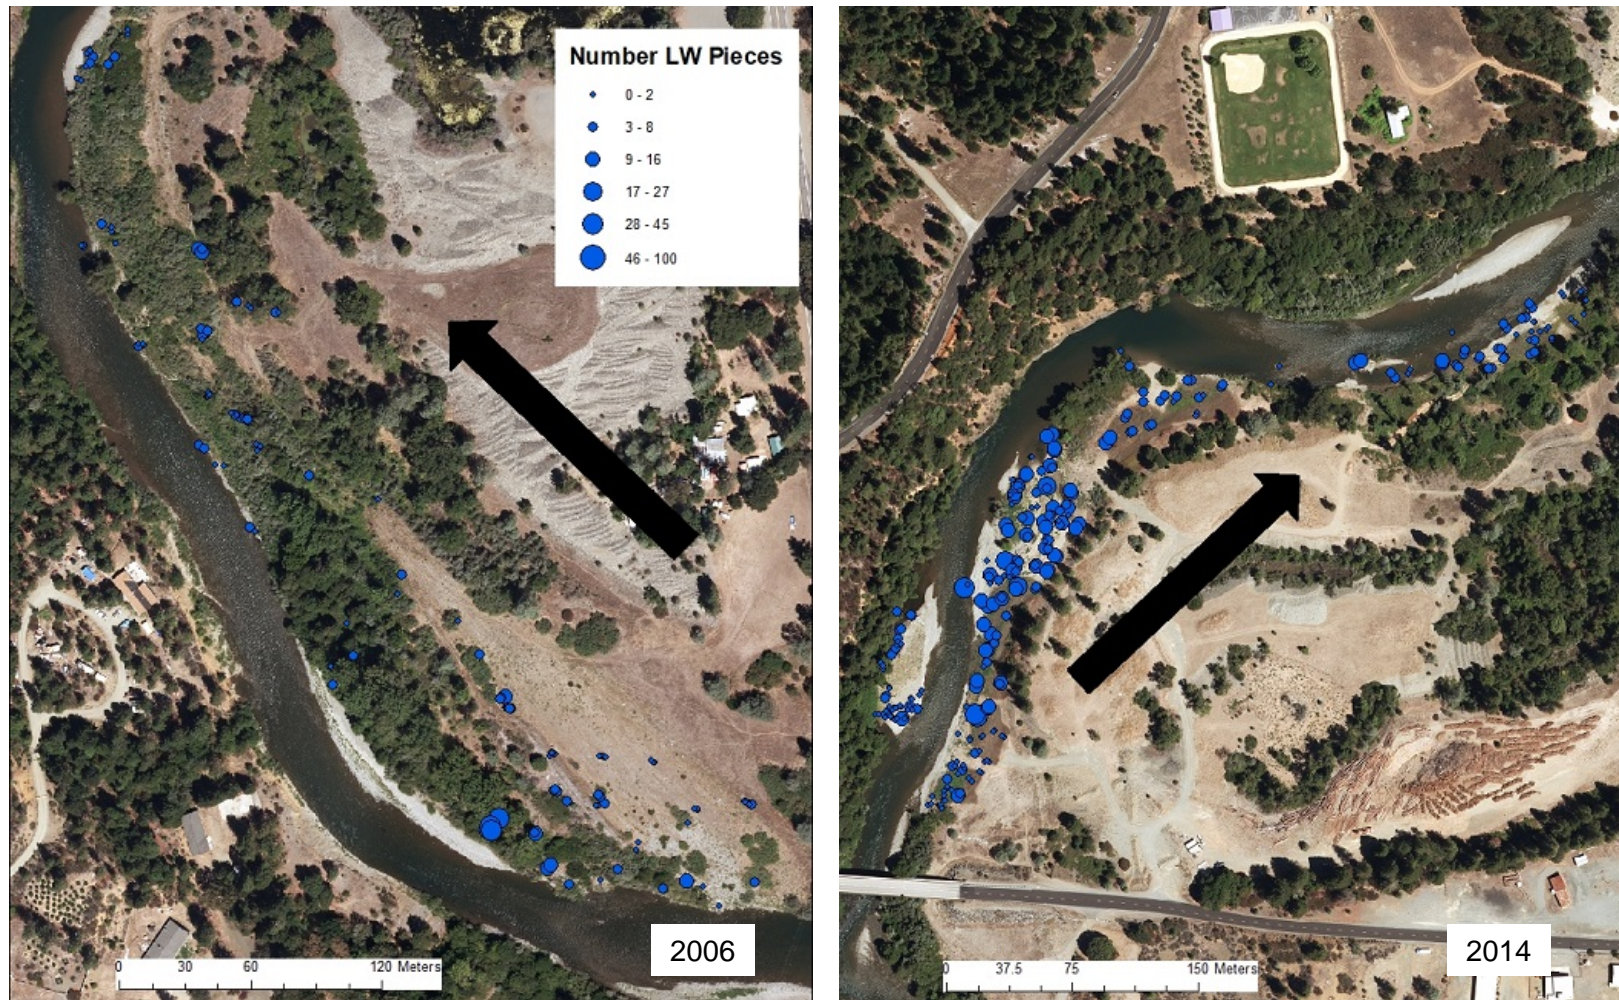
Figure 3. Aerial views of Connor Creek (left) and Lower Junction City (right) rehabilitation sites illustrating the increase in LW placement from 2006 to 2014. After construction, Connor Creek had 52 LW pieces per km while Lower Junction City had 1,315 LW pieces per km. Symbol size indicates the number of LW pieces and the arrow indicates direction of streamflow. Both sites are approximately 0.6 km in length.

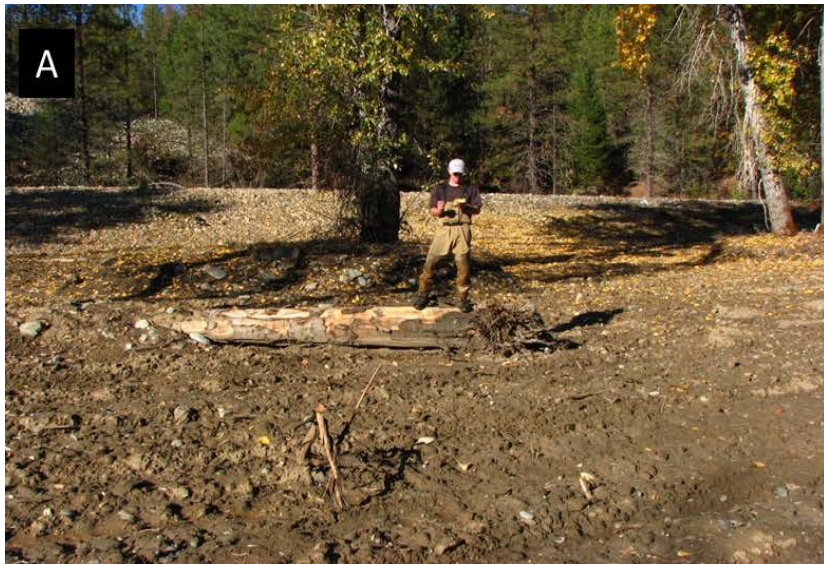
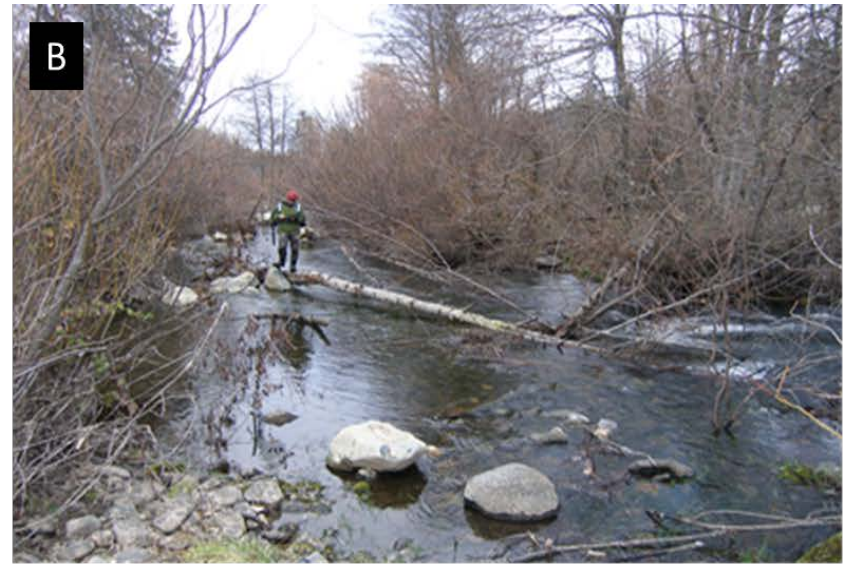
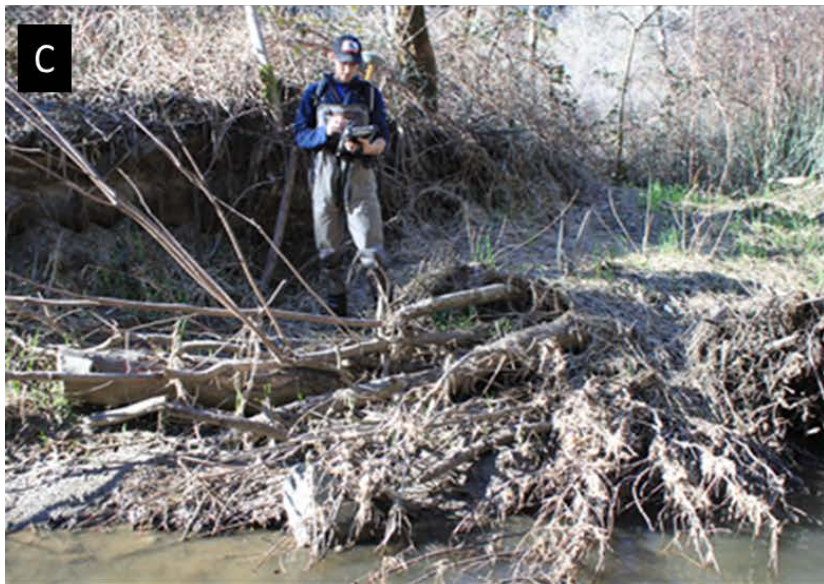
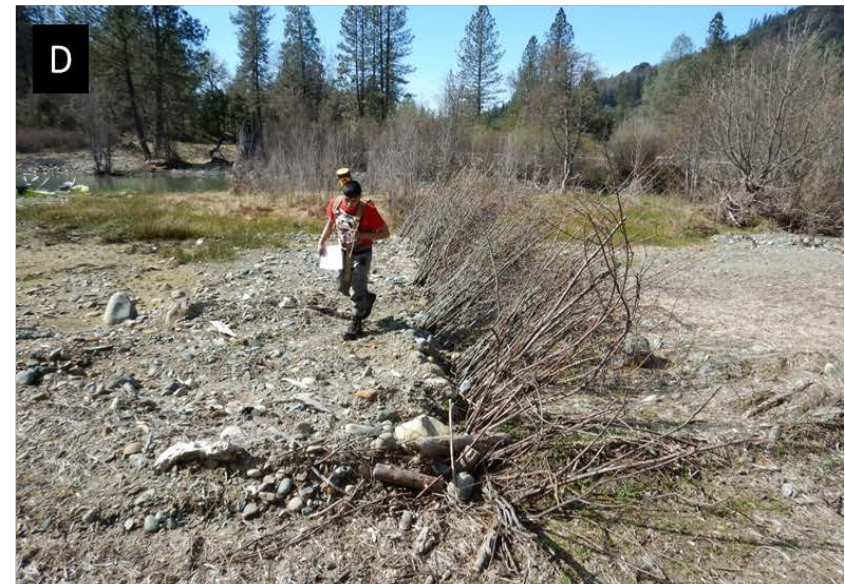
Figure 4. Examples of variation in LW placed in the “other” category (i.e. not constructed as a weir, deflector or CWJ). A). Connor Creek (2006), B). Lewiston Cableway (2009), C). Limekiln Gulch (2016), D). Bucktail (2017).

A total of 1,919 LW structures have been installed in the restoration reach since 2006 (Table 2). Forty-three percent (n=826) are structures placed in the “other” category. The morphology and degree of anchoring of structures in this category are highly variable (Figure 4). Forty-one percent (n=777) are log deflectors either placed singly or in small groups along one bank. Eight percent are in the Wildlife category (on terrace/near peak streamflow level) indicating negligible interaction with streamflow. Examples of these LW structure types can be seen in Figure 5. Six percent (n=115) are CWJ’s that increased in number per river kilometer over time (Figure 6). The number of LW pieces incorporated

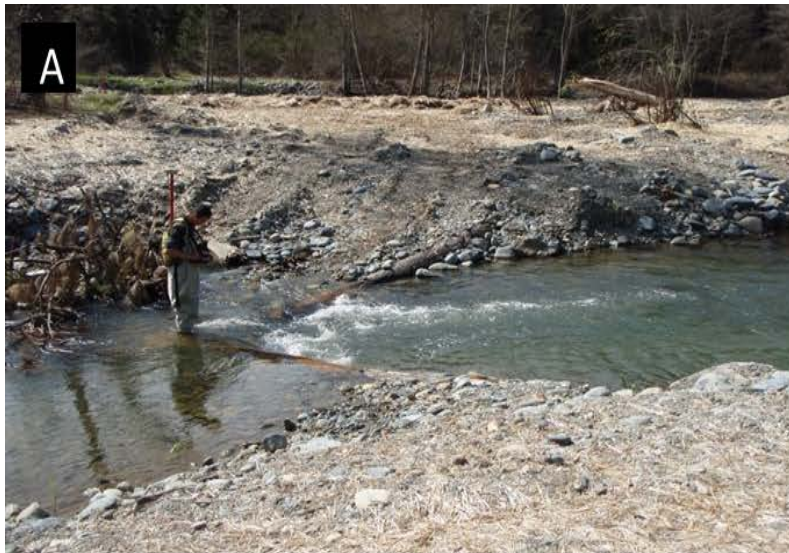
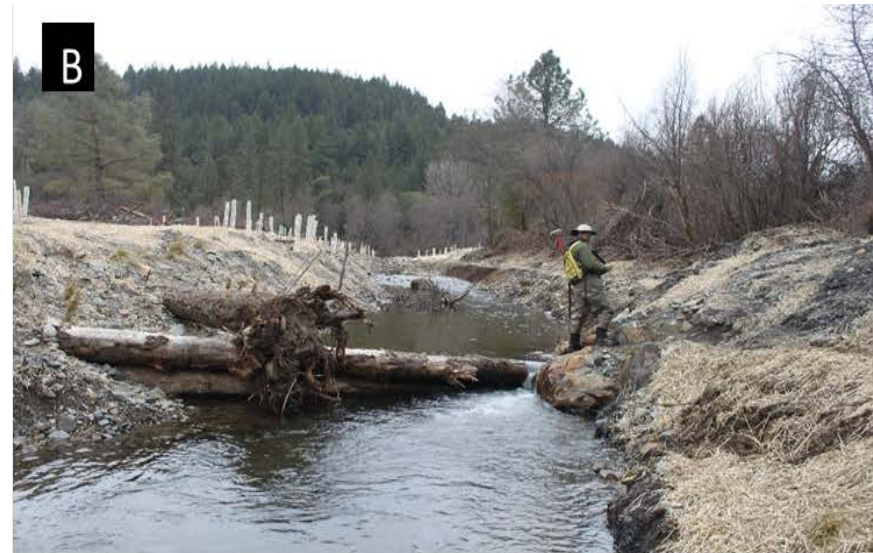
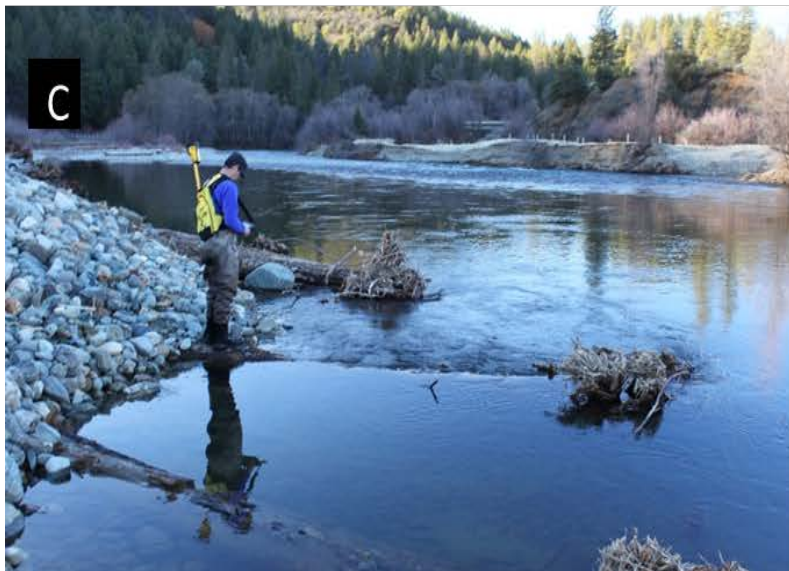
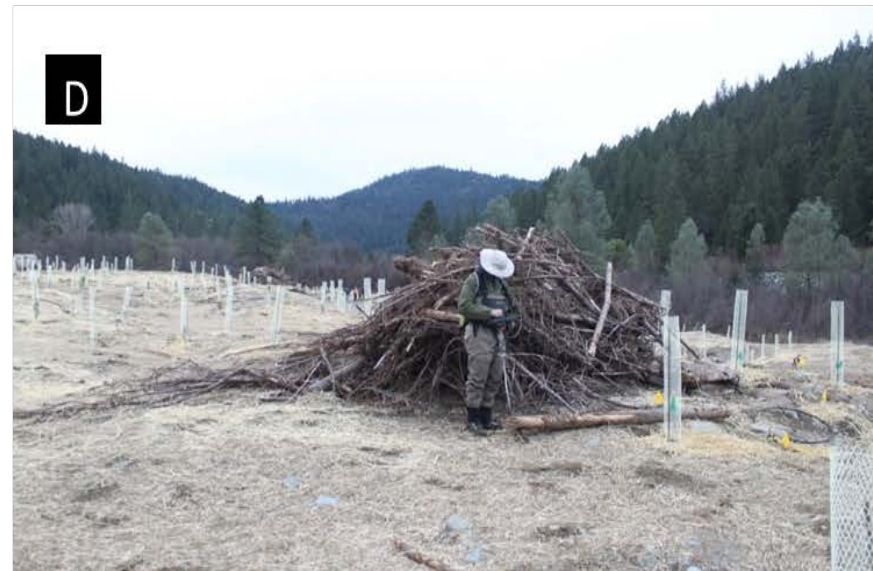
Figure 5. Examples of LW structures. A). V Weir, B). Log Weir, C). Log Deflector, D). Wildlife.

Large wood structures were categorized as V weirs, log weirs, log deflectors, wildlife, “other” and constructed wood jams (CWJ). V weirs were defined as two logs in a V-formation, spanning the channel with no space at the vertex and oriented either upstream or downstream (Anderson et al 1984; House and Boehne 1985). Log weirs were defined as one or more anchored, embedded logs spanning the channel with negligible underflow and oriented perpendicular or diagonal to the direction of flow forming a sill dam (Crispin et al 1993). Log deflectors were defined as one or more logs anchored on the bank at a 45-135

degree angle either singly or in pairs (Allan and Lowe 1997). The wildlife category includes any LW on a terrace near the peak flood zone. The “other” category was a catch-all for any placed LW that did not meet the criteria for any other category.

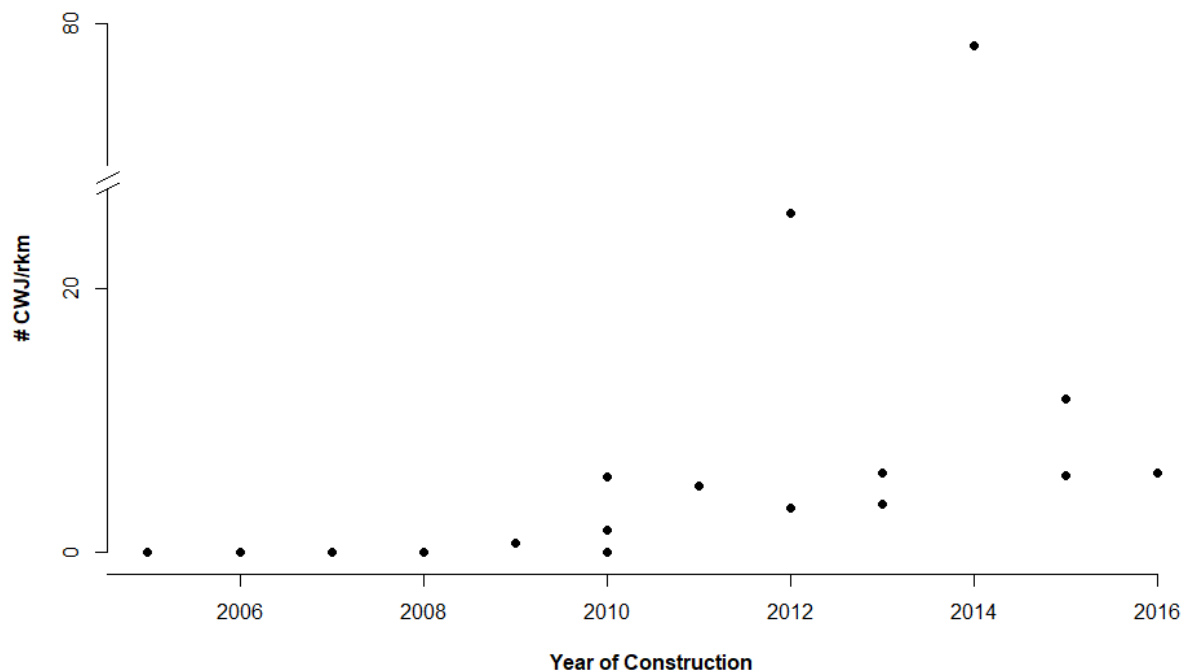
Figure 6. The number of constructed wood jams per river kilometer over the study period. The y-axis contains a break to highlight the increasing trend in wood jam density over time and the relatively high number of wood jams placed at Upper (n=26) and Lower (n=78) Junction City in 2012 and 2014, respectively.

The density (#/rkm) of CWJ's increased over our study period (Figure 6), while size class composition (Appendix A, Table A2) and number of LW pieces per CWJ were variable (Figure 7). The complexity of CWJ's can be represented by any number of metrics such as the type and degree of anchoring or the arrangement of LW pieces within CWJ's among other possibilities. We chose to assess complexity by the number of LW pieces because those data were easily accessed and the other methods were beyond the scope of our survey methods. It is perhaps not surprising that this measure of complexity would be variable given the year-to-year variation in rehabilitation site designs and logistical constraints mentioned above. Many of the smaller, less complex CWJ's were constructed to provide habitat benefits including escape cover and velocity refugia for juvenile salmonids, whereas the larger, heavily anchored CWJ's (Figure 8 B and D) were constructed with the goal of providing habitat benefits but also effecting hydraulic or geomorphic changes to the river channel. For example, it was hypothesized that placement of large wood structures at the entrances to anabranches in the lower section of the Lowden Ranch rehabilitation site, would help prolong the functioning of these off channel features by maintaining their connection to the mainstem at multiple streamflows (TRRP 2011). To date, this hypothesis appears to be supported as the anabranches are contiguous with the mainstem at all streamflows. Additionally, an increase in surface flow was observed between 2011 and 2017 entering the constructed side channel at the top of the site on river left, which also has a large wood structure at its entrance (USFWS, Hoopa Valley Tribe and Yurok Tribe, unpublished data). These examples along with the many demonstrated benefits of LW in the literature, provide justification for integrating LW into specific aspects of rehabilitation site design as well as the general restoration strategy of the program, which immediately increase the abundance and quality of fish habitats, but also influence fluvial processes in the restoration reach over longer time frames.

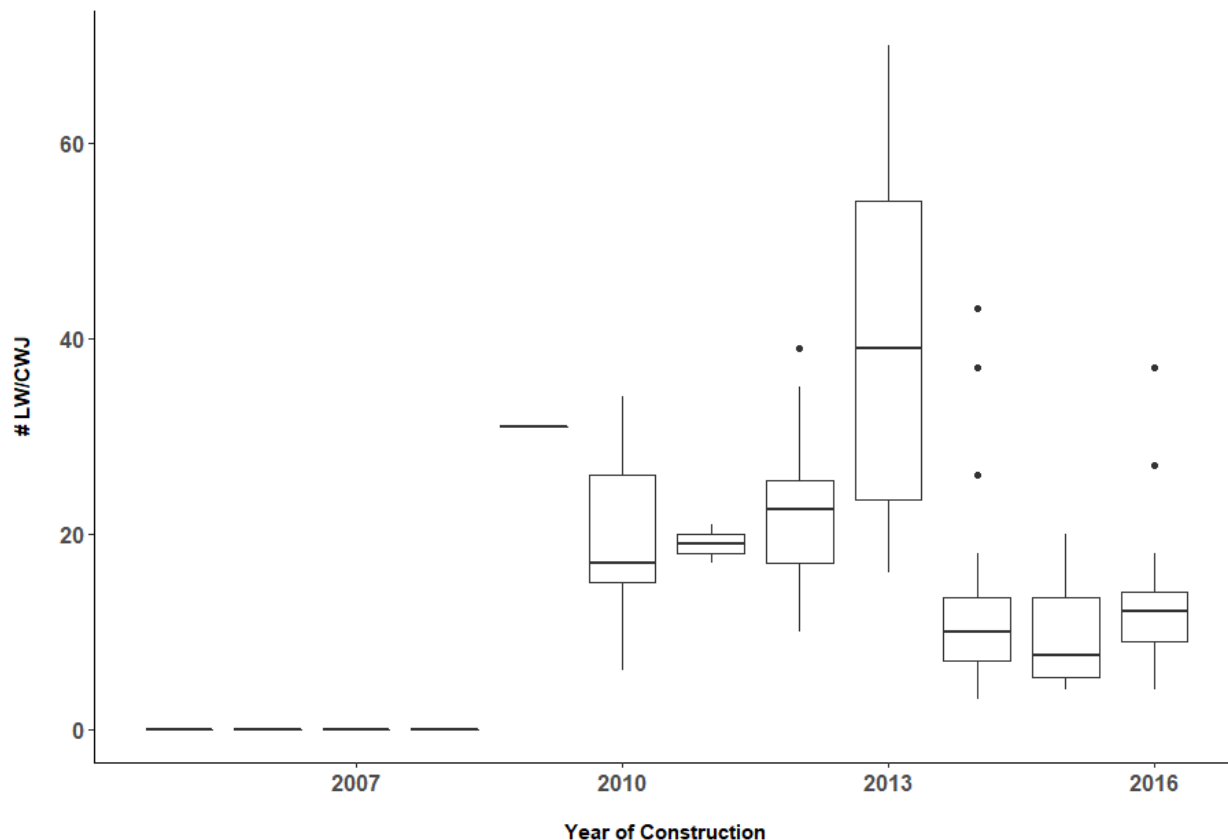
Figure 7. Variation in the number of LW pieces per CWJ over the study period. Horizontal lines indicate the median, boxes around the median indicate the interquartile range, thin vertical lines equal 1.5\* the interquartile range and black circles indicate outliers. There were no CWJ's installed between 2005 and 2008 and only one was installed in 2009.

into CWJ's was variable (median=13, range=3-70) as was the size and level of complexity of these structures (Figures 6 and 7, Appendix A, Table A2). The CWJ with 70 LW pieces was installed at Lorenz Gulch (Figure 8). V weirs (n=29) and log weirs (n=15) constitute approximately 2% of LW structures (Figure 5).

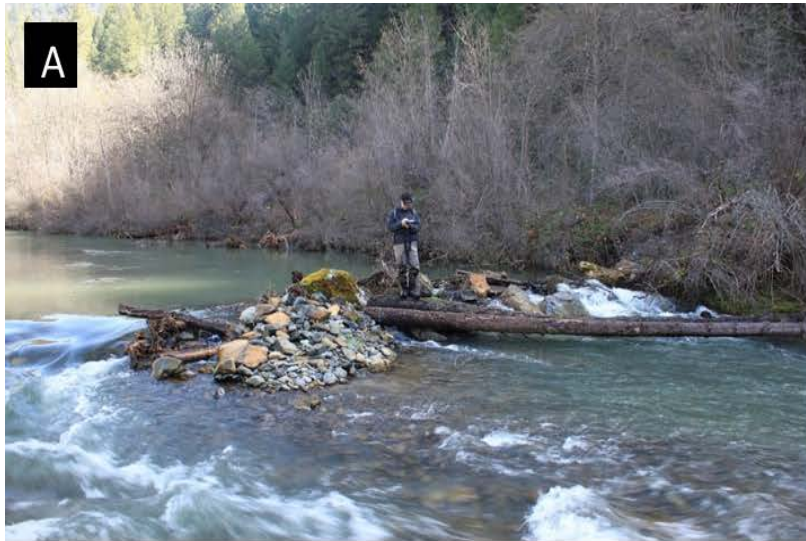
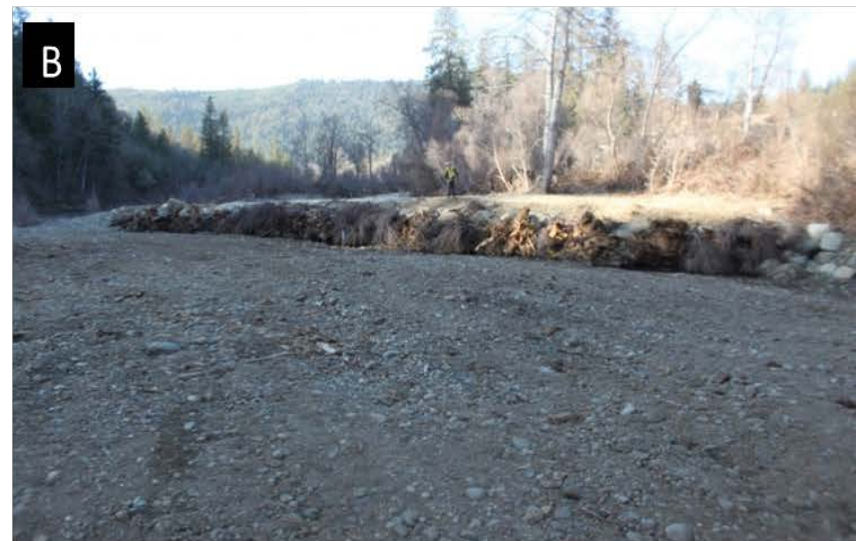
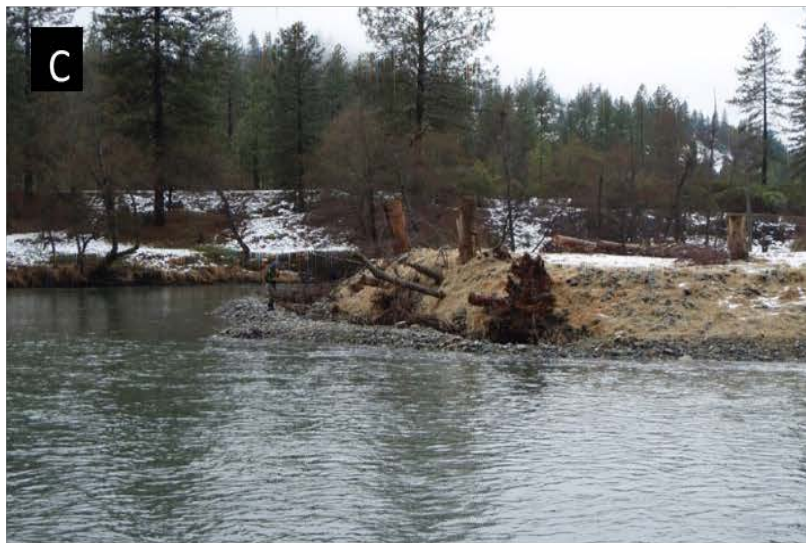
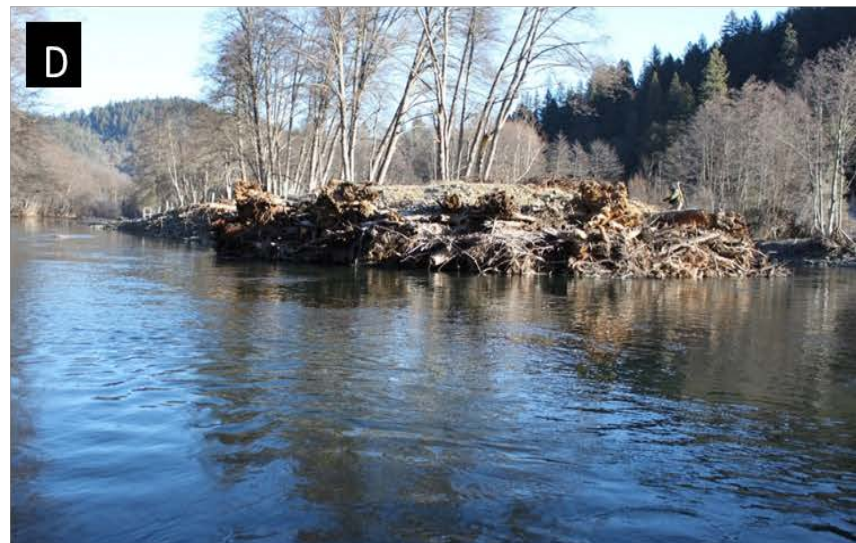
Figure 8. Examples of variation in CWJ size and complexity. A). Limekiln (2015), B). Lower Douglas City (2013), C). Wheel Gulch (2011), D). Lorenz Gulch (2013).

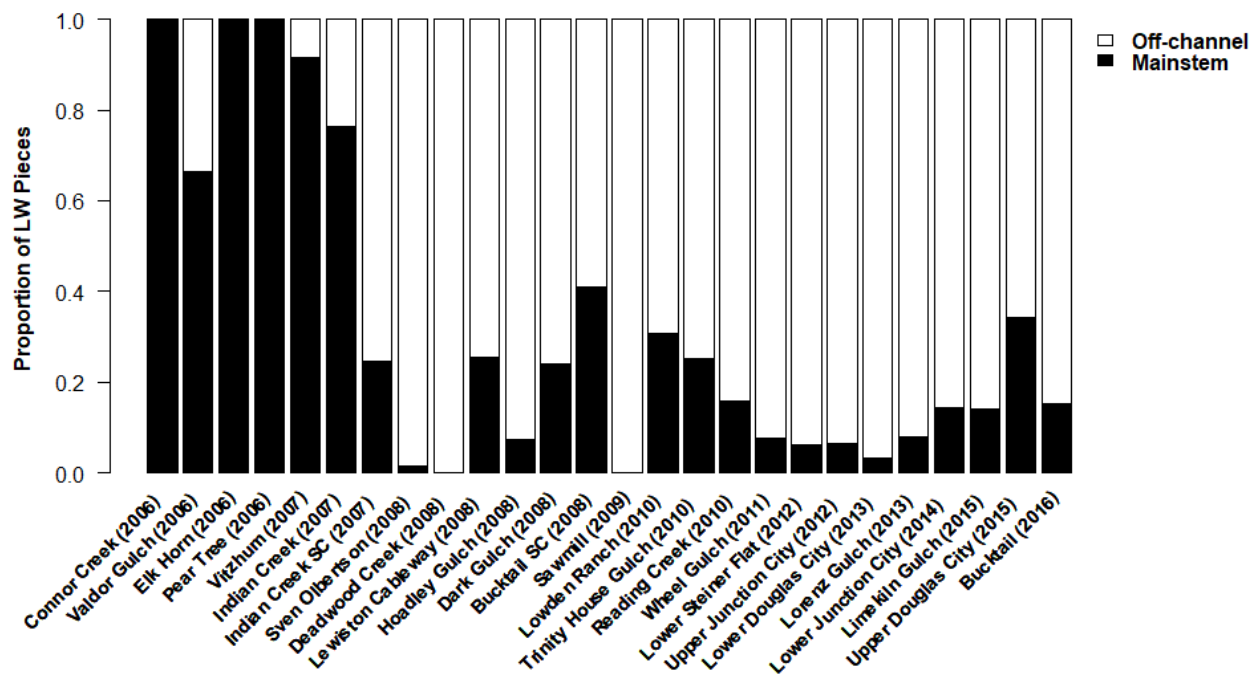
Figure 9. The proportion of LW pieces in the mainstem (closed bars) and in off-channel features (open bars). Sites are ordered chronologically by year of construction in parentheses.

The placement of a majority of LW pieces began to transition from the main channel to off-channel features in 2008 (Figure 9). Eighty-two percent (class I: n=2,895; class II: n=3,006; class III: n=392) of LW pieces were placed in off-channel features (Figure 9; Appendix A, Table A3) and 61% (class I: n=1,887; class II: n=2,308; class III: n=437) were installed within the bankfull channel and are inundated at streamflows at or below 14.2 cms. Figure 10 provides an example of LW placement relative to streamflow inundation.

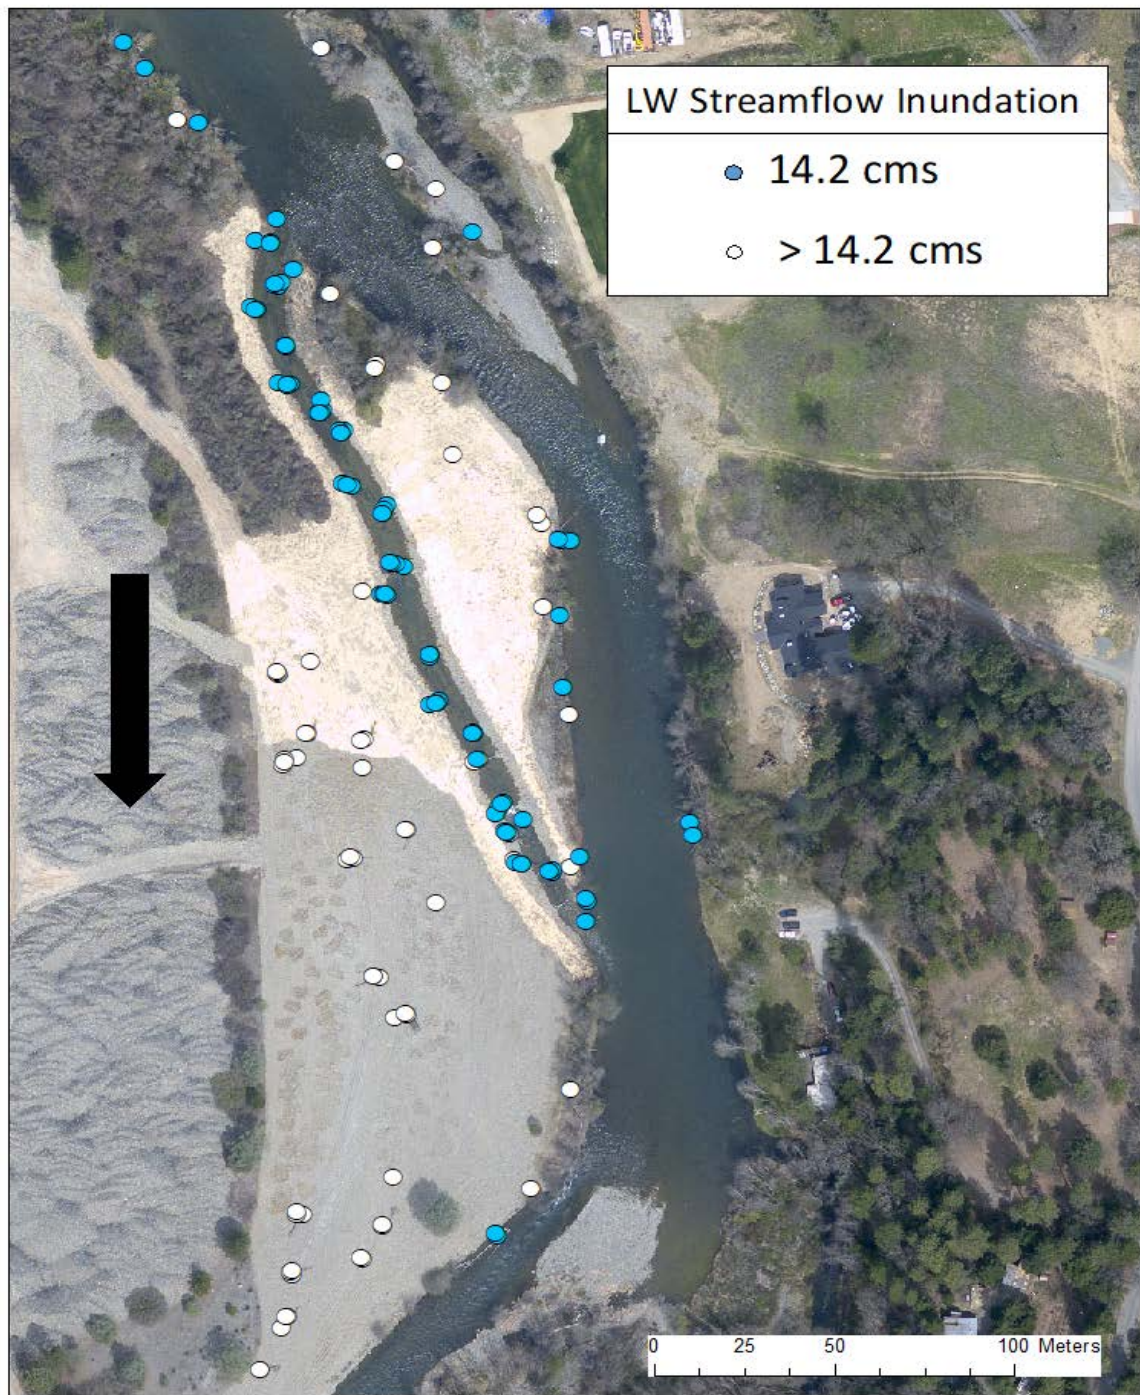
Figure 10. LW placement at Dark Gulch rehabilitation site relative to streamflow inundation in 2008. Symbols indicate any LW (pieces, structures). The arrow indicates direction of streamflow.
