Upper Conner Creek Rehabilitation Site Existing Conditions Report

Final

March 16, 2020

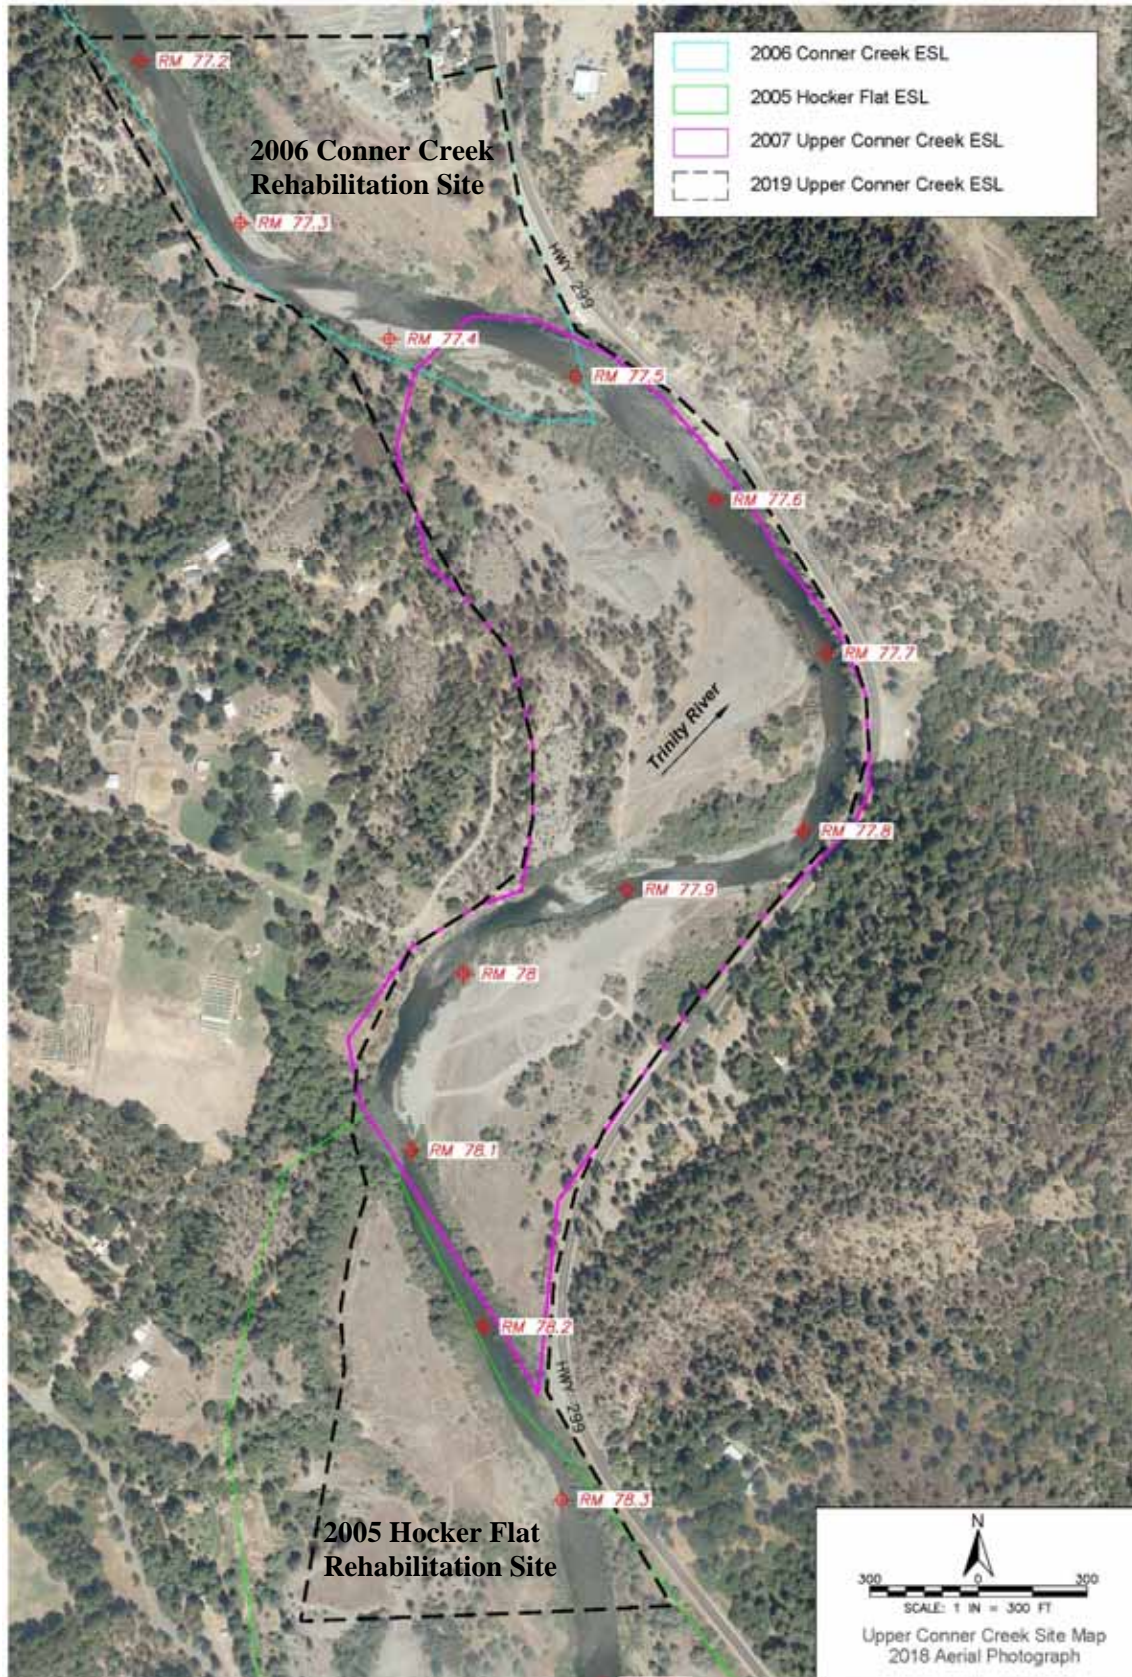
Figure 3. Upper Conner Creek Rehabilitation Site.

The project site is located approximately 1.5 miles west of Junction City, CA below the Canyon Creek confluence within the North Fork Reach (RM 79.3 to RM 72.2) of the mainstem Trinity River (Figure 1). The project site includes approximately 84 acres and spans 1.2 miles of river between River Mile (RM) 77.2 and RM 78.4 (Figure 2). The project site is approximately 35 miles downstream of the Lewiston Dam, between the previously constructed Hocker Flat (RM 78.4) and Conner Creek (RM 77.2) restoration sites.

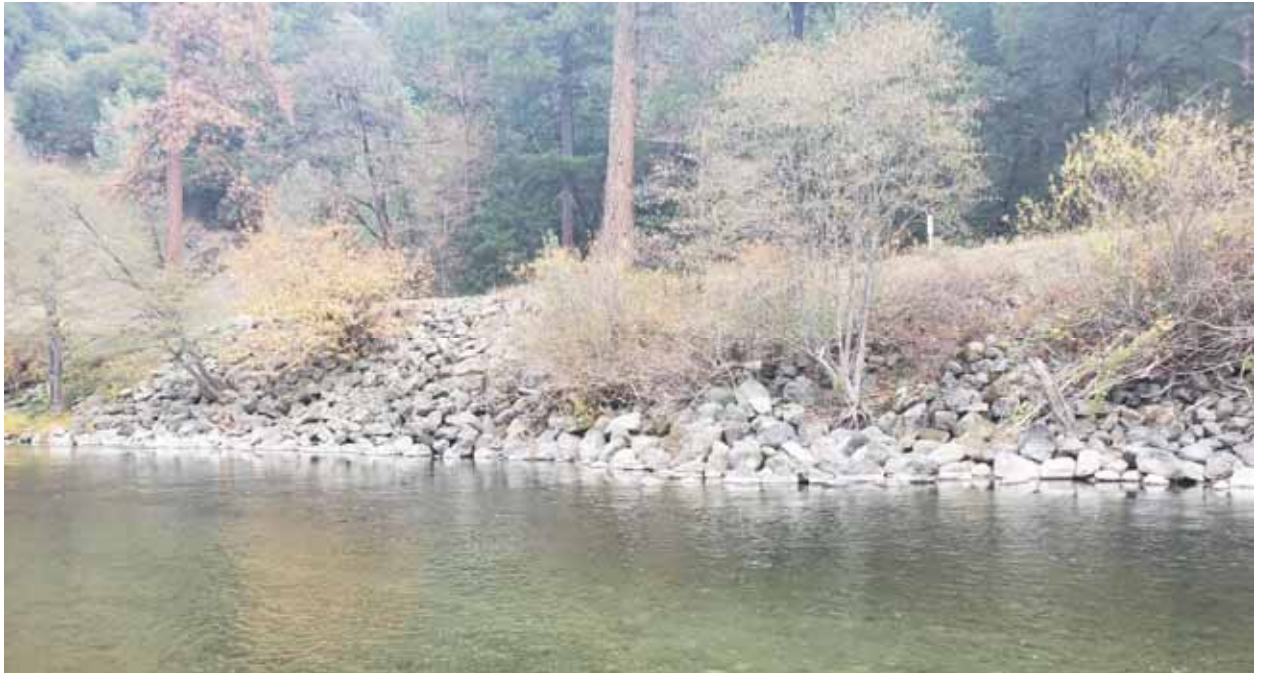
Figure 5. Riprap along the right bank from RM 77.5 to RM 77.8.

Existing infrastructure within the project site ESL includes State Highway 299, riprap along much of the right bank (Figure 5), culverts and concrete walls along the highway (Figure 6), concrete crib walls (Figure 7), and some private roads that provide river access on the left bank. Electric transmission lines and power poles exist within the project site ESL; a transmission line crosses the river at RM 77.45 (Figure 8). Existing utility lines and poles within the project site ESL shall be protected in place or relocated prior to construction activities.

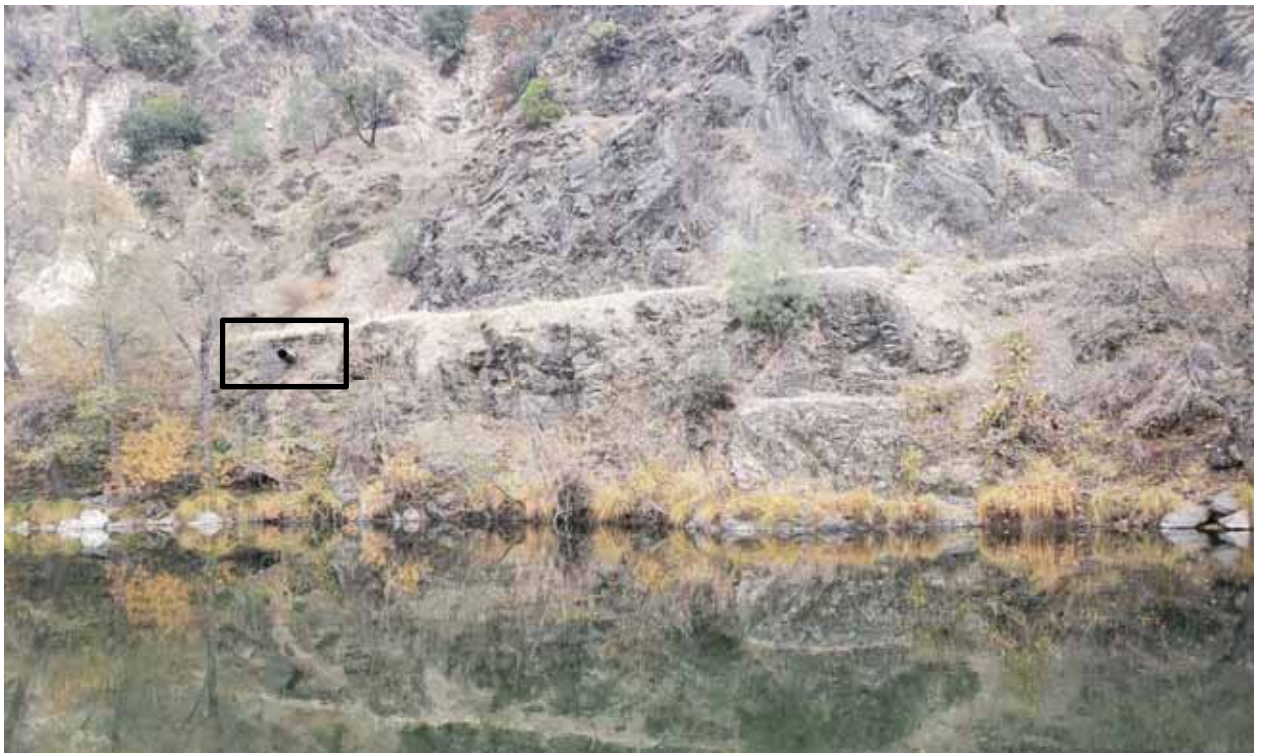
Figure 6. Existing wall with culvert used for Highway 299 drainage (outlined in black).

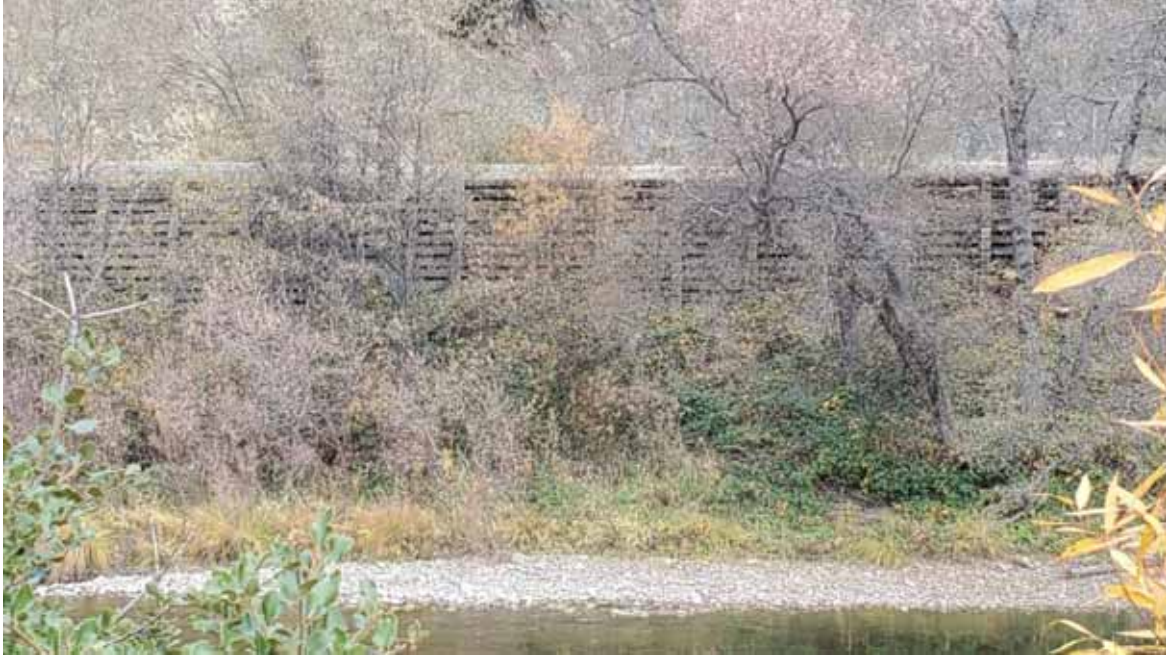
Figure 7. Concrete crib wall on river right along Highway 299.

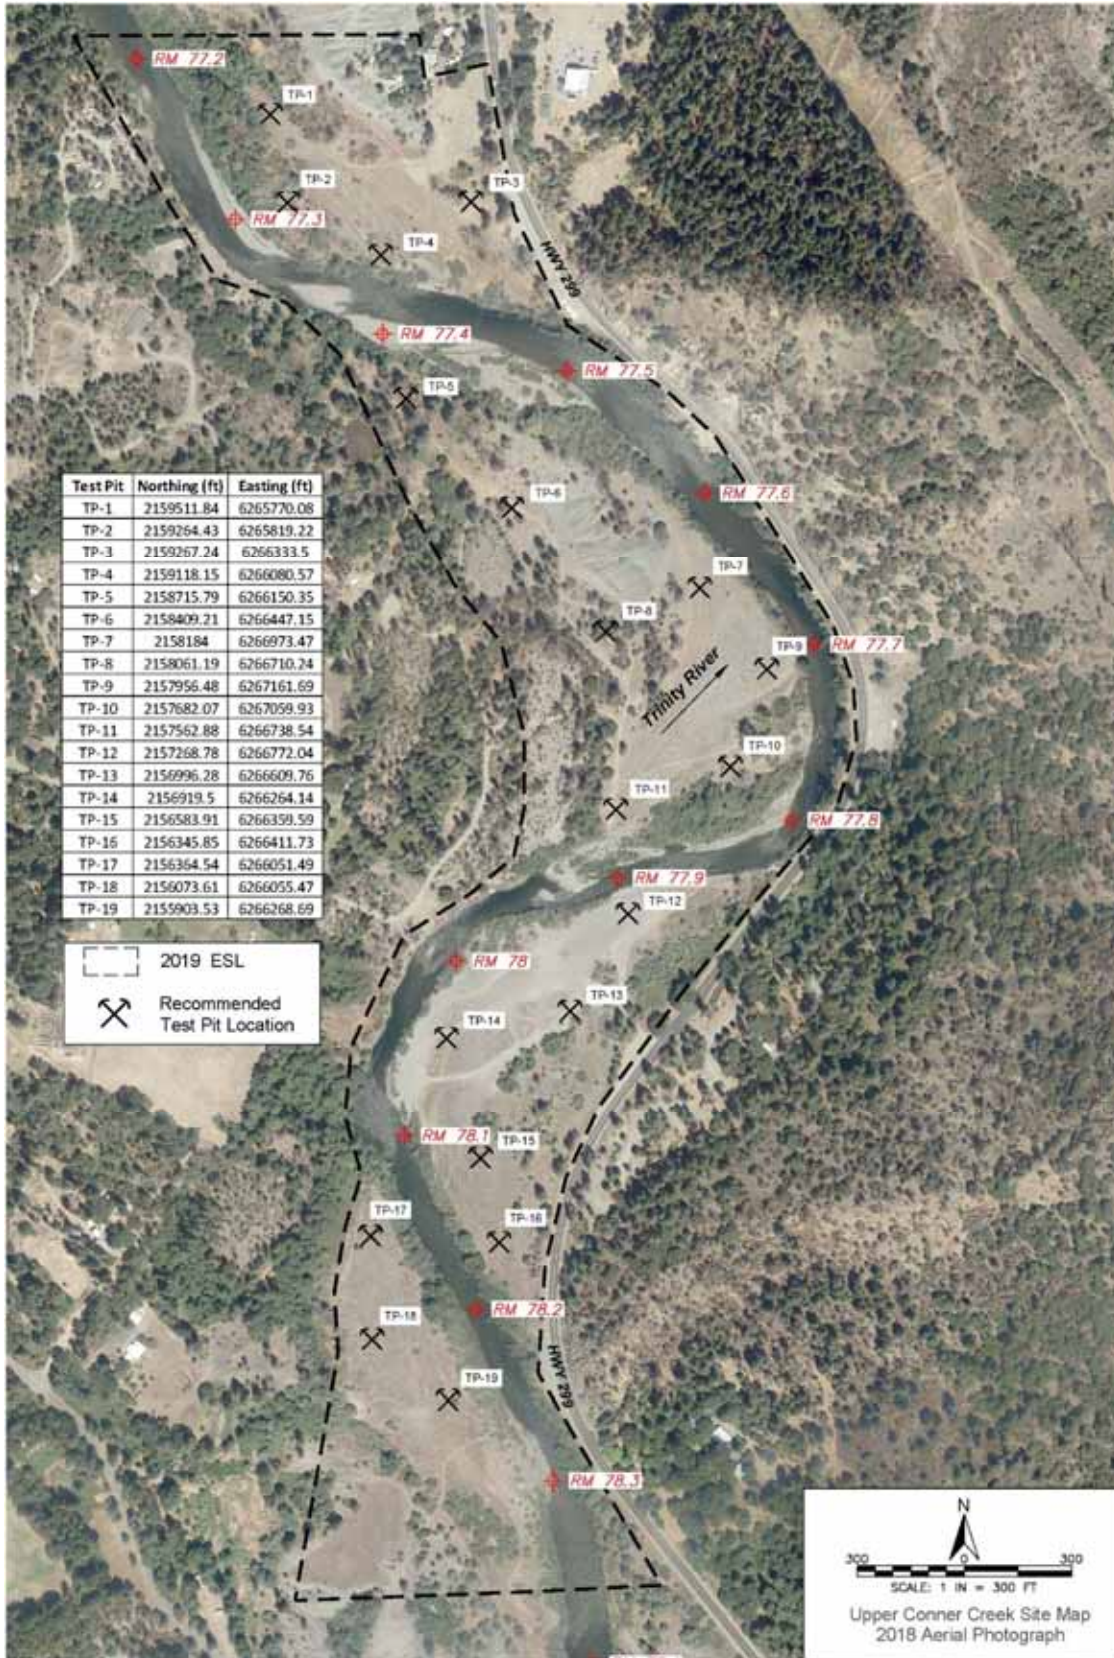
Figure 9. Recommended test pit locations.

Site-specific geotechnical investigations will be conducted by the TRRP for the Upper Conner Creek Rehabilitation project. Geotechnical investigations will identify bedrock contacts, identify the depth to groundwater throughout the project site, and document the subsurface stratigraphy (e.g., material type and composition), all of which inform the project. Proposed test pit locations, recommended by McBain Associates, for the project site are shown in Figure 9; actual test pit locations will be determined by the TRRP in collaboration with the HVT design team.

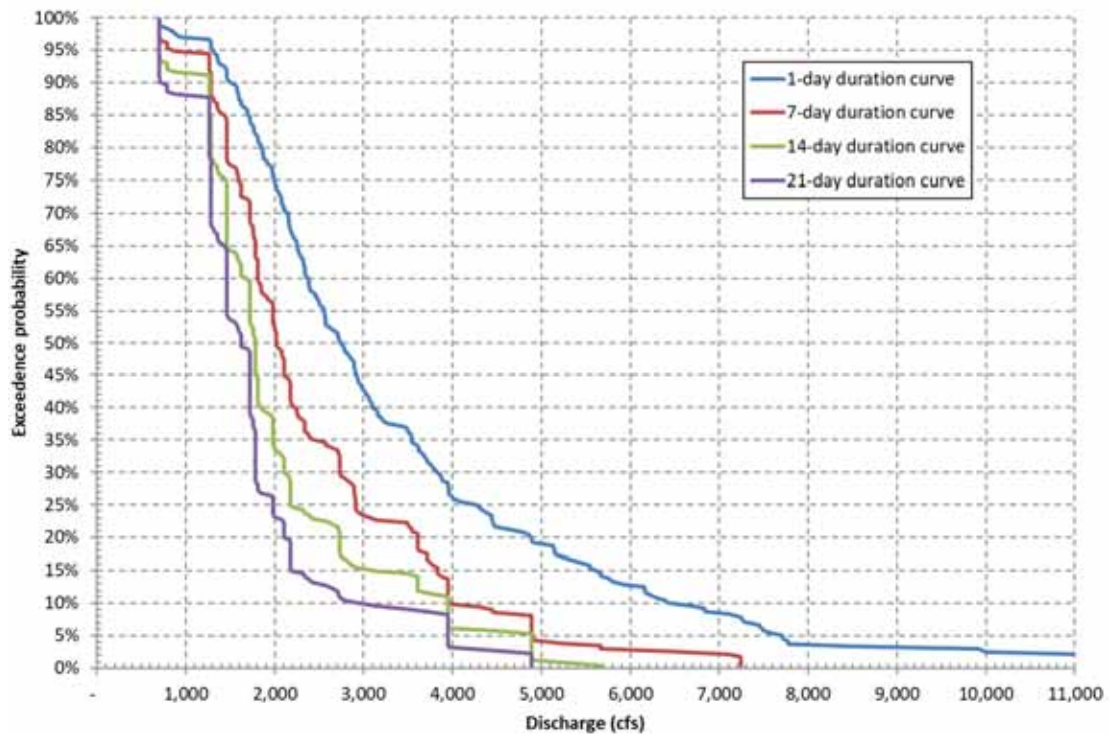
Figure 10. Flow duration curves for Extremely Wet water years (n=2) for winter rearing: January–April 30.

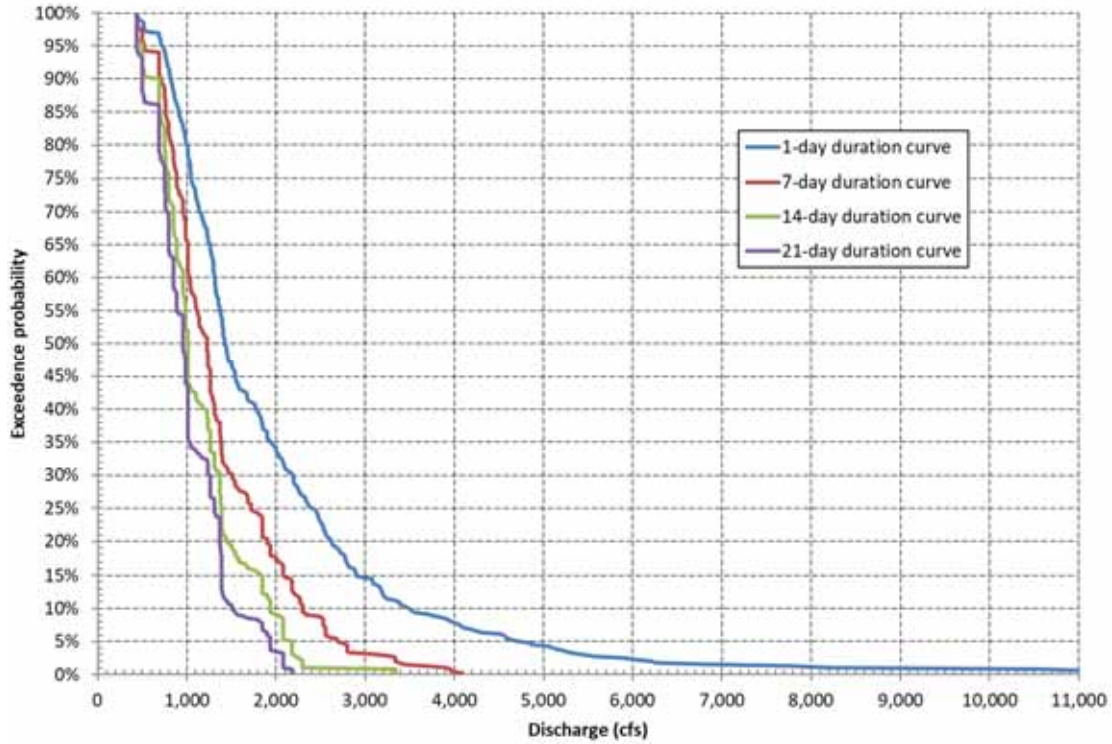
Figure 11. Flow duration curves for Wet water years ($n=3.5$) for winter rearing: January 1–April 30.

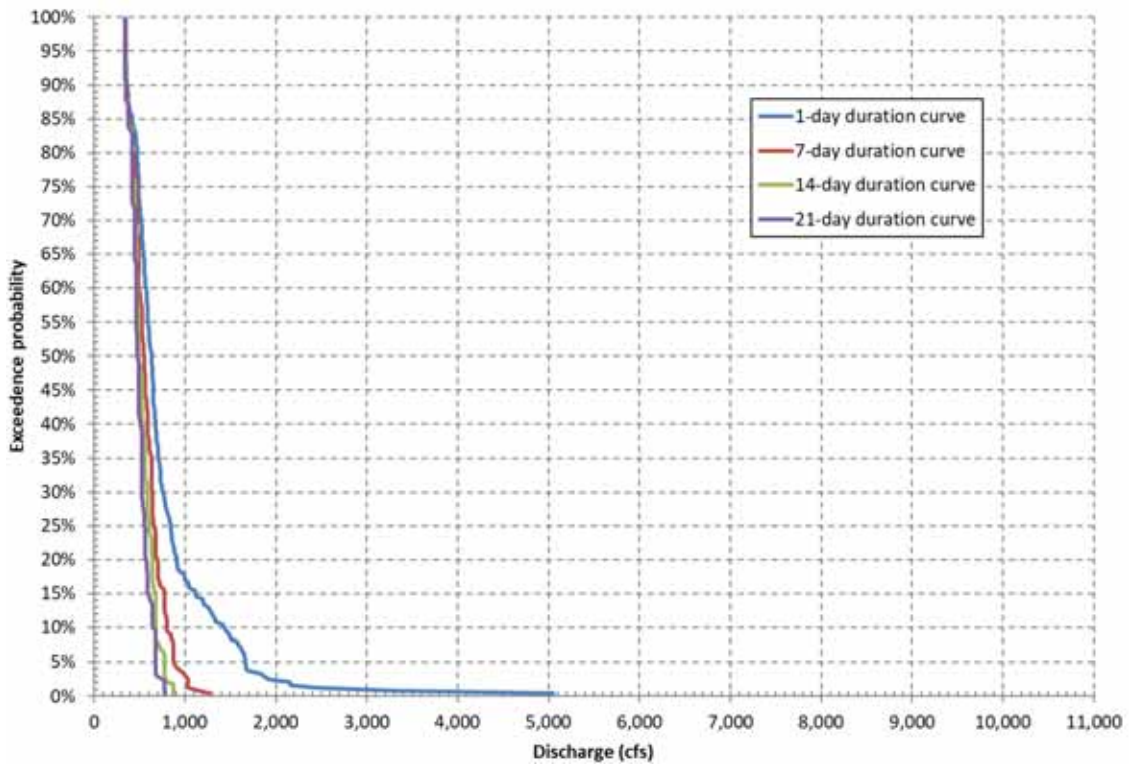
Figure 14. Flow duration curves for Critically Dry water years (n=2) for winter rearing: January 1–April 30.

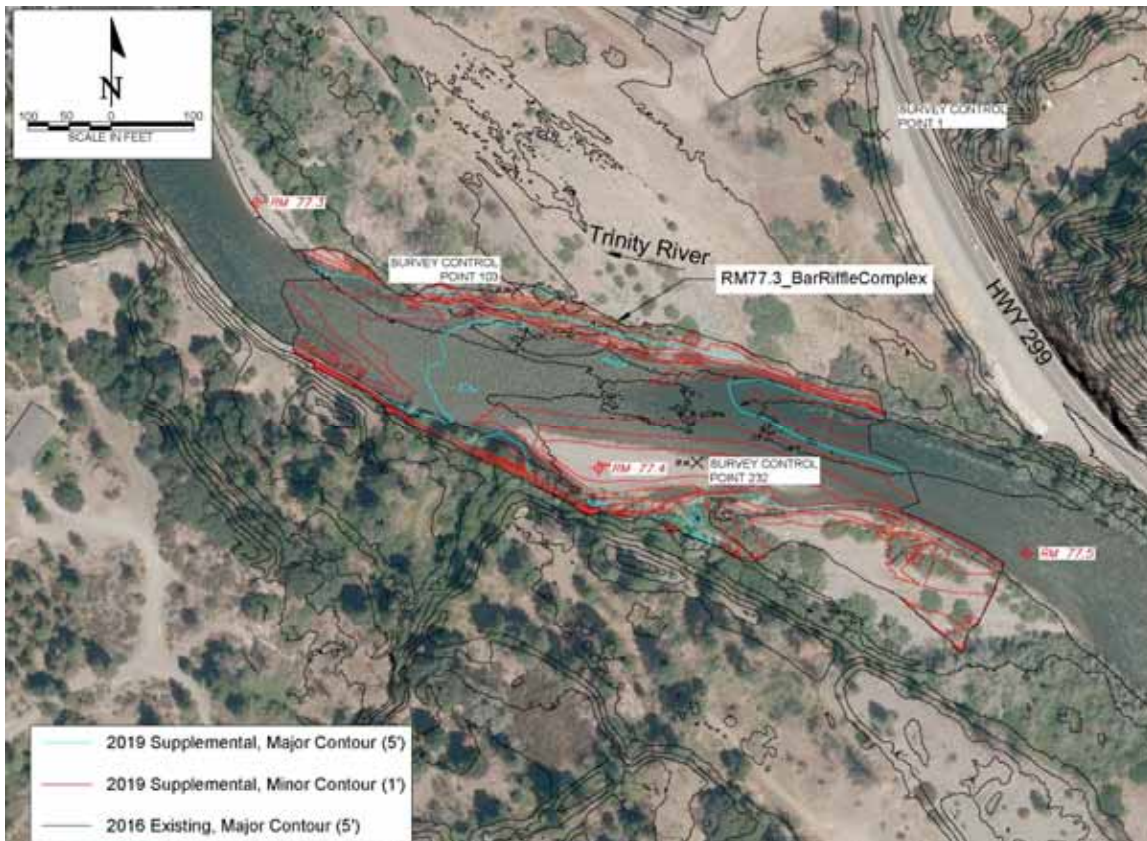
Figure 17. 2019 topographic supplemental survey for the evolved bar–riffle complex at RM 77.3.

The existing topography was built from terrestrial LiDAR and sonar data, collected in 2016 by Graham Matthews Associates, and supplemental surveys, conducted in November 2019, of dynamic features that were formed after the 2016 bathymetric surveys. Significant topographical changes at RM 77.3, RM 77.9, and RM 78.0 resulting from winter flood peaks in water year (WY) 2019 (21,000 cfs at “the above NF Trinity River” gage) were observed during an initial site visit in October 2019. Features that were surveyed during the November 2019 supplemental surveys include the downstream riffle and bar at RM 77.3, the bar–riffle complex at RM 77.9, and the bar at RM 78.0. Point data from these surveys were imported to Civil 3D and refined using breaklines, daylighting edges, and surface boundaries to create surfaces for these features (Figure 17, Figure 18).

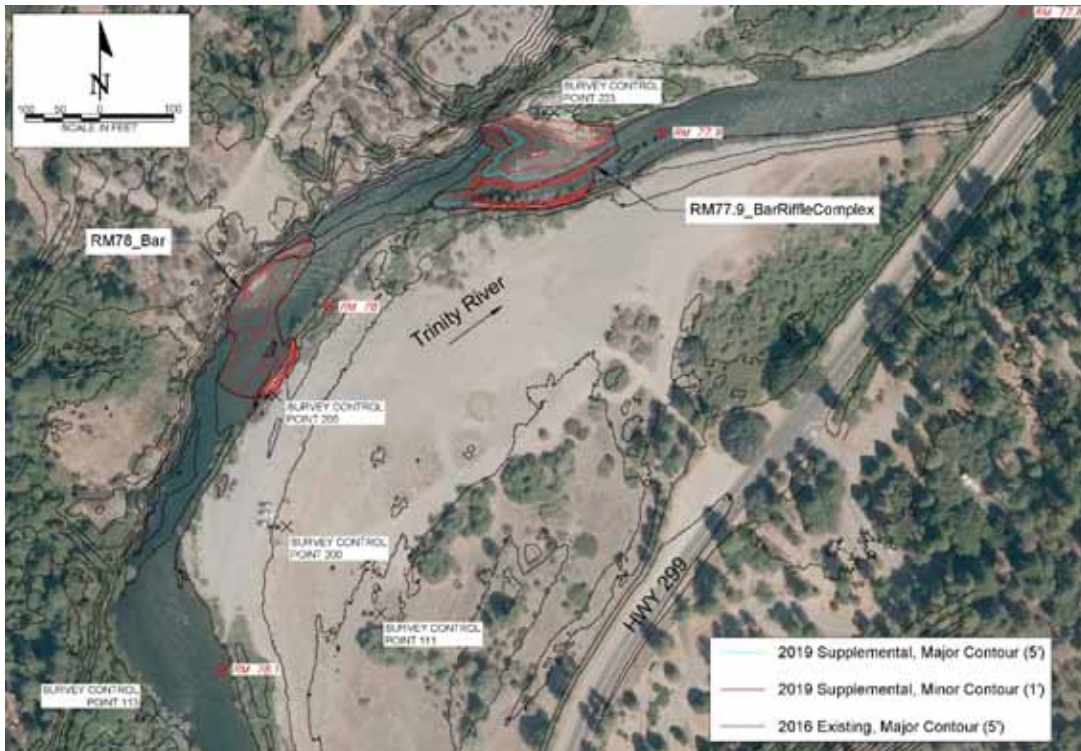
Figure 18. 2019 topographic supplemental survey for the evolved bar-riffle complexes at RM 77.9 and RM 78.0.

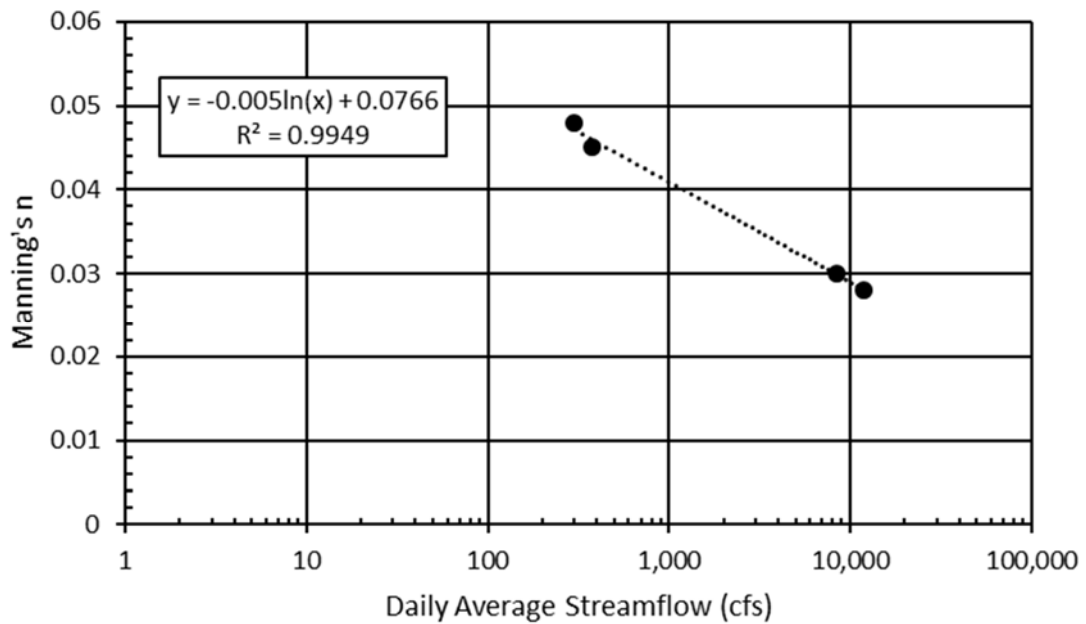
Figure 20. Flow-roughness rating curve for Upper Conner Creek 2-D hydraulic model for in-channel areas.

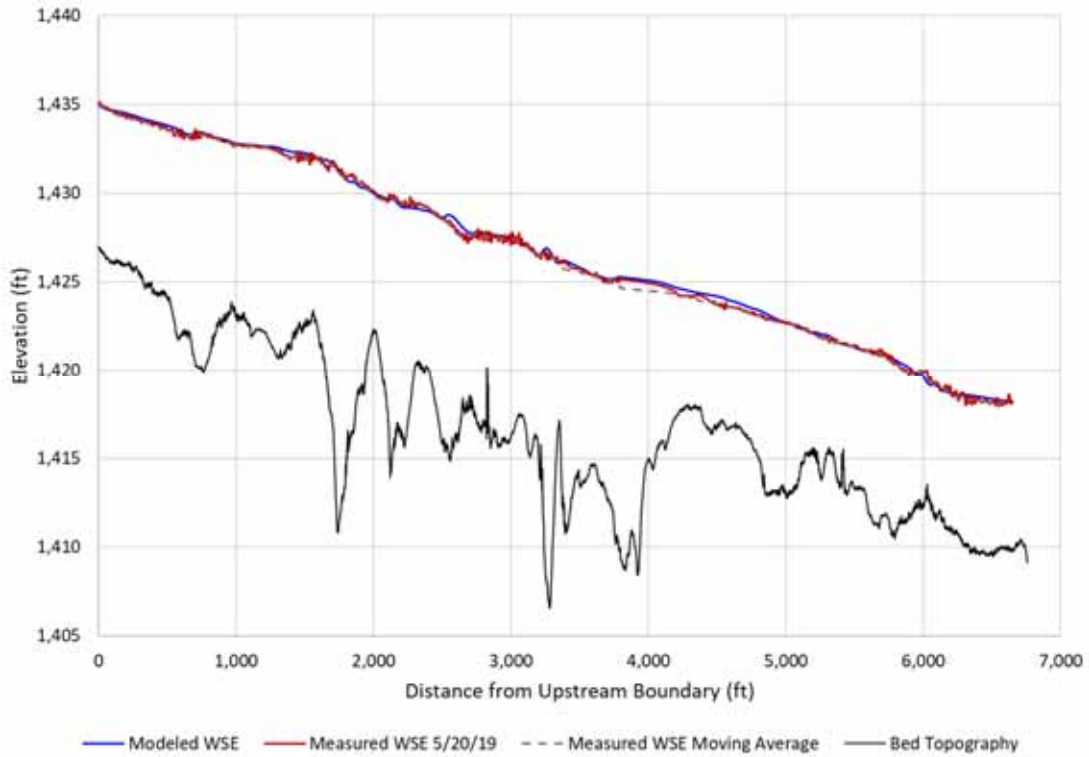
Figure 22. Modeling results for the high-flow scenario (8,500 cfs).

Model results for the high-flow scenario (8,500 cfs) showed a close match to measured data throughout the project site (Figure 22). Model results for the low-flow scenario (380 cfs) were more complex to examine due to geomorphic changes in the project site (Figure 23). Statistics used to examine the high-flow results compared modeled and measured WSEs over the entire reach. Low-flow results compared modeled WSE to the LiDAR-extracted WSEs in areas of the site that were not updated with 2019 topography. In areas that were updated, modeled WSEs were compared to WSE measurements surveyed during the 2019 field effort (Table 4). Overall, the WSE results in the low-flow scenario matched well with 2016 LiDAR-extracted WSE data in the non-updated areas of the project site. Areas that were updated with 2019 topography did not match well with the 2016 data due to bed topography changes that have occurred between 2016 and 2019. However, these areas generally matched well with WSE data collected in November 2019 (Figure 23). WSE model results, and the 2016 terrestrial LiDAR-extracted WSE data in the Hocker Flat portion of the site were both greater than the 2019 WSE data collected in the area, indicating that this portion of the channel has incised since 2016. McBain Associates will request that the TRRP update the LiDAR and bathymetry of the reach prior to construction.

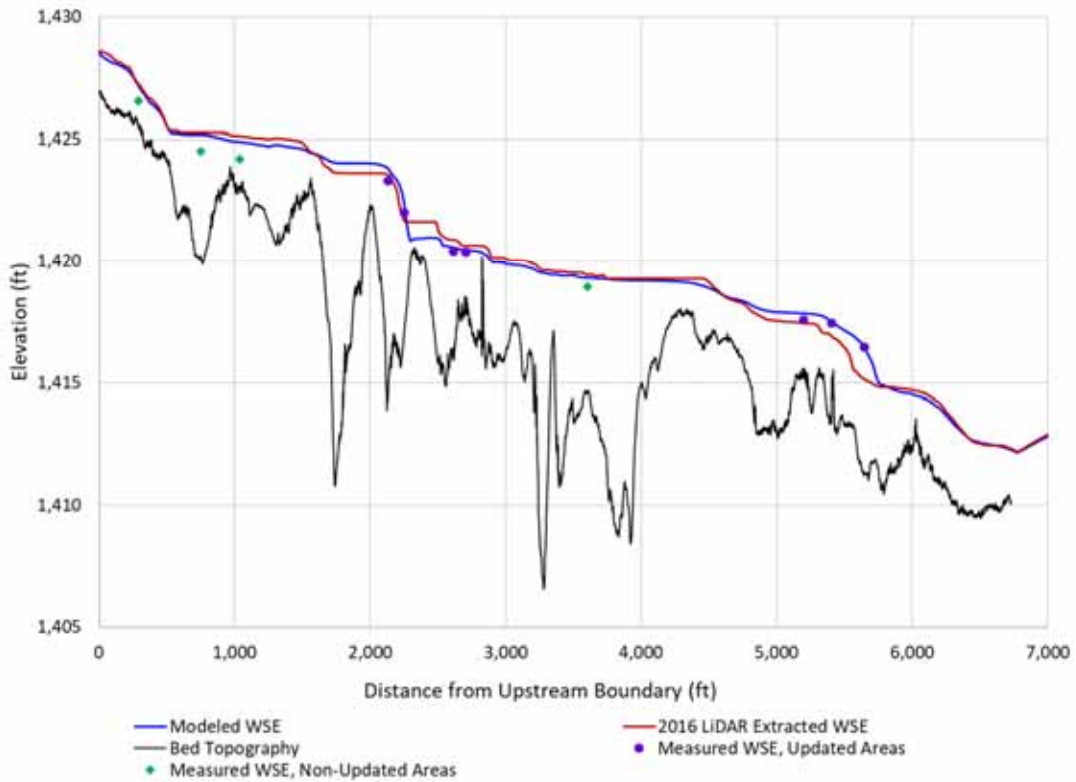
Figure 23. Modeling results for the low-flow scenario (380 cfs). Measured WSE (11/10/2019) diamond markers indicate measured WSEs that are not associated with updated topographic features.

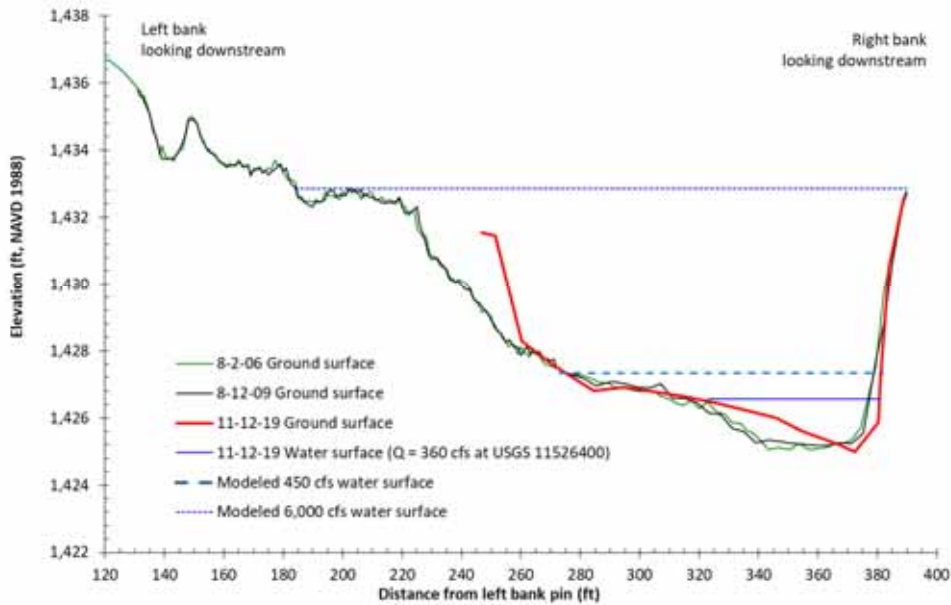
Figure 37. Trinity River, Upper Conner Creek, cross section 314+15 showing the development of a riparian berm on the left bank and slight channel migration towards the right bank.

between 2006 and 2019 (Figure 37, Figure 38). However, they did reveal significant riparian berm development 4 to 5 ft in height along the left bank of 314+15 (Figure 37) and the right bank of 302+75. The aggradation along the left bank of 302+75 was a sand bar which was associated with the high-flow channel return which enters the mainstem immediately upstream. The 2 ft of bed scour between the 2005 and 2019 ground surfaces shown in Figure 38 (XS 302+75) does not appear in the DEM of difference (Figure 36) because it occurred prior to the GCD analysis period (2012–2019).

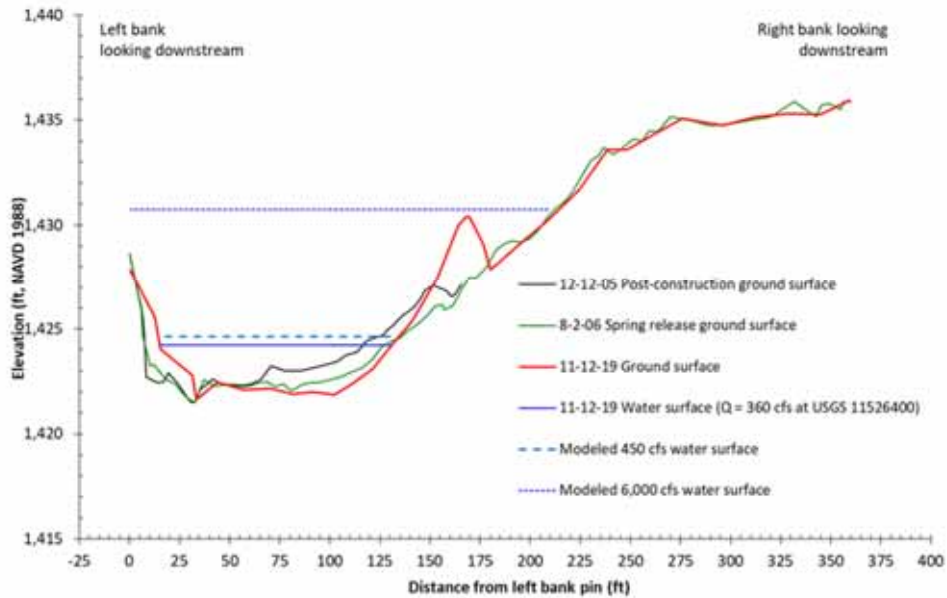
Figure 38. Trinity River, Upper Conner Creek, cross section 302+75 showing riparian berm development along the right bank.

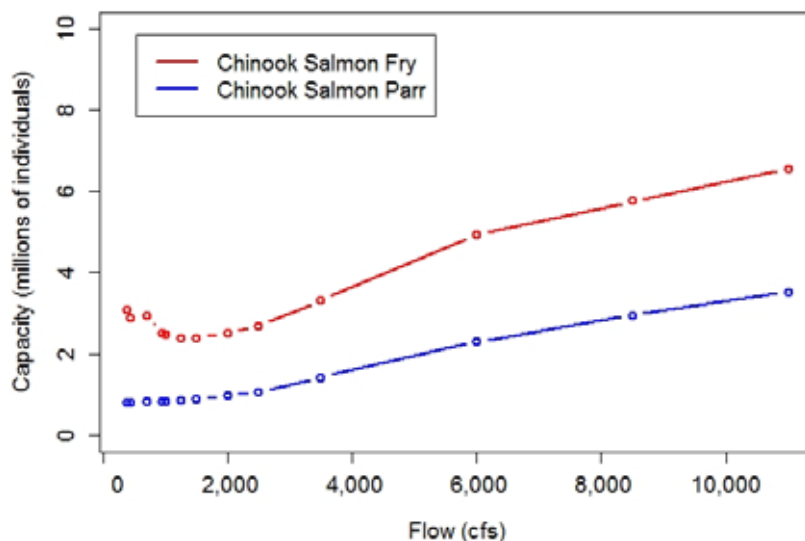
Figure 53. Capacity for Chinook Salmon fry and parr life stages under existing conditions at the Upper Conner Creek project site.

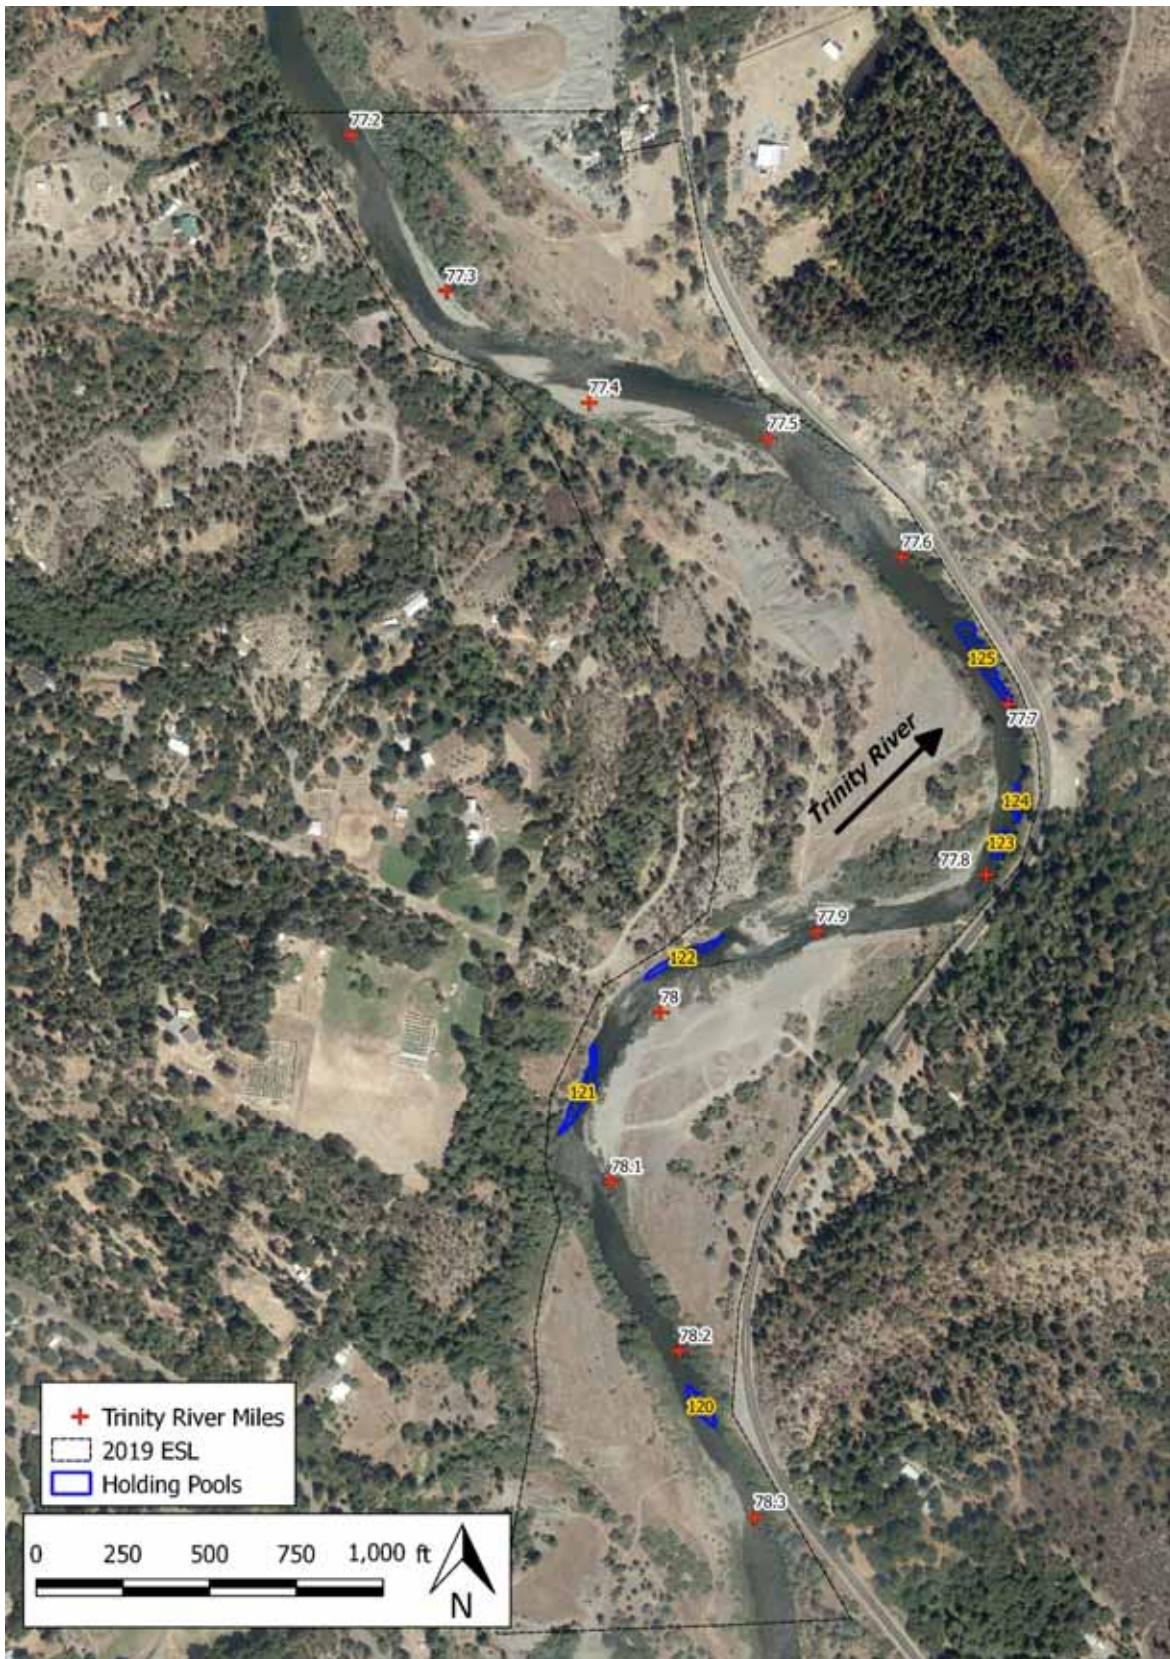
Figure 54. Adult Chinook Salmon holding pool locations based on 2019 existing condition hydraulic model results. Pool numbering matches Gaeuman and Krause (2013).

flow at the downstream boundary of Hocker Flat. Surveys conducted in 2009 and 2010 by Gaeuman and Krause (2013) showed that, within the project site, some pools are aggrading and some are deepening. An analysis of the pools using the 2019 existing conditions hydraulic model with the 2019 topography and a flow of 450 cfs was conducted to compare the existing pool depths. For pools deeper than 6.6 ft, existing pool were compared to values presented in Gaeuman and Krause (2013), in which the maximum depth and 75th percentile depths were examined. Maximum depth examines the deepest portion of each pool and change in this parameter provides insight into changes at the deepest locations since 2010. The 75th percentile depth parameter examines the broader range of depths in each pool and changes in this parameter provide insight on how the depth distribution of the pool has changed since 2010.
