# Vegetation Encroachment Synthesis for the Trinity River

Final Report

April 14, 2021

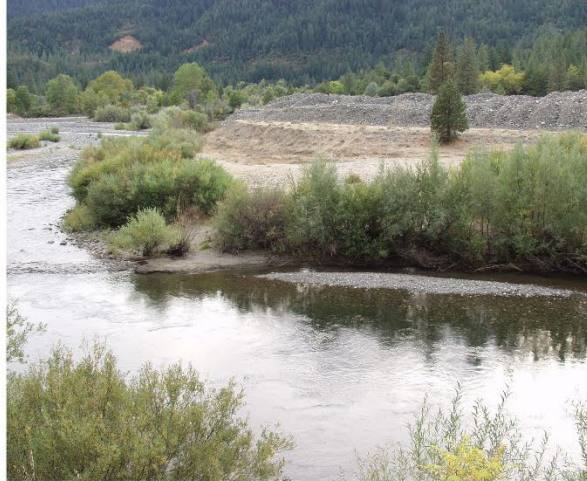
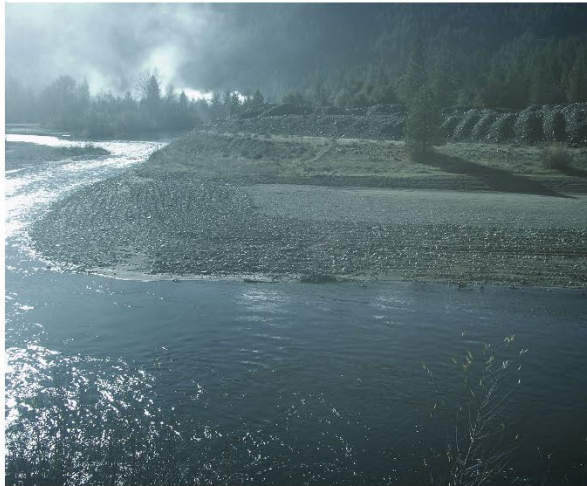
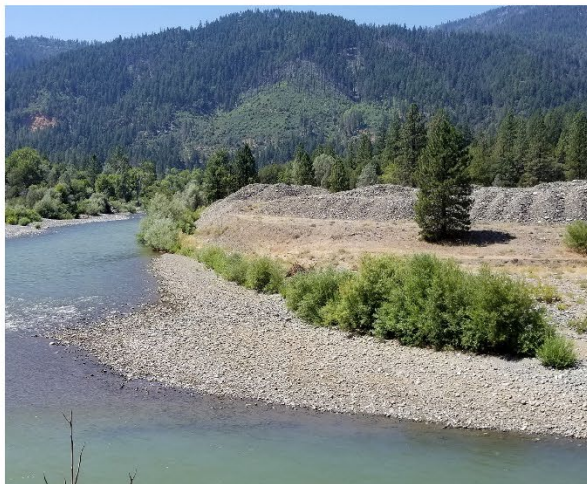
Hocker Flat Channel Rehabilitation Site. Top: 2004 Pre-construction  
Middle: 2005 Post-construction; Bottom: 2019 Post-construction

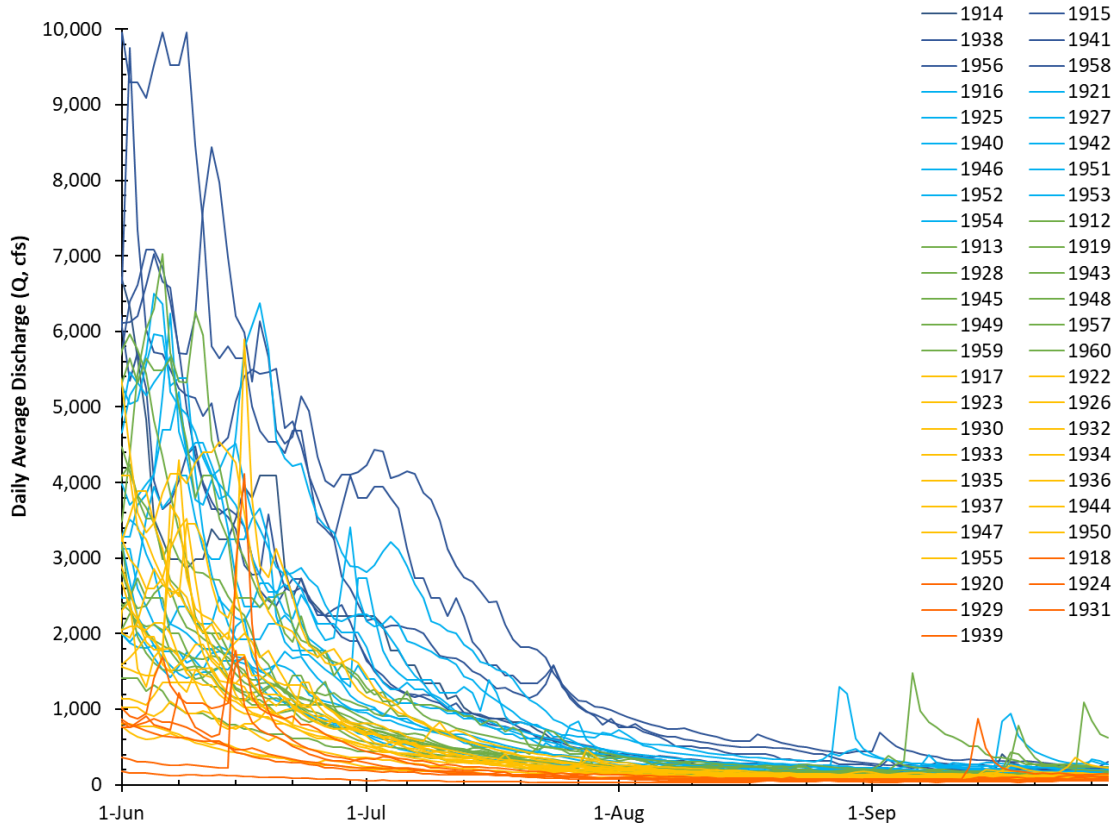
Figure 5. Trinity River at Lewiston unimpaired hydrographs 1912–1960, showing June to September receding limb and summer baseflow period. Water years are color coded by type (Extremely Wet = dark blue, Wet = light blue, Normal = green, Dry = Yellow, Critically Dry = Orange).

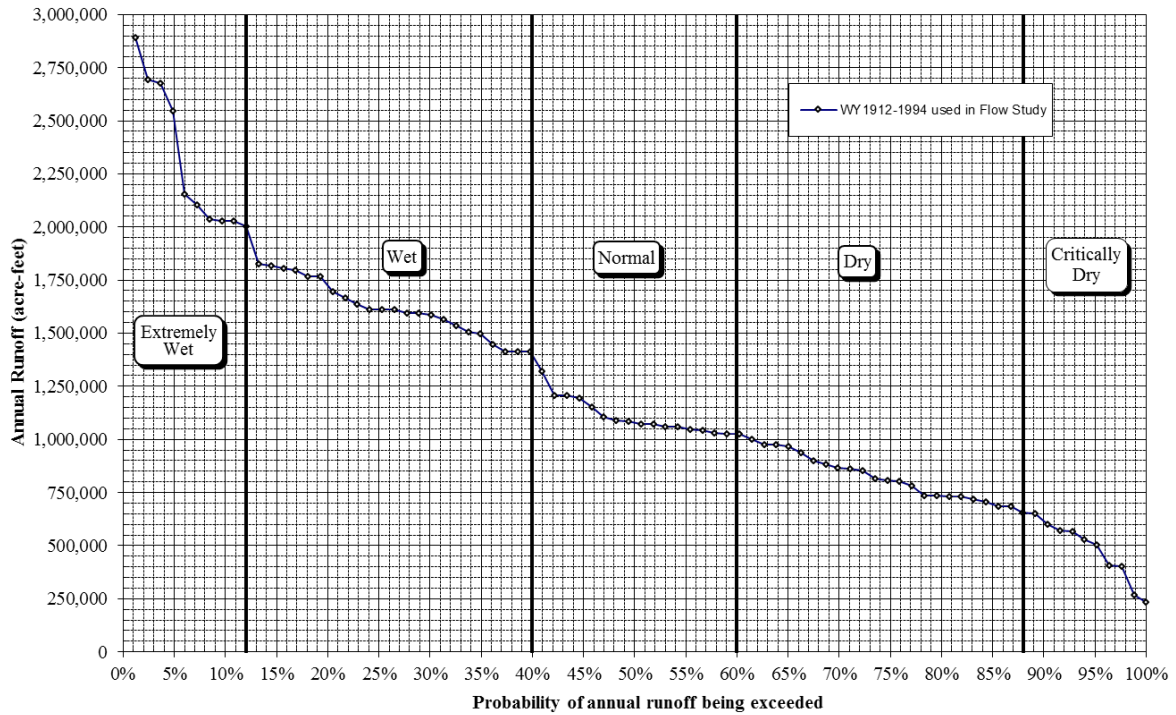
Figure 6. TRFE Water Year Classification based on WY 1912–1994 unimpaired annual runoff (USFWS and HVT 1999).

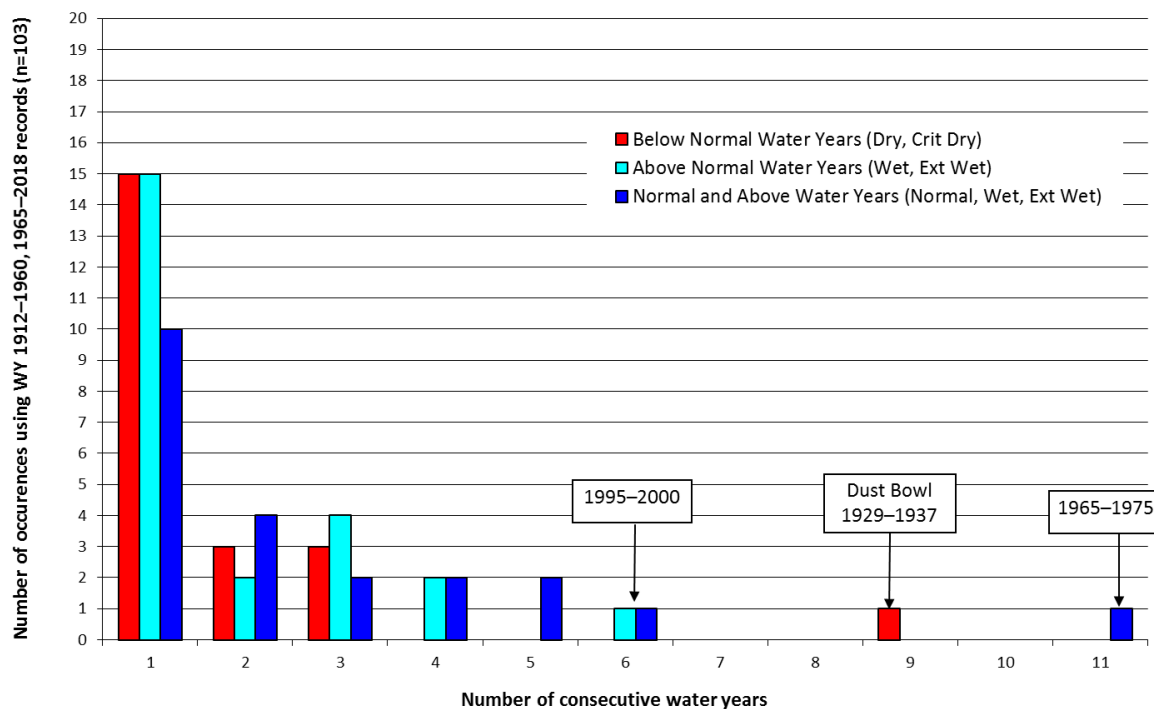
Figure 7. Consecutive water year classes for below Normal, Normal and above, and above Normal water year types from WY 1912–2018.

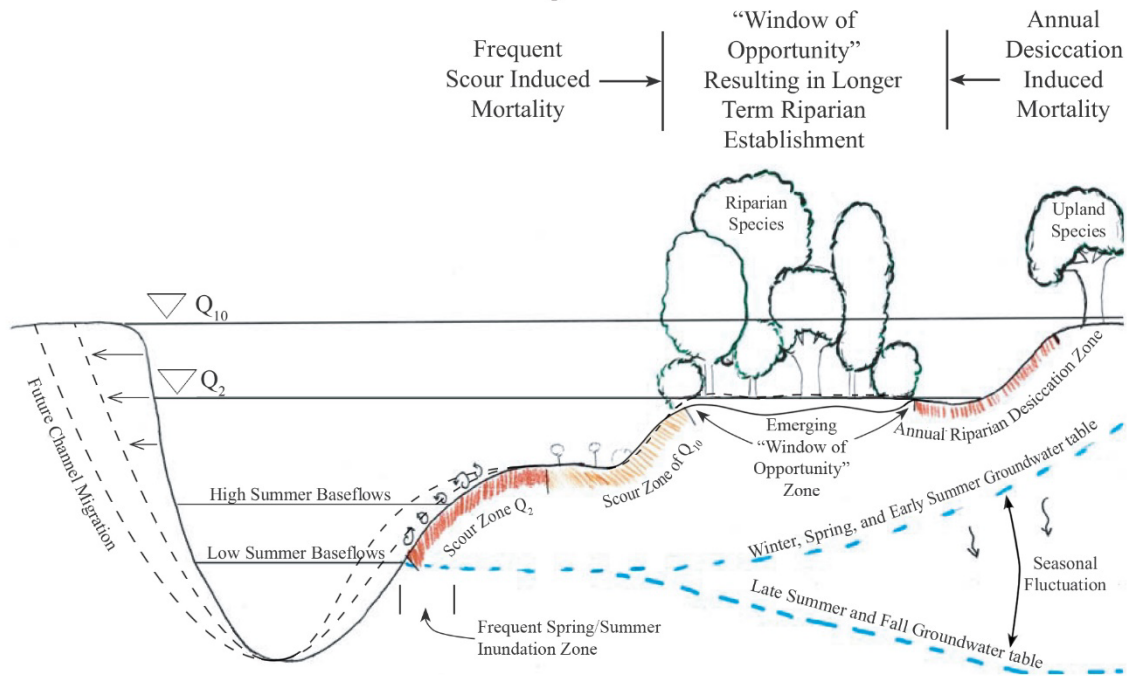
- The 2 year flood ( $Q_2$ ) removes seedlings
- The 10+ year flood ( $Q_{10}$ ) removes small trees / shrubs, maintaining channel width

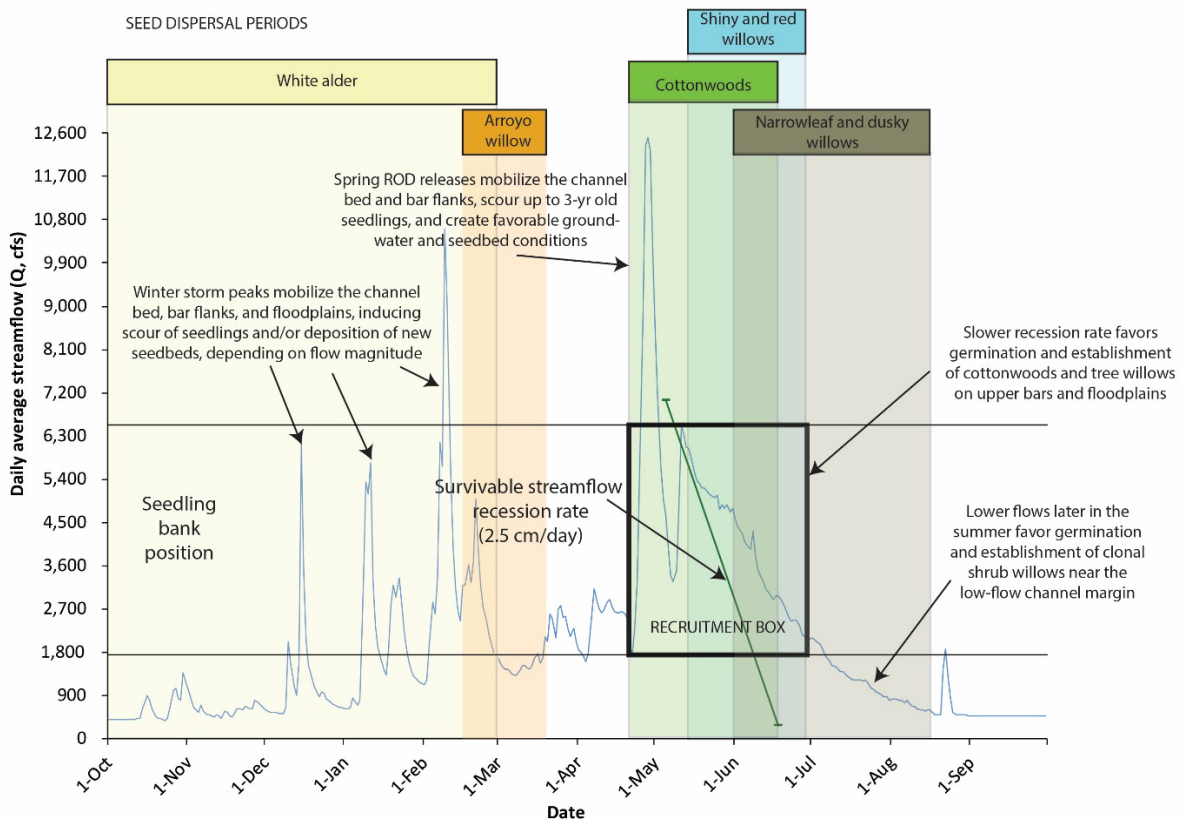
Figure 9. Approximate streamflow release hydrograph from Lewiston for WY 2017, showing hydrograph components that influence survival of riparian hardwoods. While winter storms and spring peak flows may induce both scour and inundation of seedlings, the receding limb of the hydrograph can be used to encourage recruitment. The recruitment box model (Mahoney and Rood 1998) describes favorable conditions for recruitment as the coincidence of seed dispersal onto moist streambank and floodplain positions with gradual flow recession rates. The recruitment box is shown for cottonwoods and tree willows.

Integral to riparian woody plant ecology are the different times when ascending limbs, peak streamflows (floods), receding limbs, and baseflows begin and end, and total duration of each flow stage (Figure 9). Successful germination, initiation, and establishment of many riparian woody plants rely on the timing of seed dispersal coincident with these flow periods (Bradley and Smith 1986, Scott et al. 1993, Mahoney and Rood 1998). If seed dispersal occurs during peak streamflows, the seeds will fall on inundated surfaces and wash away. As flows recede, seeds may land on recently exposed moist substrates and germinate. Germination can lead to successful establishment if flows recede gradually enough to provide favorable soil moisture conditions to growing seedling roots. This interaction between the timing of seed dispersal, the availability of suitable moist germination sites on streambanks and floodplains, and gradual flow recession rates that allow growing seedling roots to access retreating groundwater is known as the recruitment box model (Mahoney and Rood 1998). In the Restoration Reach, cottonwood and willow seed dispersal occurs during the receding limb and ends during summer baseflows (Figure 9).

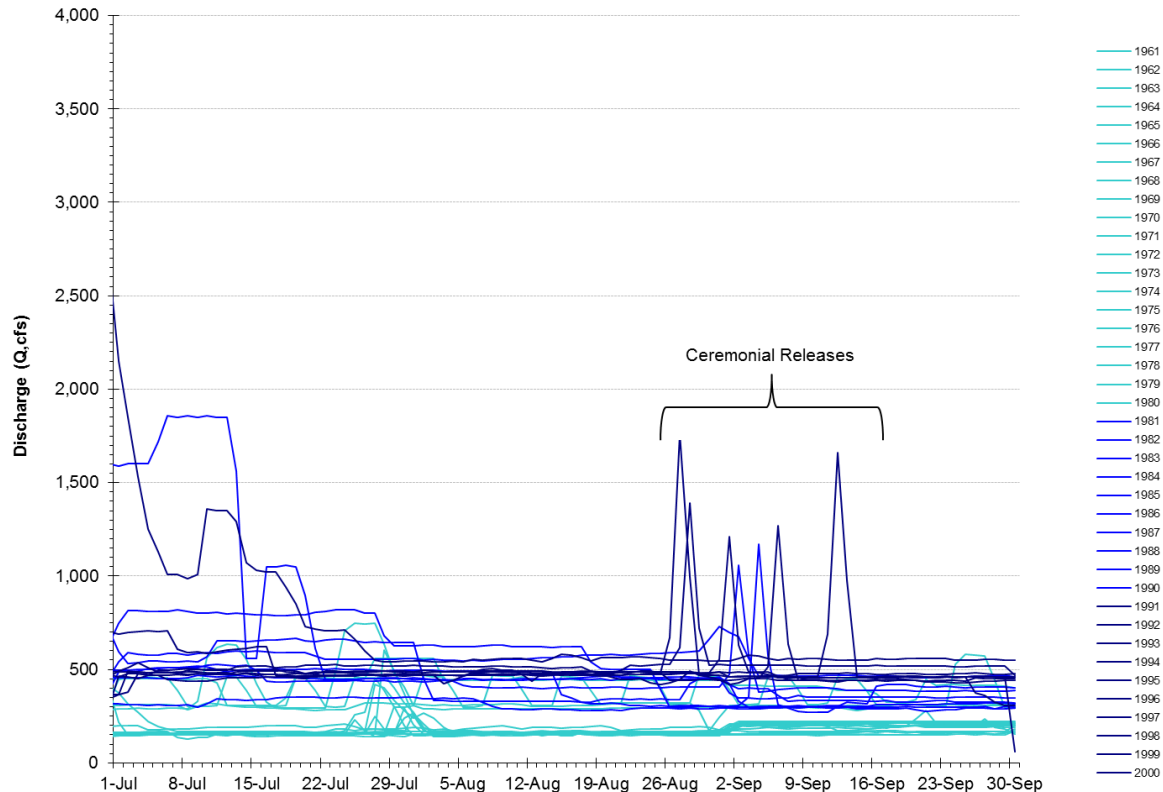
Figure 11. Streamflows during the summer and early fall during the 1961–1980, the 1981–1992, and post-1993 time periods.

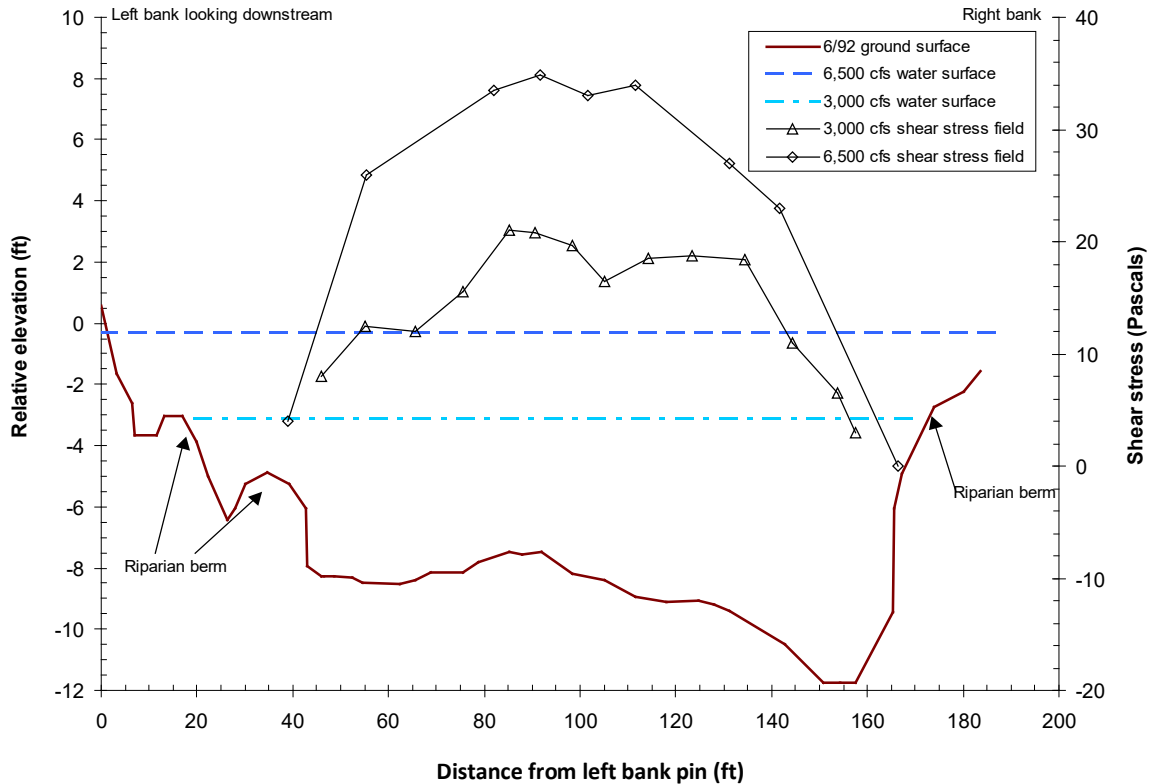
Figure 14. Riparian encroachment at cross section at Poker Bar (RM 102.7) showing computed shear stress fields from Wilcock et al. (1995).

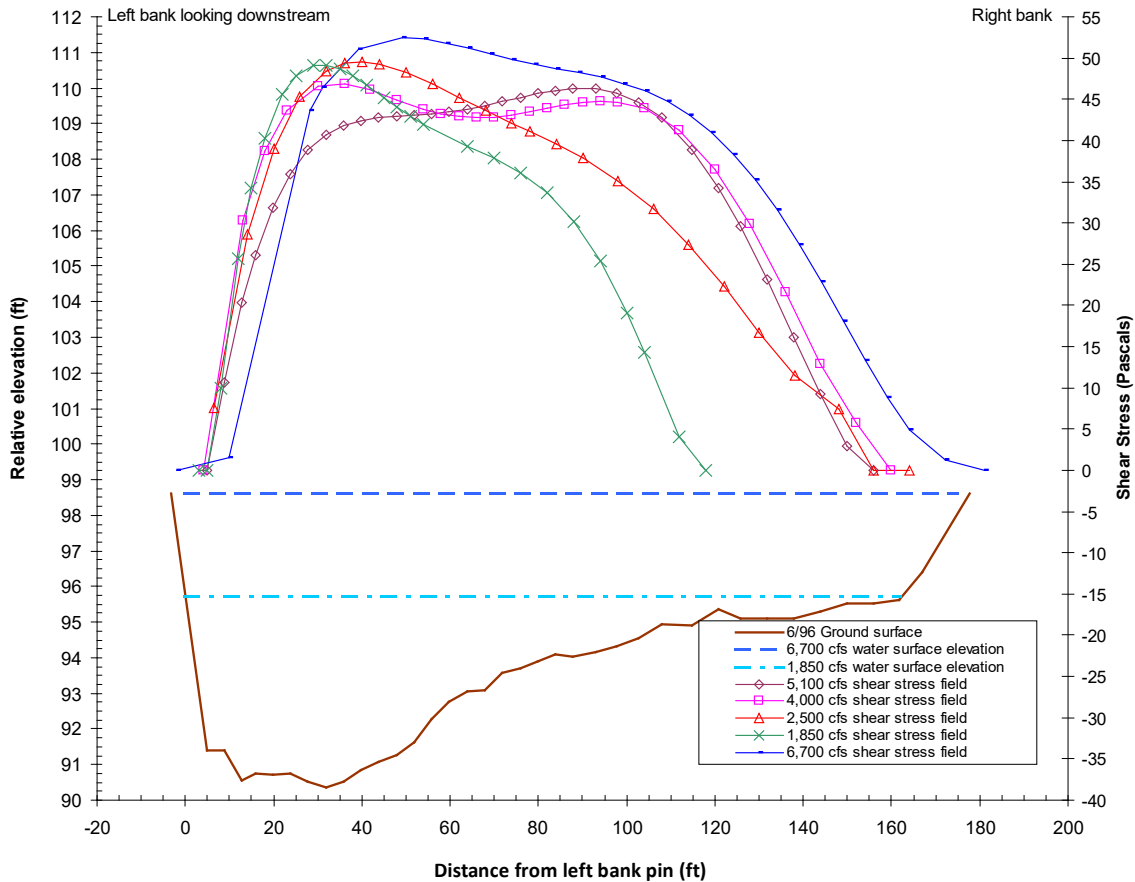
Figure 15. Steiner Flat pilot bank rehabilitation site (RM 91.9) cross section showing shear stress fields for flows ranging from 1,850 cfs to 6,700 cfs.

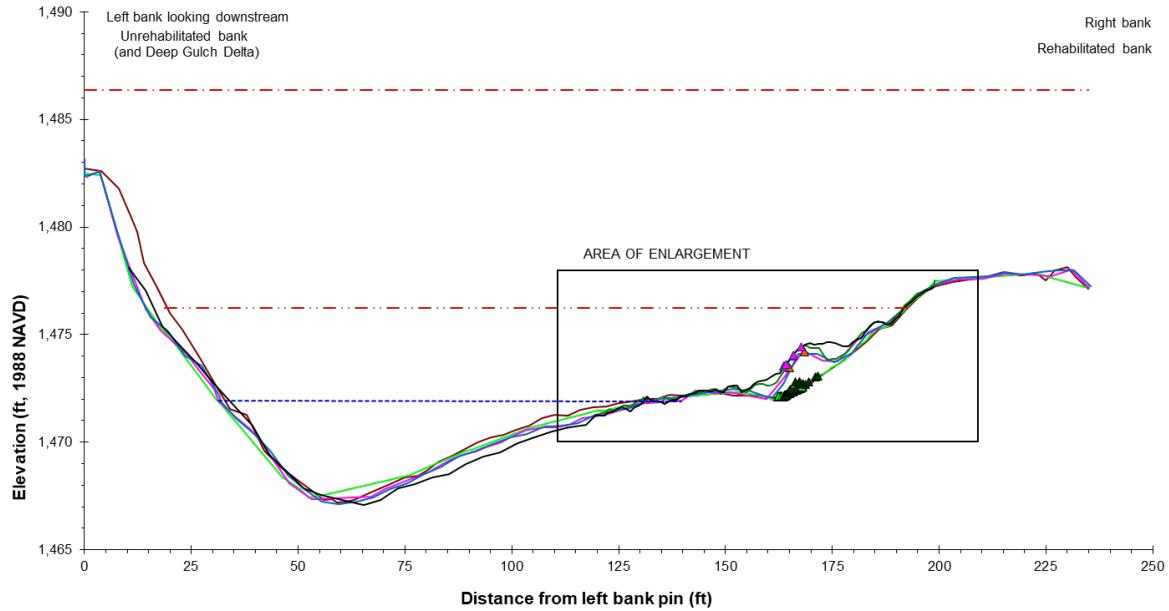
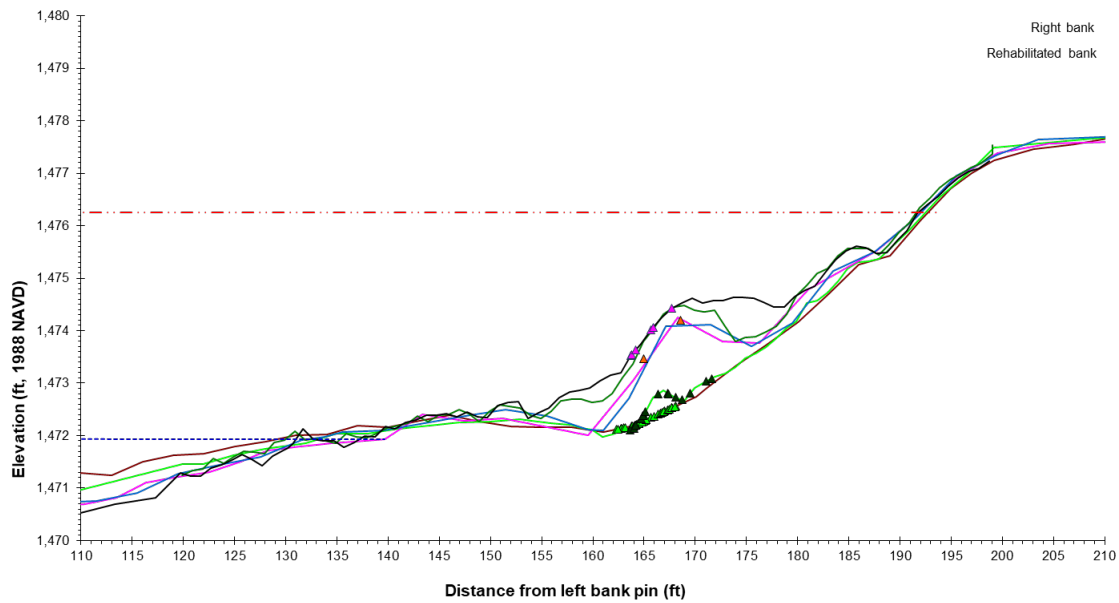
Figure 20. WY 1995 cohort seedling establishment during the 1999–2002 period and incipient berm development at one cross section at the Sheridan Creek pilot bank rehabilitation site. (Top) Entire cross section length. (Bottom) Enlargement of WY 1995 cohort establishment area. Note the developing berm in the WY 2000 ground surface, corresponding to the location of narrowleaf willow seedling initiation in WY 1995.

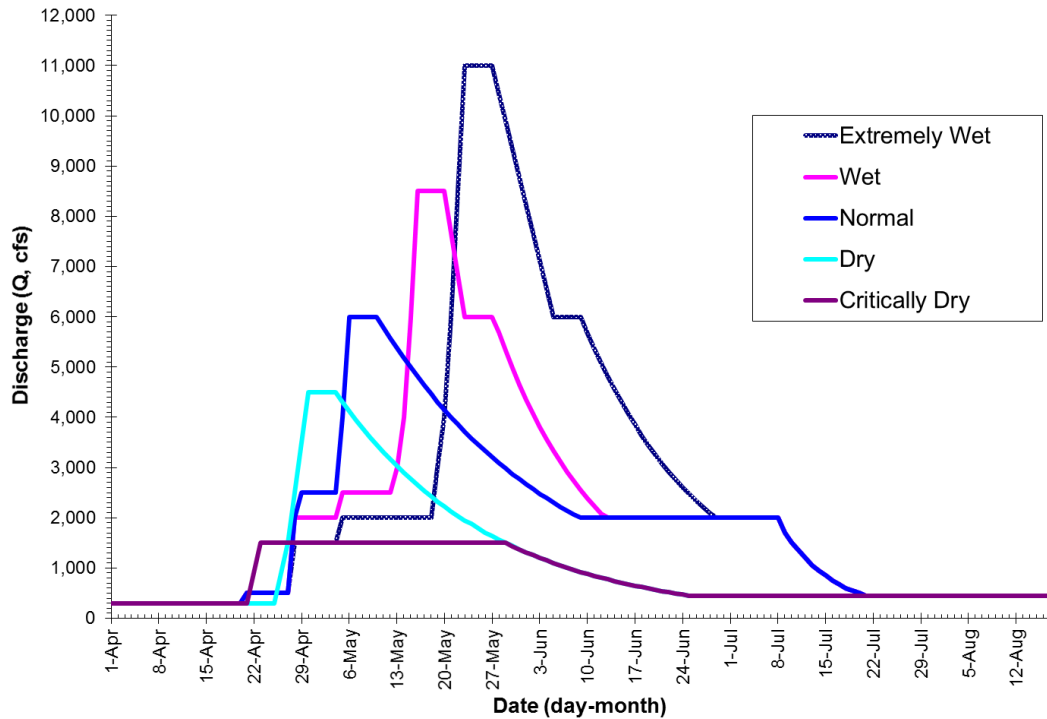
Figure 23. Five water year-specific hydrographs developed in the TRFER (USFWS and HVT 1999) and adopted in the ROD (DOI 2000).

The TRFE and ROD provided considerable flexibility in scheduling and planning annual flow releases. The TRFE acknowledged that in many years, winter floods often exceeded geomorphic thresholds and acted as the primary encroachment-limiting factor. However, the TRFE also recognized that tributary accretion was largely the cause of winter floods downstream of TRD, and that upstream of Weaver Creek, winter tributary accretion was often insufficient to surpass geomorphic thresholds at the desired frequency.

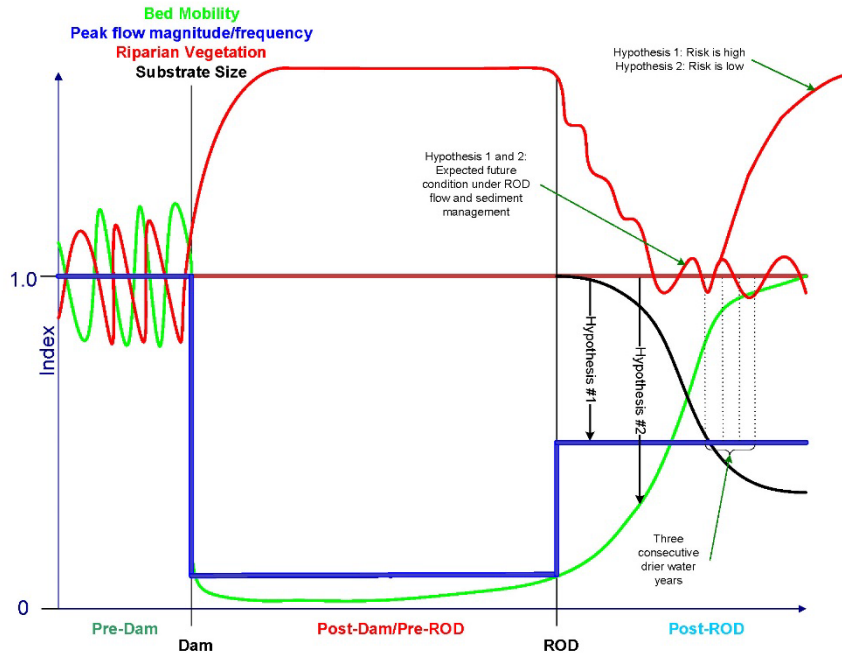
The TRRP flow and sediment regimes are considerably smaller than pre-dam conditions, resulting in a high level of risk for future detrimental riparian encroachment to occur, particularly following a series of drier water years.

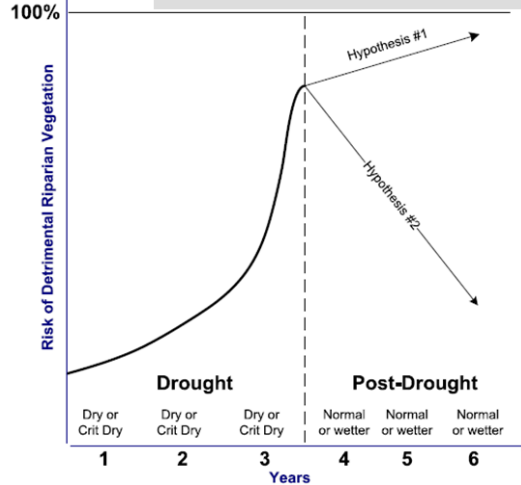
The TRRP flow and sediment regimes are considerably larger than the post-dam conditions that led to detrimental riparian encroachment. The combination of the ROD (variable) flow regime and the prescribed annual gravel augmentations reduces the risk of future detrimental riparian encroachment.

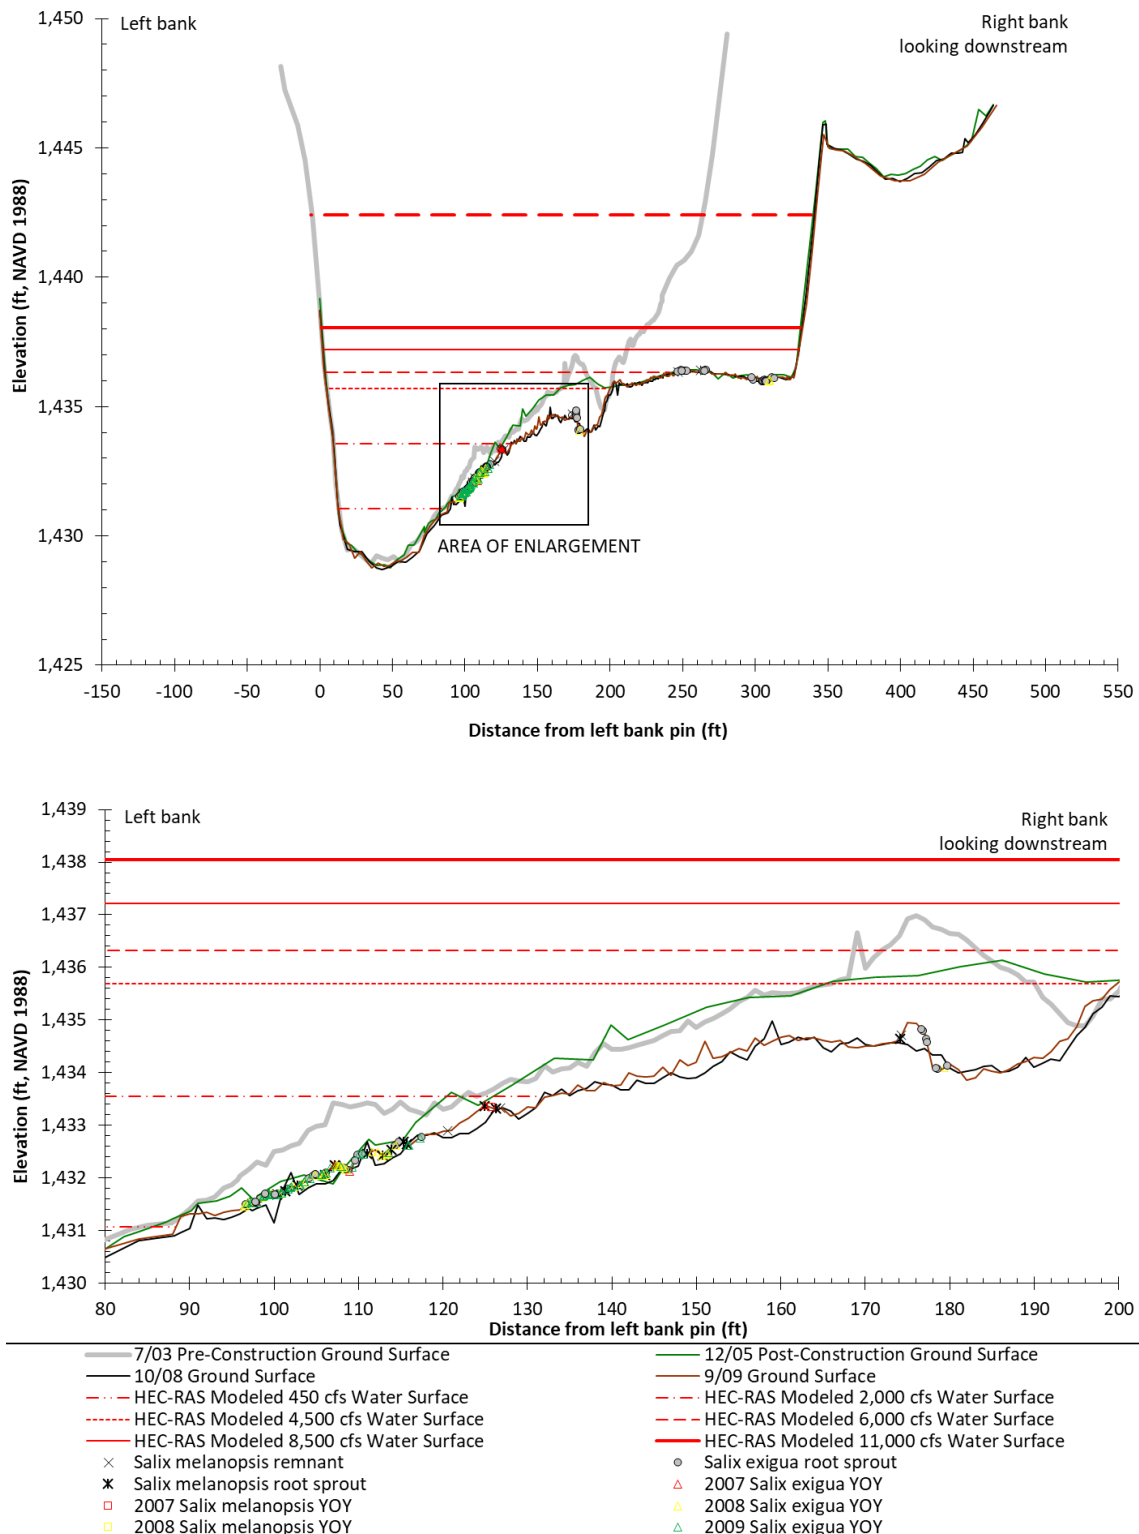
Figure 25. WY 2007–WY 2009 seedling establishment at Hocker Flat cross section 326+90 (Jim Smith pilot bank rehabilitation site cross section 12+00). (Top) Entire cross section length, showing pre-construction ground surface, post-construction ground surface, and location of seedling establishment. (Bottom) Enlarged portion of Hocker Flat channel rehabilitation site cross section 326+90 showing WY 2007–WY 2009 seedling establishment on bank locations between 450 and 2,000 cfs.

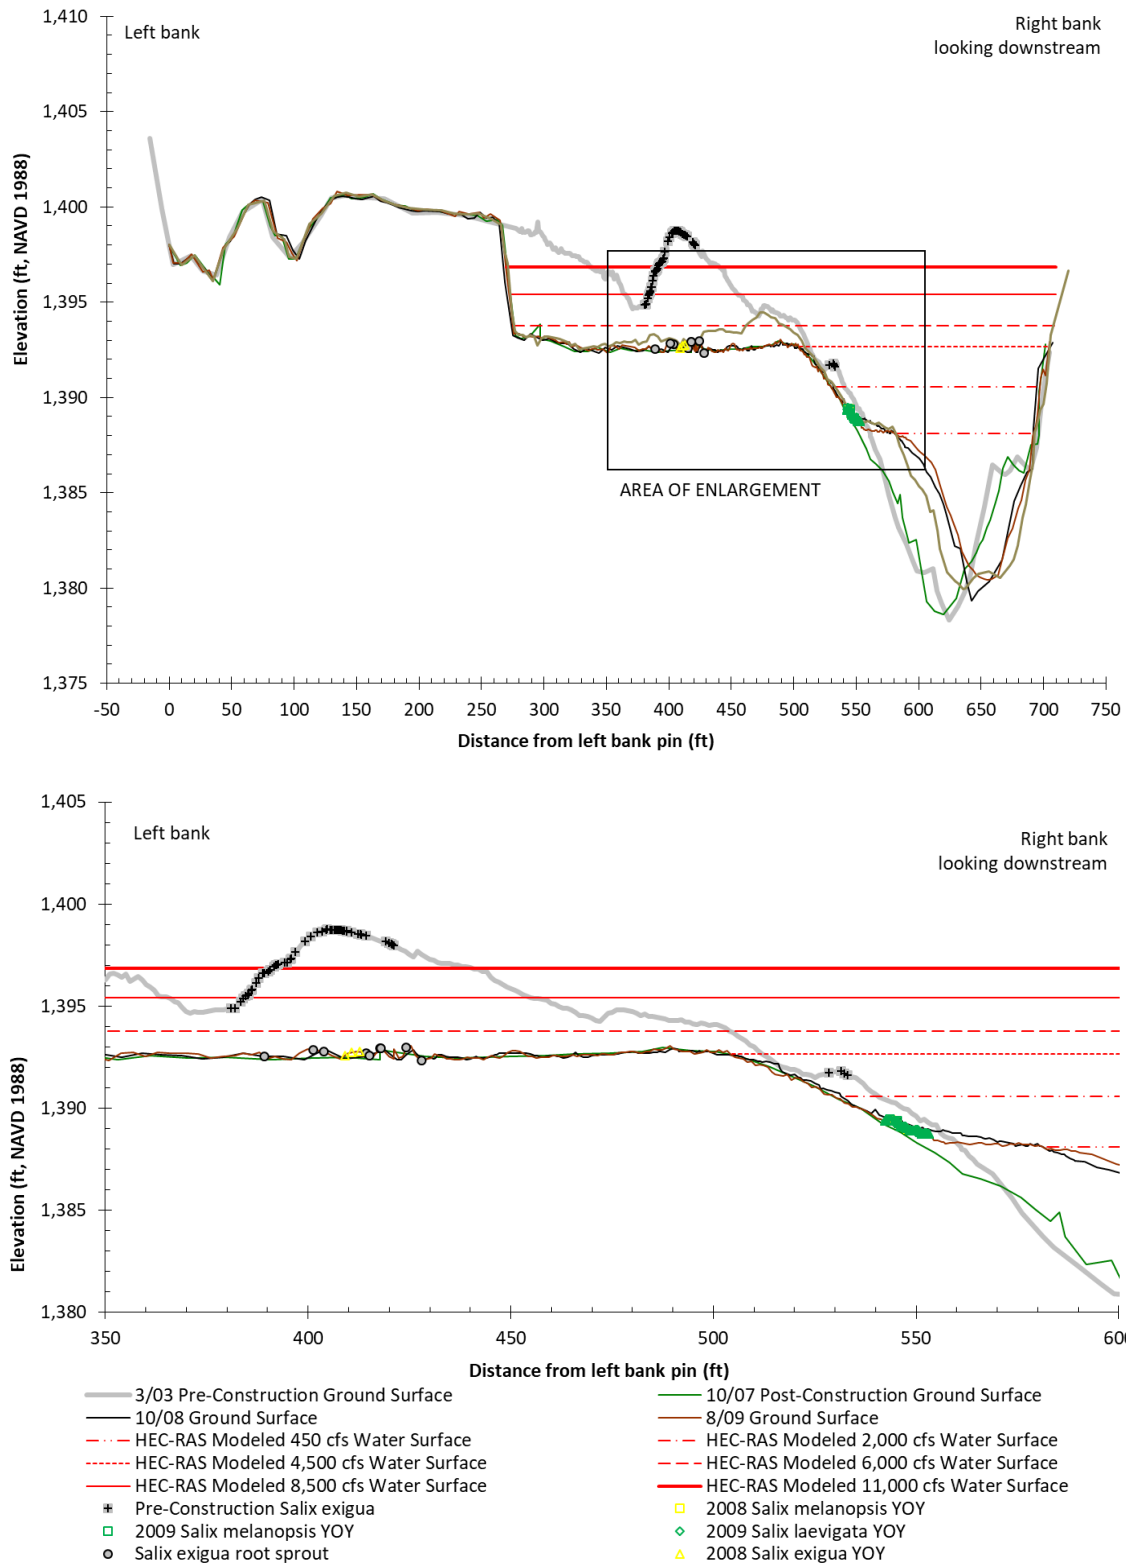
Figure 26. WY 2008–WY 2009 seedling establishment and root regrowth locations at Valdor Gulch cross section 141+20. (Top) Entire cross section length, showing pre-construction ground surface and plant locations, post-construction ground surface, and locations of seedling establishment. (Bottom) Enlarged portion of Valdor Gulch channel rehabilitation site cross section 141+20 showing WY 2008–WY 2009 seedling establishment and root regrowth locations relative to the pre-construction narrowleaf willow established shrub locations.

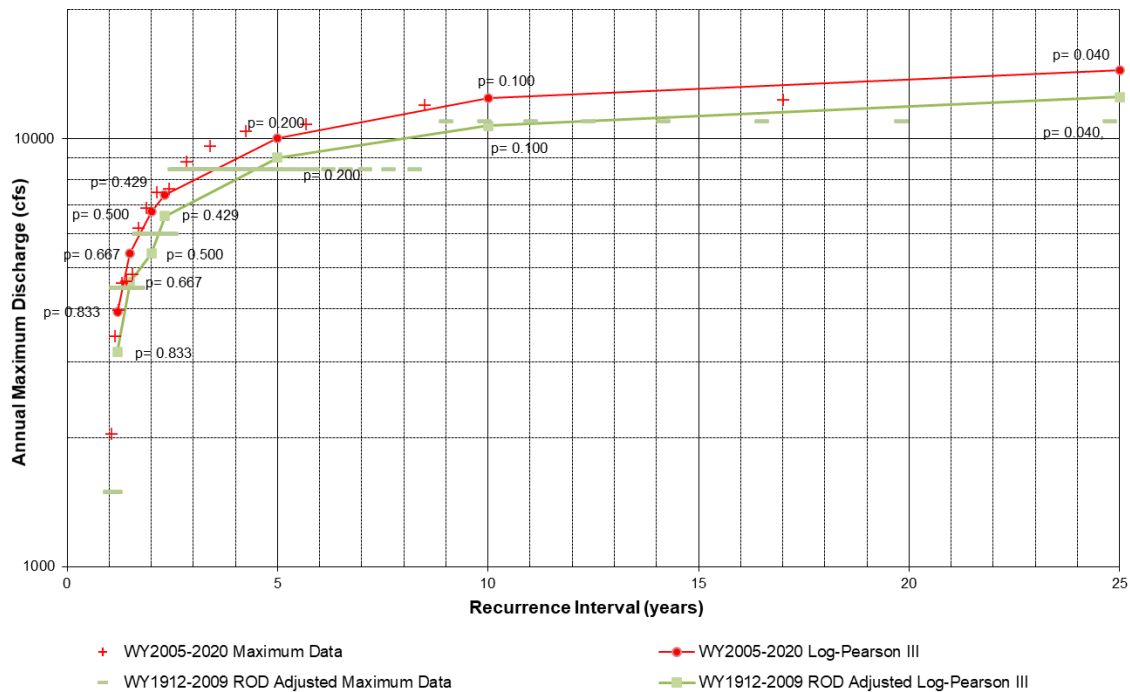
Figure 30. 1912 to 2009 flood peaks scaled down to ROD flood peaks based on water year class (green) vs actual (red) WY 2005–WY 2020 flood frequency at USGS gage at Lewiston.
