**Performance, evolution, and longevity of
constructed channel and floodplain features on
the Trinity River, California**

Final Report

January 2021

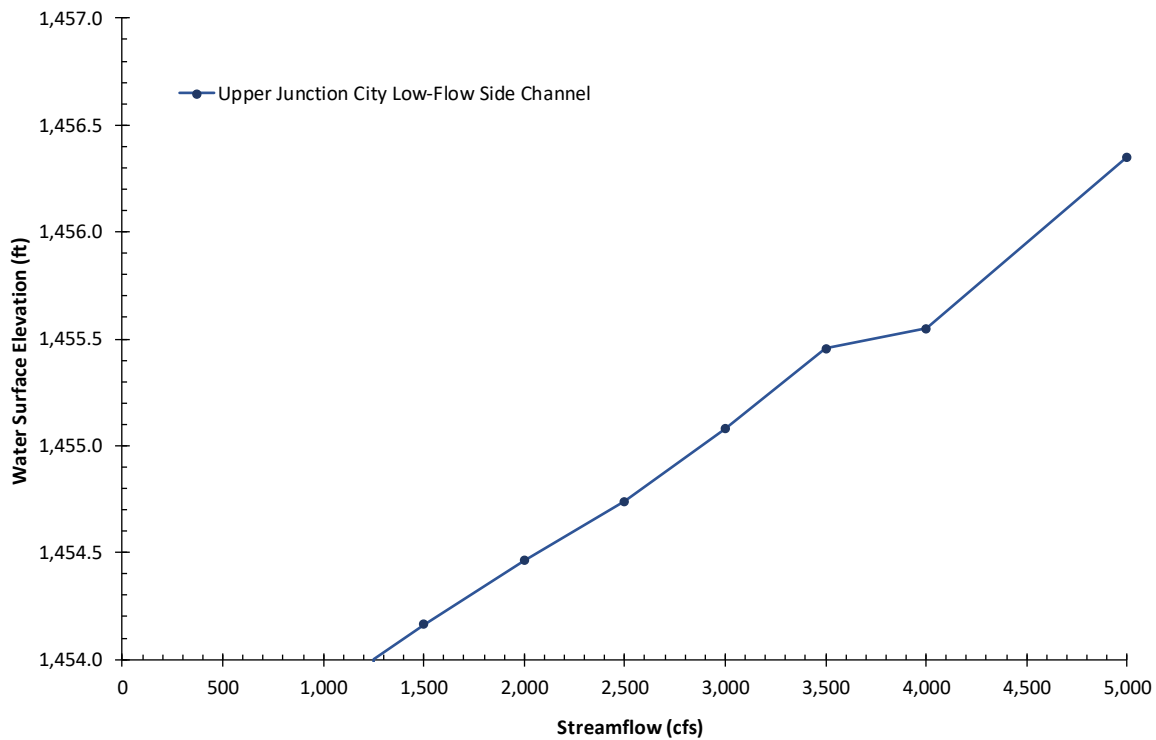
Figure 2. Linear interpolation of the relationship between predicted water surface elevation at the side-channel hydraulic control and total river streamflow generated using the SRH-2D water surface elevation outputs at UJC. The water surface elevations were extracted from the model for flows ranging from 450 cfs to 5,000 cfs (Figure 1), and the resulting rating curve above predicts that the side-channel will begin to flow at 1,250 cfs.

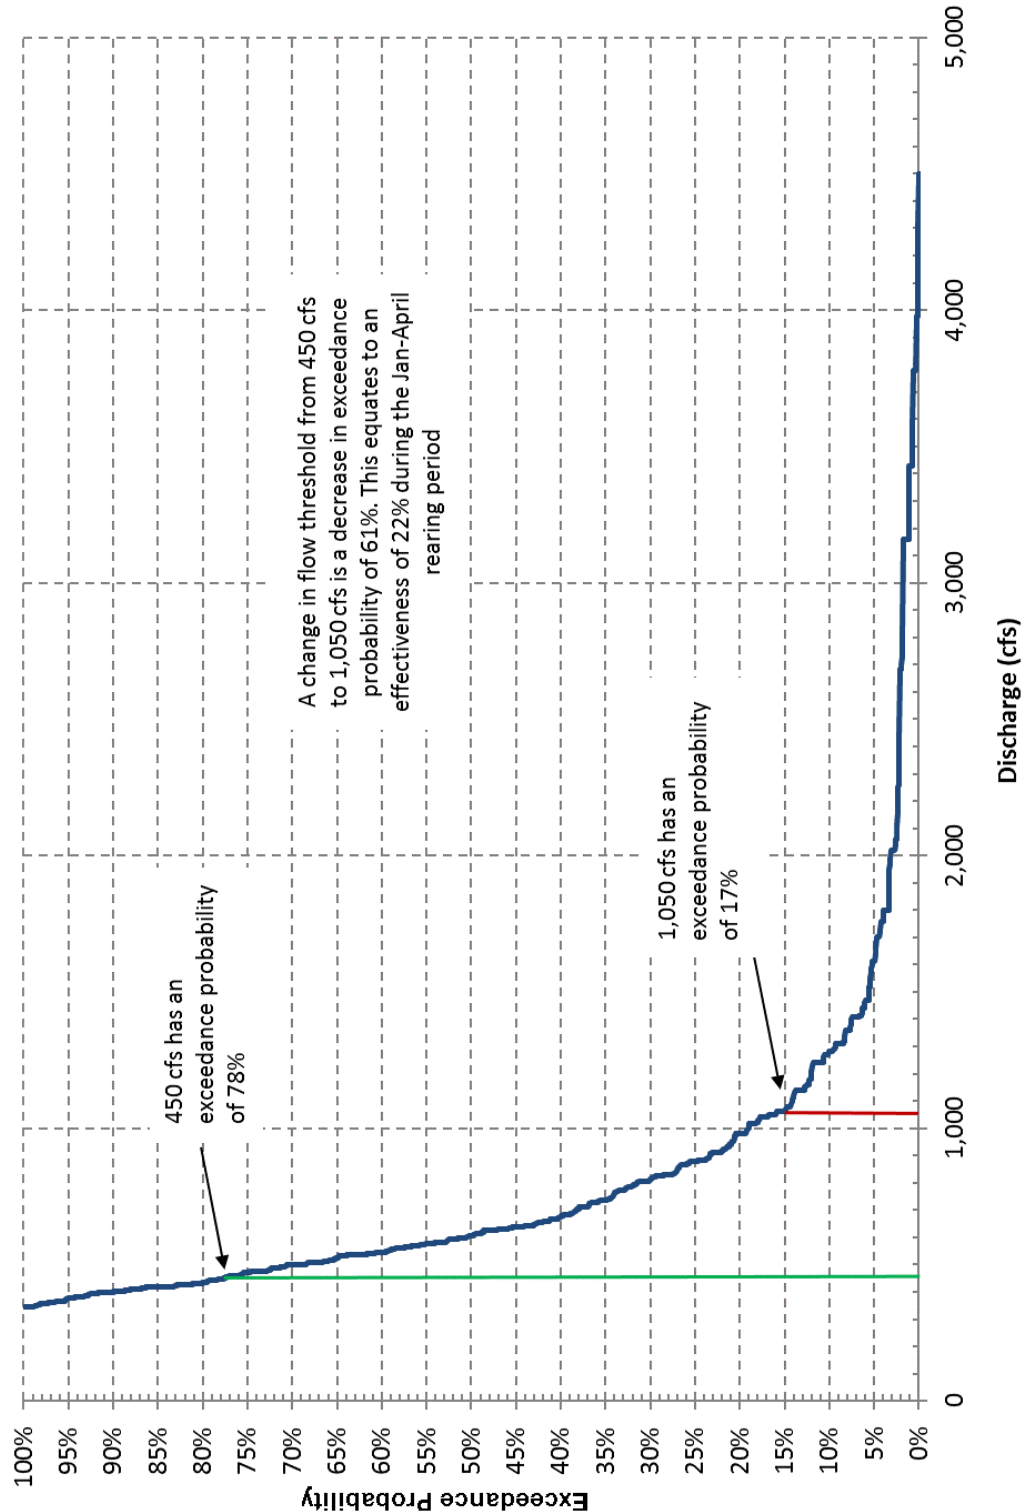
Figure 3. 14-day flow duration curve for the USGS Junction City Gage for the January 1 through April 30 period, incorporating all available data between water year (WY) 2006 and WY 2019. Flow exceedance curves were generated for the Trinity River at each of the mainstem USGS gages and were used to evaluate the exceedance probability at each side-channel. Effectiveness was based on the reduction in flow exceedance under contemporary conditions (1,050 cfs) compared to the flow exceedance at the design flow of 450 cfs. This site has an effectiveness of 22%.

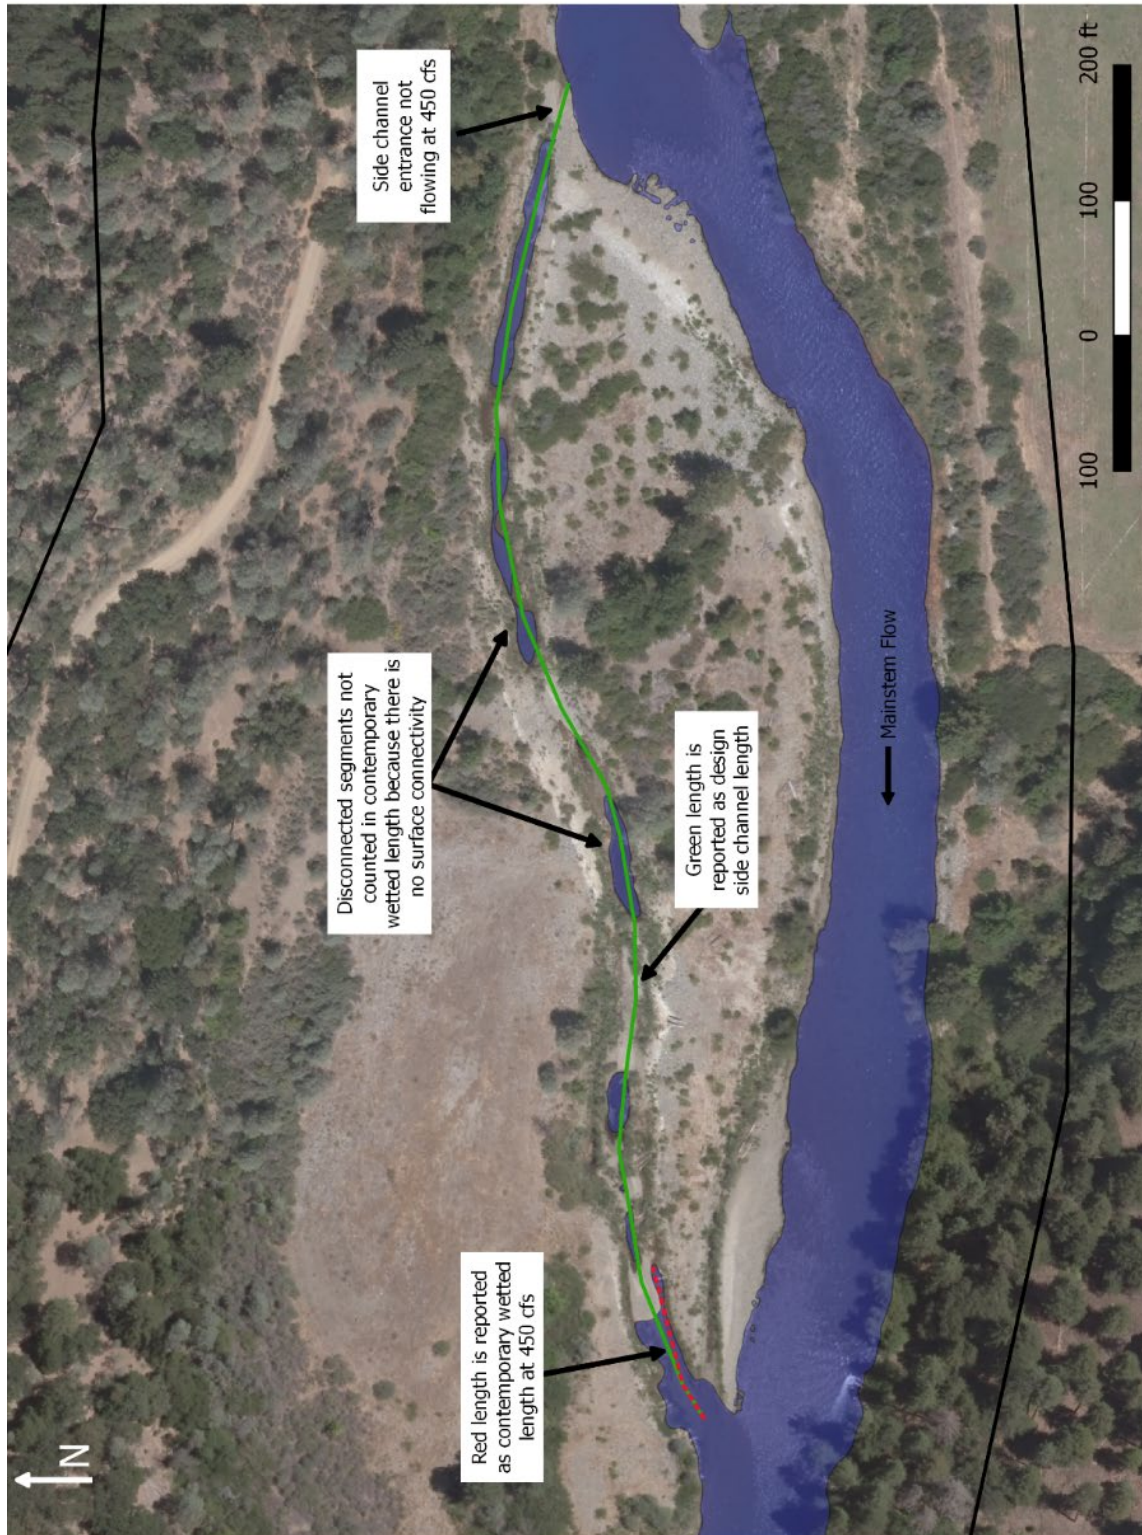
Figure 4. Example at Trinity House Gulch of the side-channel flow connectivity at 450 cfs analysis. The SRH-2D wetted perimeter output for 450 cfs is shown in blue. Effectiveness was evaluated by calculating the percent change in length between the design length and contemporary wetted length. Trinity House Gulch is a special case because there is less flow connectivity through the side-channel but there has been no deposition at the side-channel entrance; instead, channel erosion (downcutting) in the mainstem near the side-channel entrance is the reason for less flow conveyance into the side-channel.

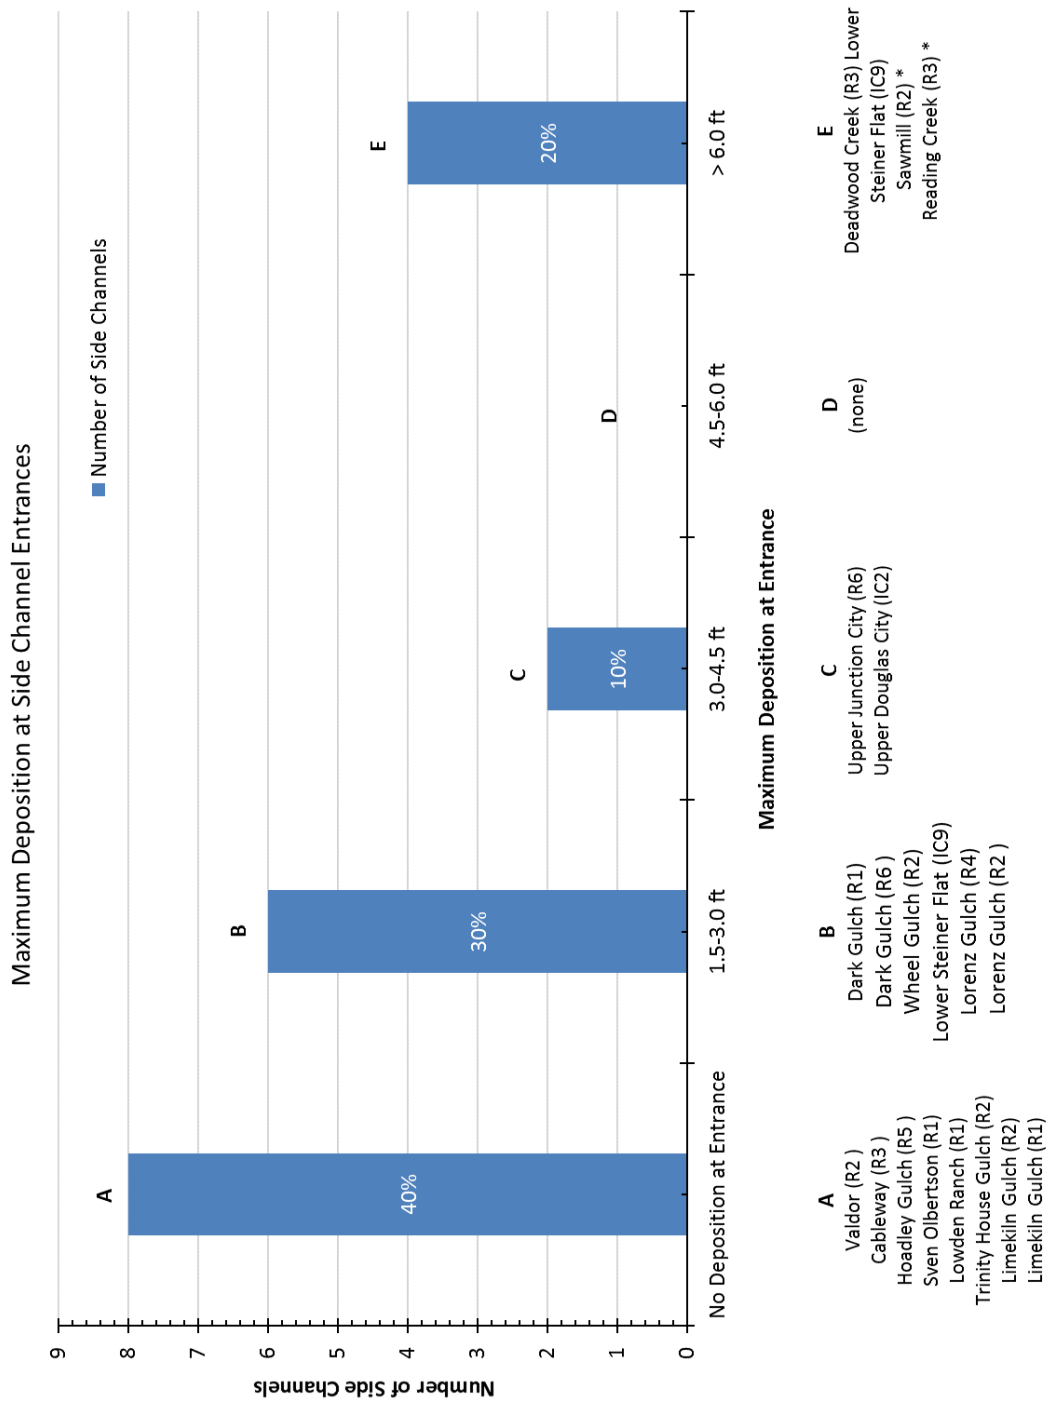
Figure 5. Maximum deposition detected at side-channel entrances in the GCD analysis. The x-axis increments are based on the GCD analysis increments of detection (called “bins”). The figure shows the number of side-channels within each bin, as well as the percent that each bin makes up in the total population. The bottom of the chart lists the side-channels in each bin. Sawmill and Reading Creek (*) are special cases because deposition occurred at these sites prior to the post-construction survey that was used in the GCD analysis. The GCD registered lower amounts of change, but those sites were added to the highest deposition bin because aerial photographs confirmed previous deposition that the GCD was unable to capture. Note that any scour that occurred in the side-channels is not depicted.

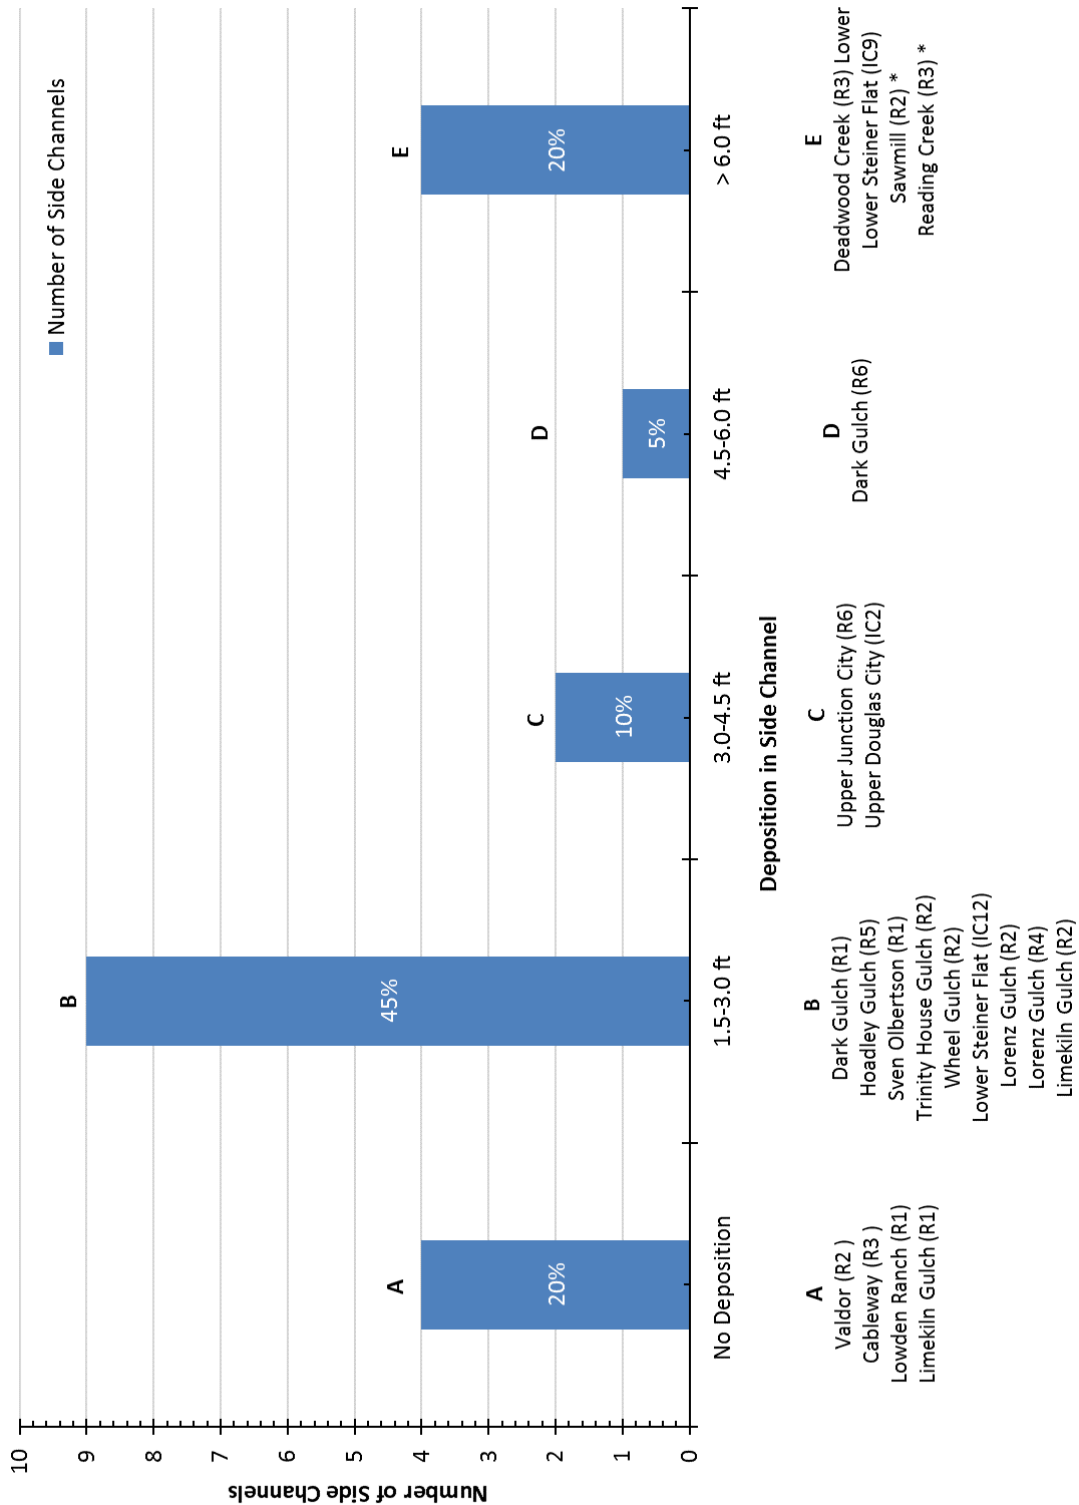
Figure 6. Deposition detected by the GCD analysis that occurred throughout the side-channels (including but not limited to the entrances). The number of side-channels within each bin is shown, as well as the percent that each bin makes up in the total population. The bottom of the chart lists the side-channels in each bin. Sawmill and Reading Creek (*) are special cases because deposition occurred at these sites prior to the post-construction survey used in the GCD analysis. The GCD registered lower amounts of change, but these sites were added to the highest deposition bin because aerial photographs confirmed previous deposition that the GCD was unable to capture. Note that any scour that occurred in the side-channels is not depicted.

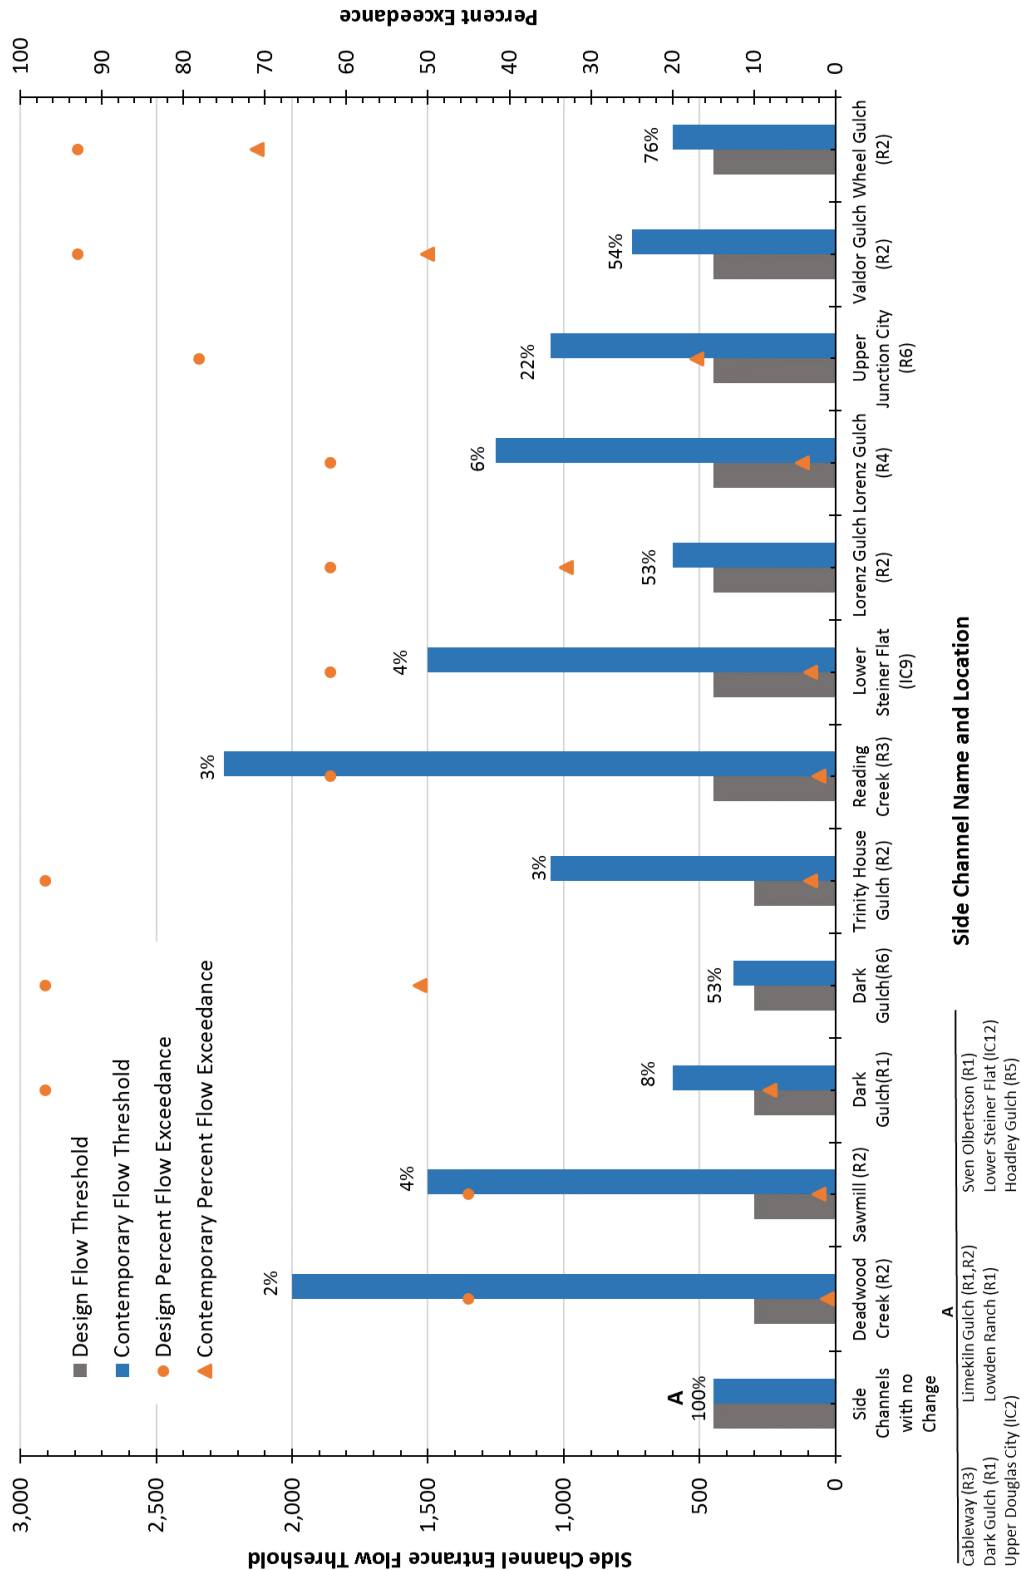
Figure 7. Design and contemporary flow thresholds and percent exceedances for side-channel entrances. The percent effective is reported for each side-channel based on reduction of percent exceedance. The percent exceedance values were calculated using 14-day flow duration curves created for all five USGS streamflow gages on the Trinity River using all available data between 2006 and 2019. Table 5 lists the USGS streamflow gage that was used for each site.

The results of the flow threshold analysis showed that 12 side-channels (60%) had increased flow thresholds (and therefore decreased flow exceedance probabilities) required to induce flow through the entrance and provide full connectivity to the exit (Figure 7). Increases in flow thresholds ranged from 75 to 1,800 cfs (median = 675 cfs, Figure 7) and occurred even at sites where deposition was not detected. This can happen if the GCD level of detection failed to show deposition or if mainstem incision occurred. Effectiveness is computed as the ratio of the contemporary versus the designed flow exceedance probability, and results are presented in Figure 7 and in Table 5.

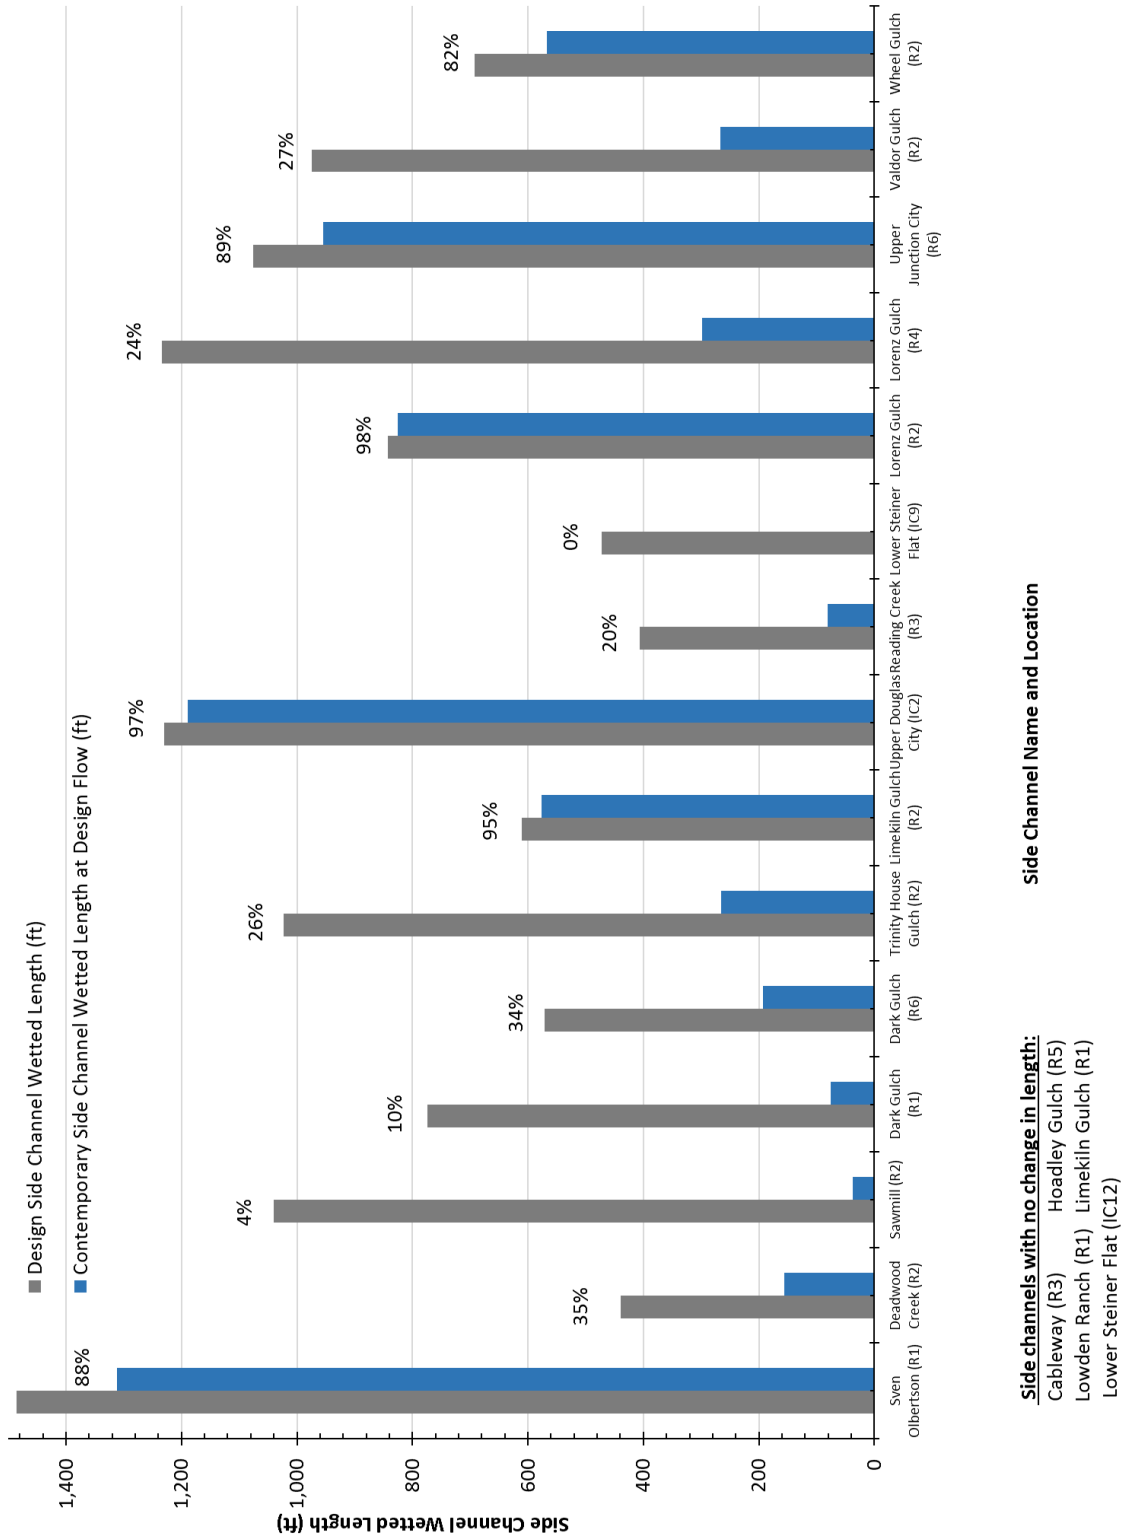
Figure 8. The difference at side-channel features between wetted length under design conditions compared to contemporary conditions at a flow of 300 or 450 cfs, showing whether flow connectivity from the side-channel entrance to the exit has been impaired under contemporary conditions. The percent effective is based on the change in wetted length. The side-channels that had no change in wetted length are listed in the bottom left. Contemporary side-channel lengths were based on SRH-2D wetted area outputs and assume that the model outputs are representative of real conditions.

Another special case occurs at Sven Olbertson and Upper Douglas City. Both sites show a slightly decreased channel length (Figure 8), some level of aggradation and yet exhibit no change in flow threshold (Table 5). This appears to be due to secondary inlets continuing to function near the upstream end of the feature, even after the primary inlet becomes plugged.

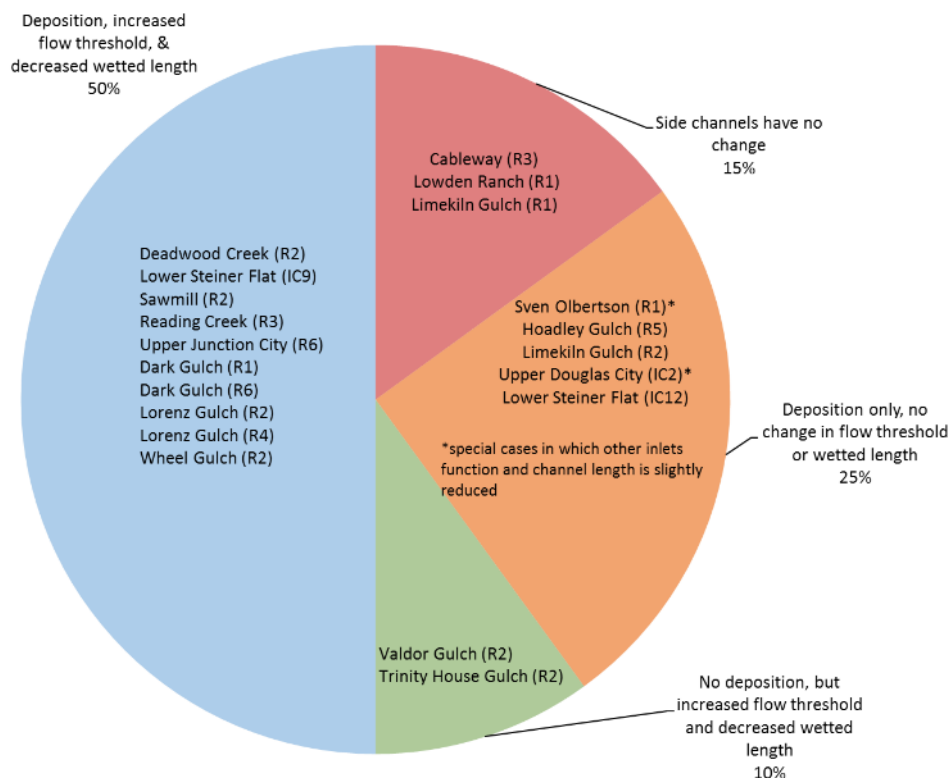
Figure 9. Side-channels grouped by the changes for the four metrics that were evaluated, with the percentage that each group represents in the total population. Overall, half of side-channels experienced some level of deposition, increased flow thresholds, and decreased wetted channel lengths.

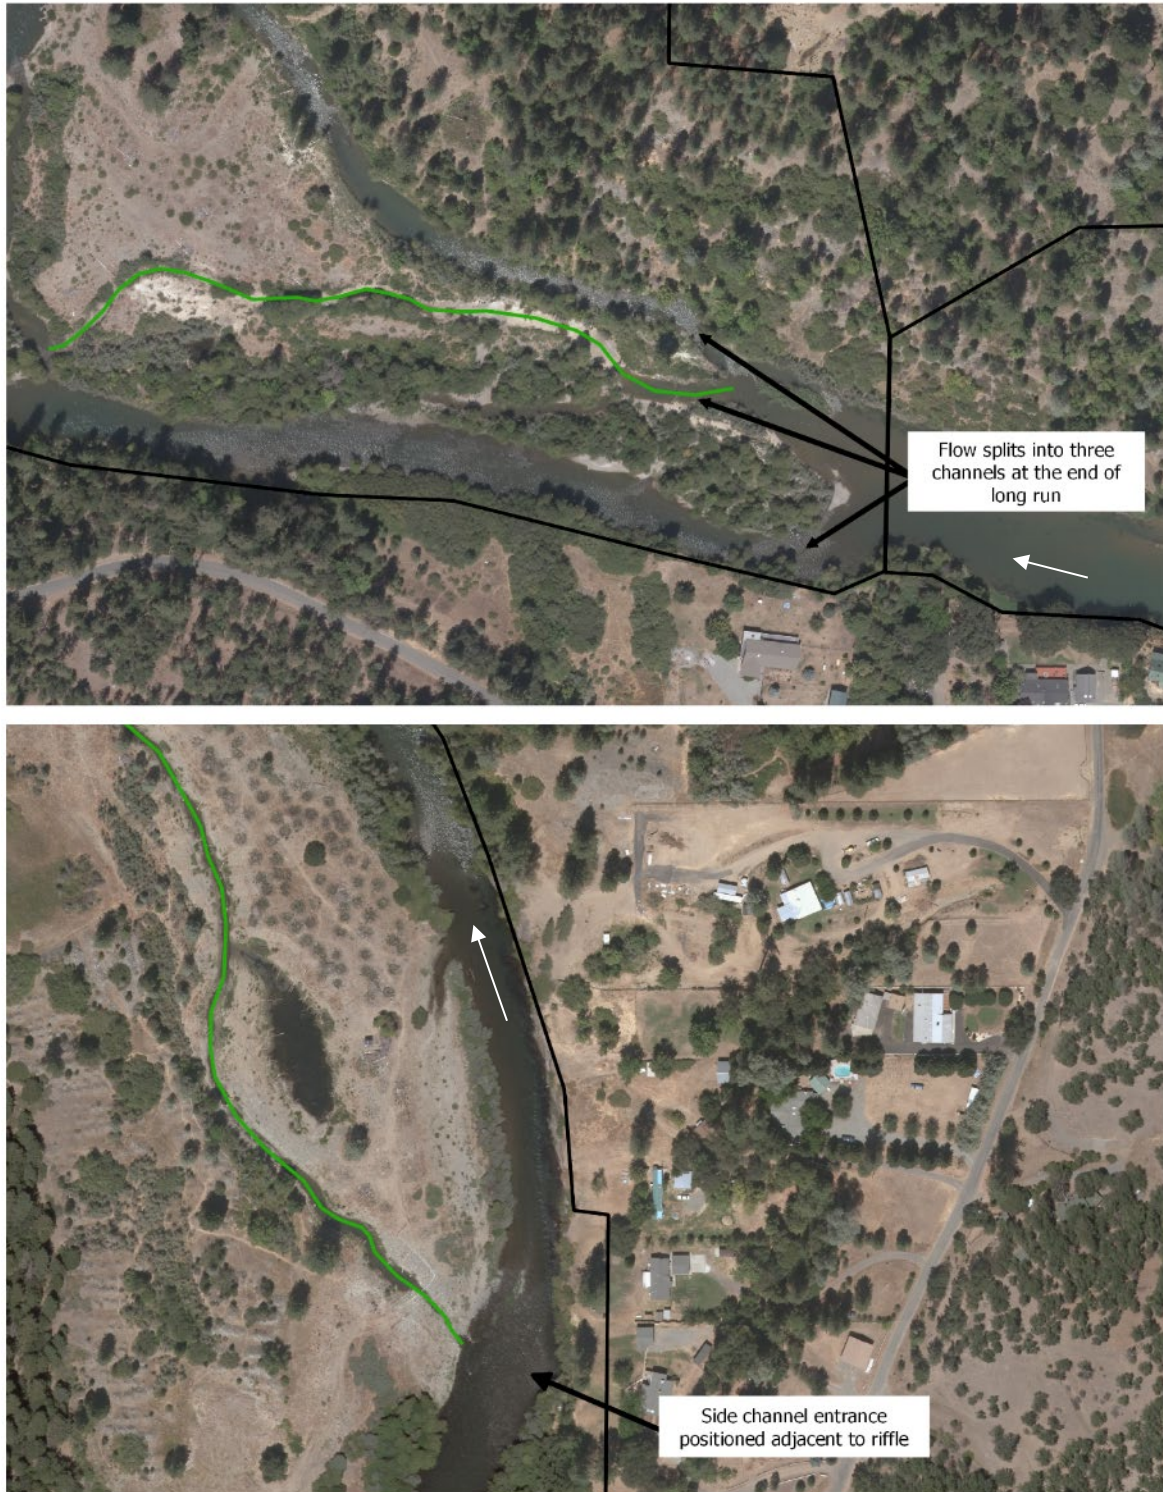
Figure 10. 2016 aerial photographs showing the geomorphic setting of side-channel R2 at Sawmill (top) and side-channel R4 at Lorenz Gulch (bottom). Both side-channels were constructed across wide floodplain areas and both have experienced deposition at the entrances. Deposition at Sawmill may have been greater because the flow splits into three channels, causing less flow and higher deposition in R3, and/or because the entrance is not positioned adjacent to or directly upstream of a riffle crest.

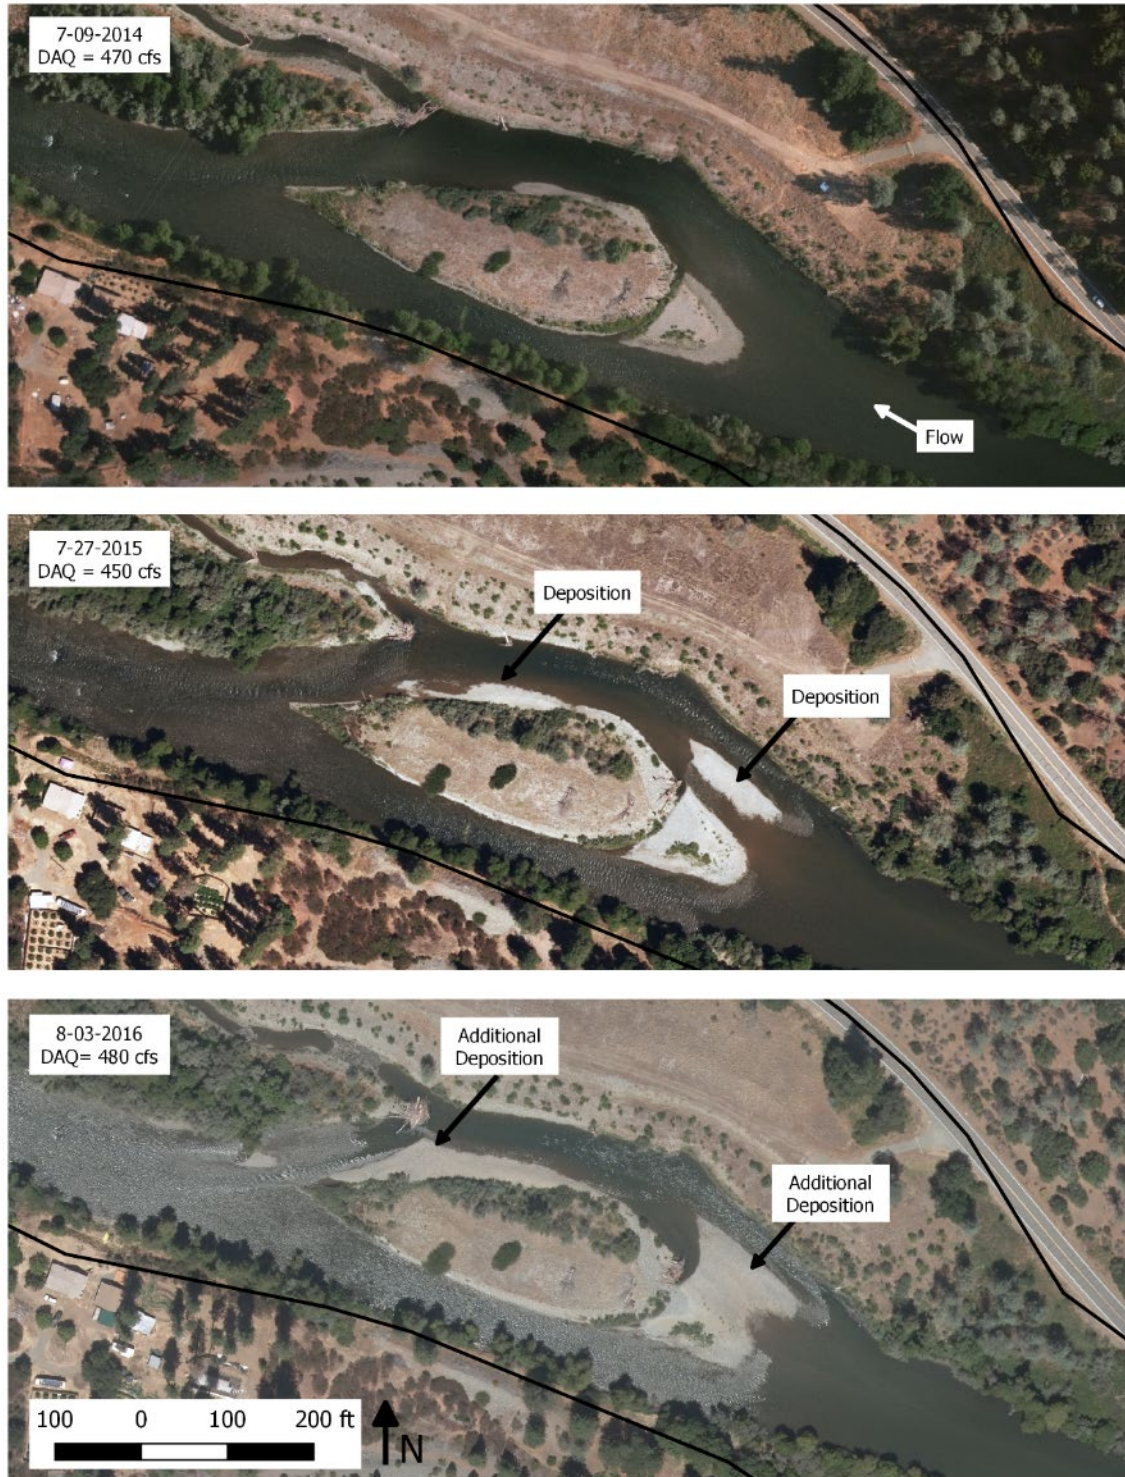
Figure 11. Aerial photographs from 2014–2016 that show deposition occurring through time in the split-flow channel at Wheel Gulch, constructed in 2011. The 2014 aerial photo is shown instead of the 2011 aerial photo because no noticeable change occurred between 2011 and 2014, and the 2014 image is of better quality. Note that deposition is occurring only within the right bank split-flow channel, which meanders, while no deposition is occurring in the left bank split-flow channel, which is straight. The reported streamflow on each aerial photograph is daily average streamflow from the Trinity River above North Fork gage (USGS # 11526400).

For Task 1, the GCD results were used to evaluate if the split-flow channels are aggrading, eroding, or migrating. The aerial photographs were used to further evaluate planform changes at each site (Figure 11).

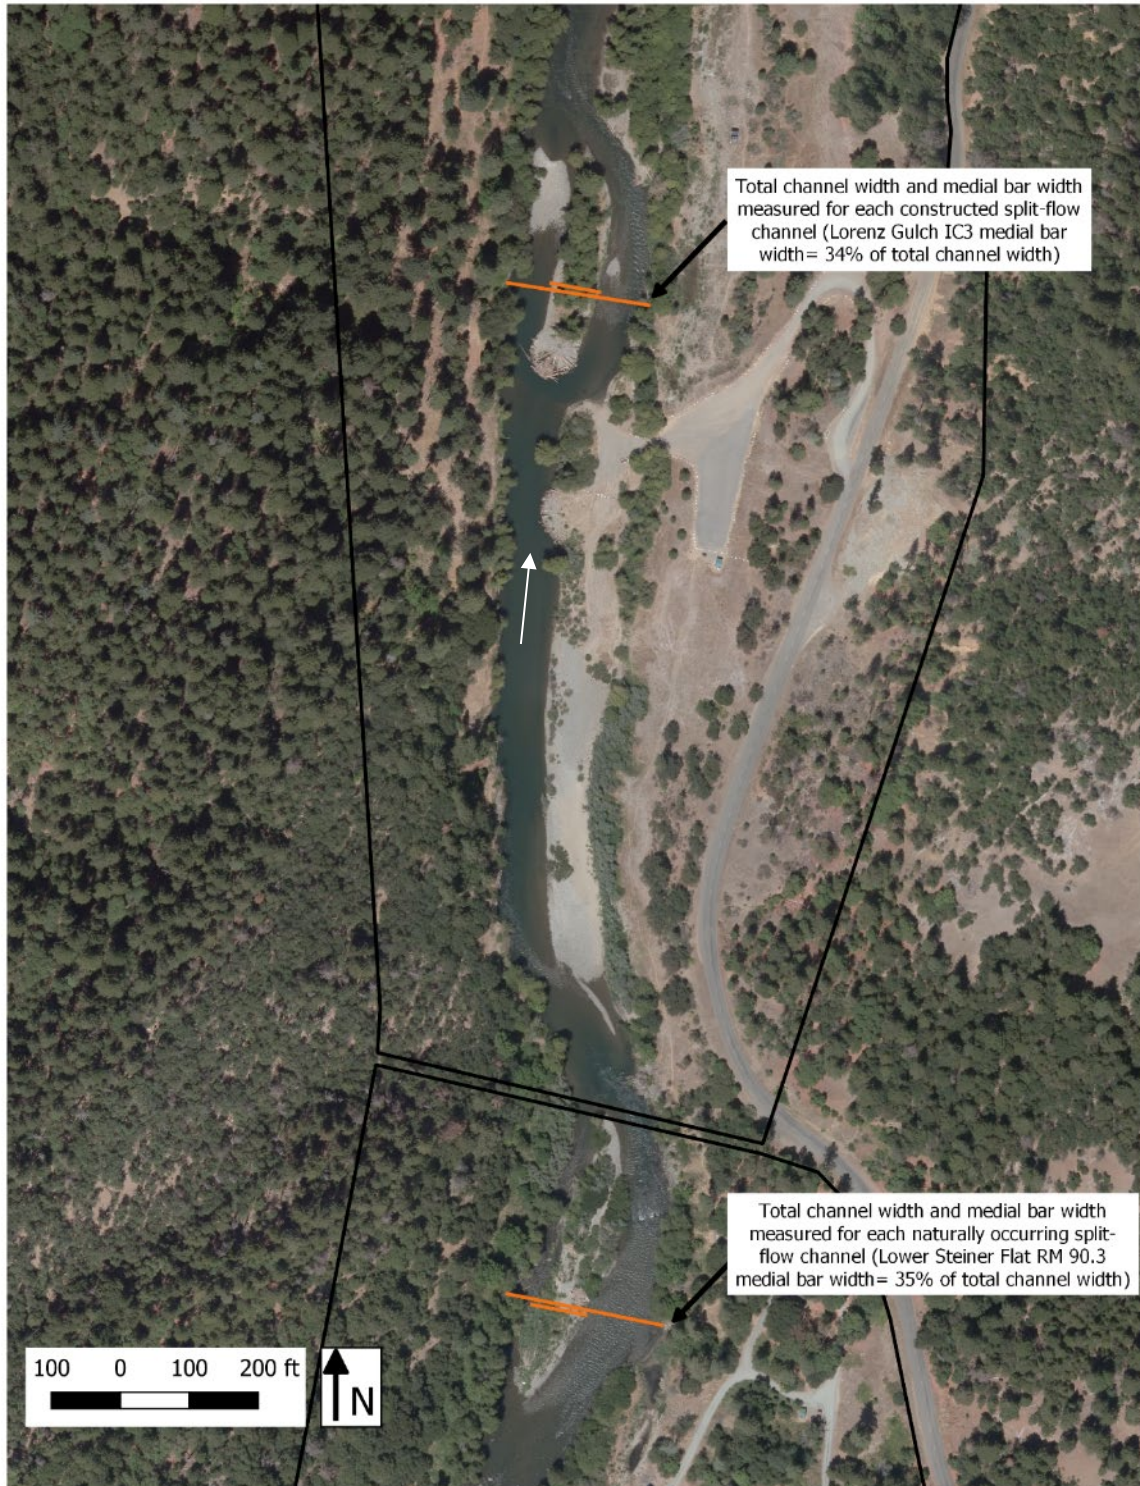
Figure 13. 2016 aerial photograph showing how total channel widths and medial bar widths were measured in GIS to compare the percentage that the medial bar makes up in the total channel width for both the constructed and naturally occurring split-flow features. This comparison evaluates whether total channel width is related to the size of the medial bar that forms and persists. This was also used to explore whether constructed split-flow channels are adjusting (eroding or aggrading) through time to achieve a balance between total channel width and medial bar width. Note that the percentage that the medial bar width makes up in the total channel width is very similar at these two sites.

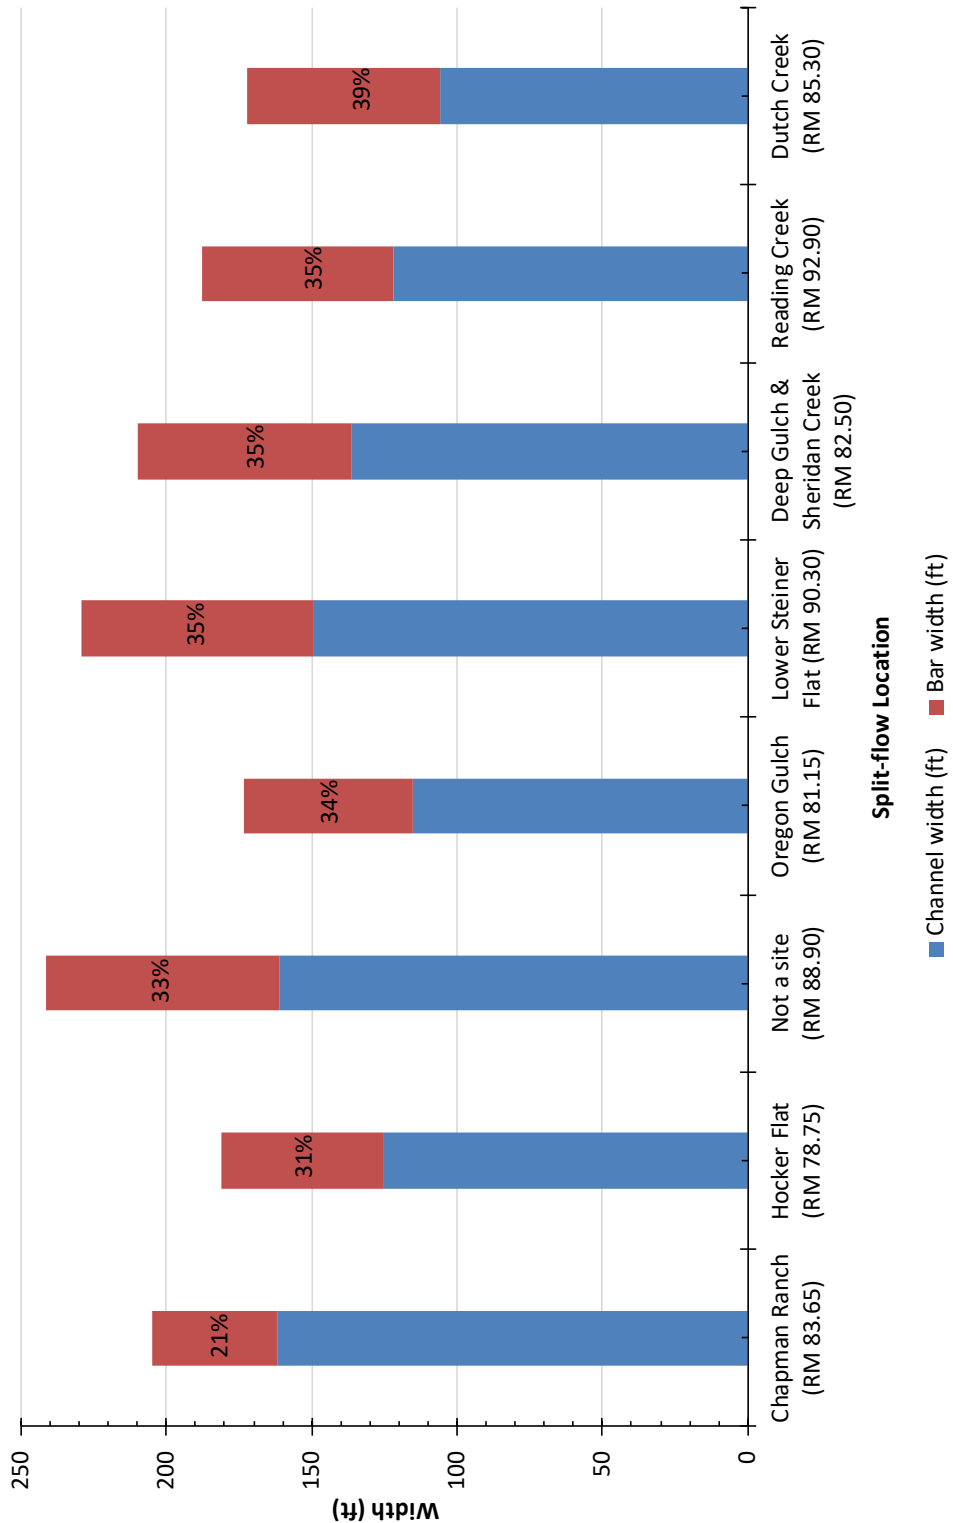
Figure 14. Ratio of bar width to total channel width at naturally occurring split-flow channel locations in 2016. The percentage of the total channel width made up of the medial bar is shown for each split-flow channel. River mile is shown for the naturally occurring split-flow channels because they don't have feature names. Note that seven of the eight split-flow locations have medial bar width between 30% and 40% of the total channel width. This suggests that there is a relationship between medial bar formation, persistence through time, and total channel width. "Not a site" means the split-flow channel occurs outside of any TRRP sites that have been named.

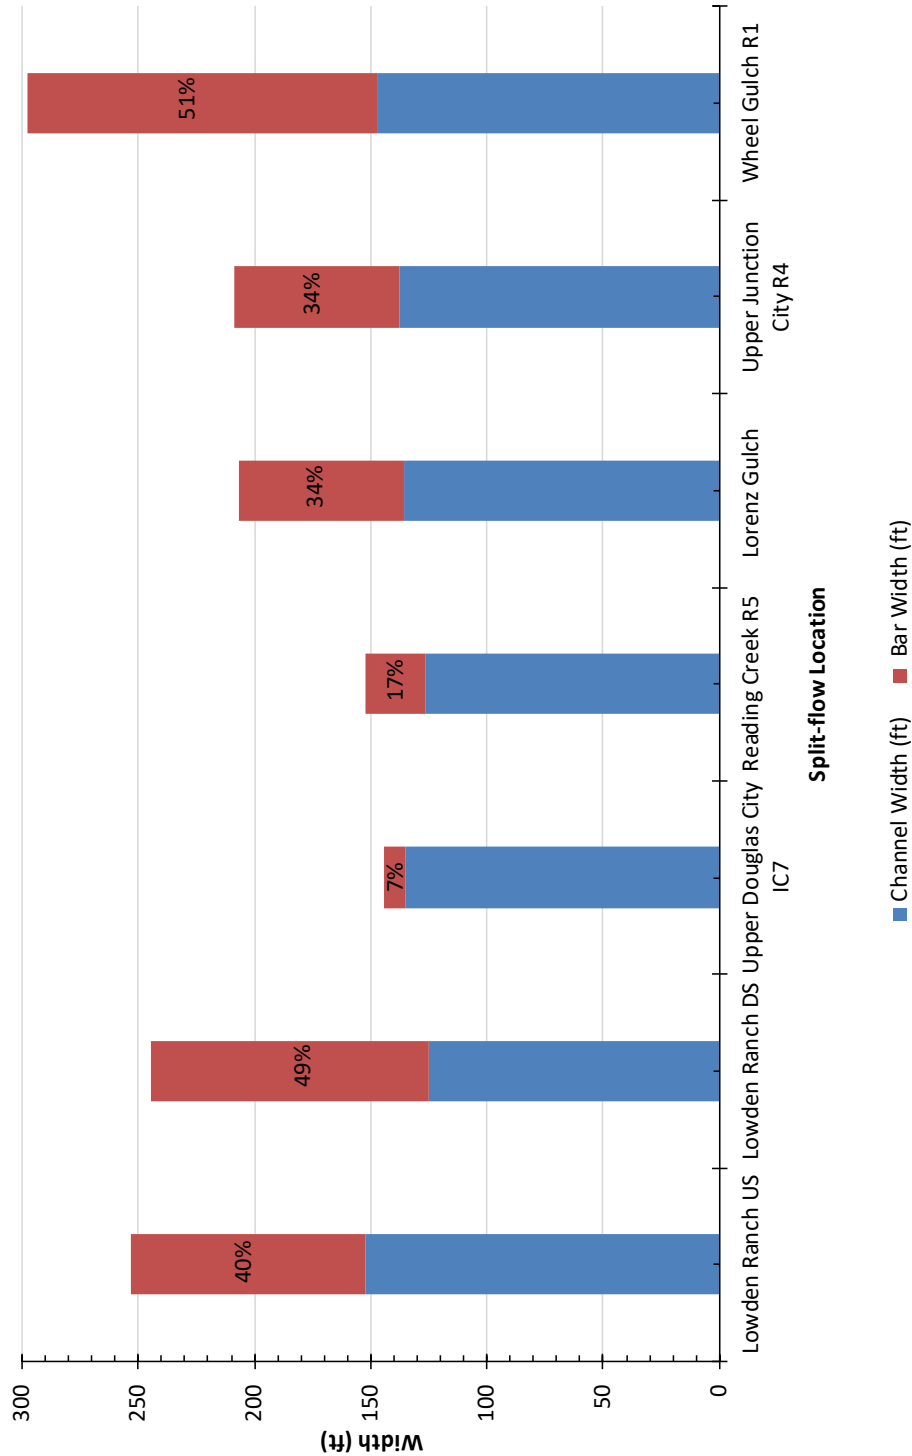
Figure 15. Total channel width and medial bar width at constructed split-flow channel locations. The percentage of the total channel width made up of medial bar is shown for each split-flow channel. The Lorenz Gulch and Upper Junction City split-flow channels have a very similar total channel width and medial bar percentage as the naturally occurring sites discussed (Figure 14). The Reading Creek and Douglas City split-flow channels have the narrowest total channel widths and have had the most erosion on the medial bars, which suggests that there may be a minimum channel width associated with longevity of medial bars. The results also show that as the total channel width increases, so does medial bar width, which suggests that total channel width influences the width of the medial bar that can persist at constructed split-flow channels.
