**Performance, evolution, and longevity of
constructed channel and floodplain features on
the Trinity River, California**

Final Report

January 2021

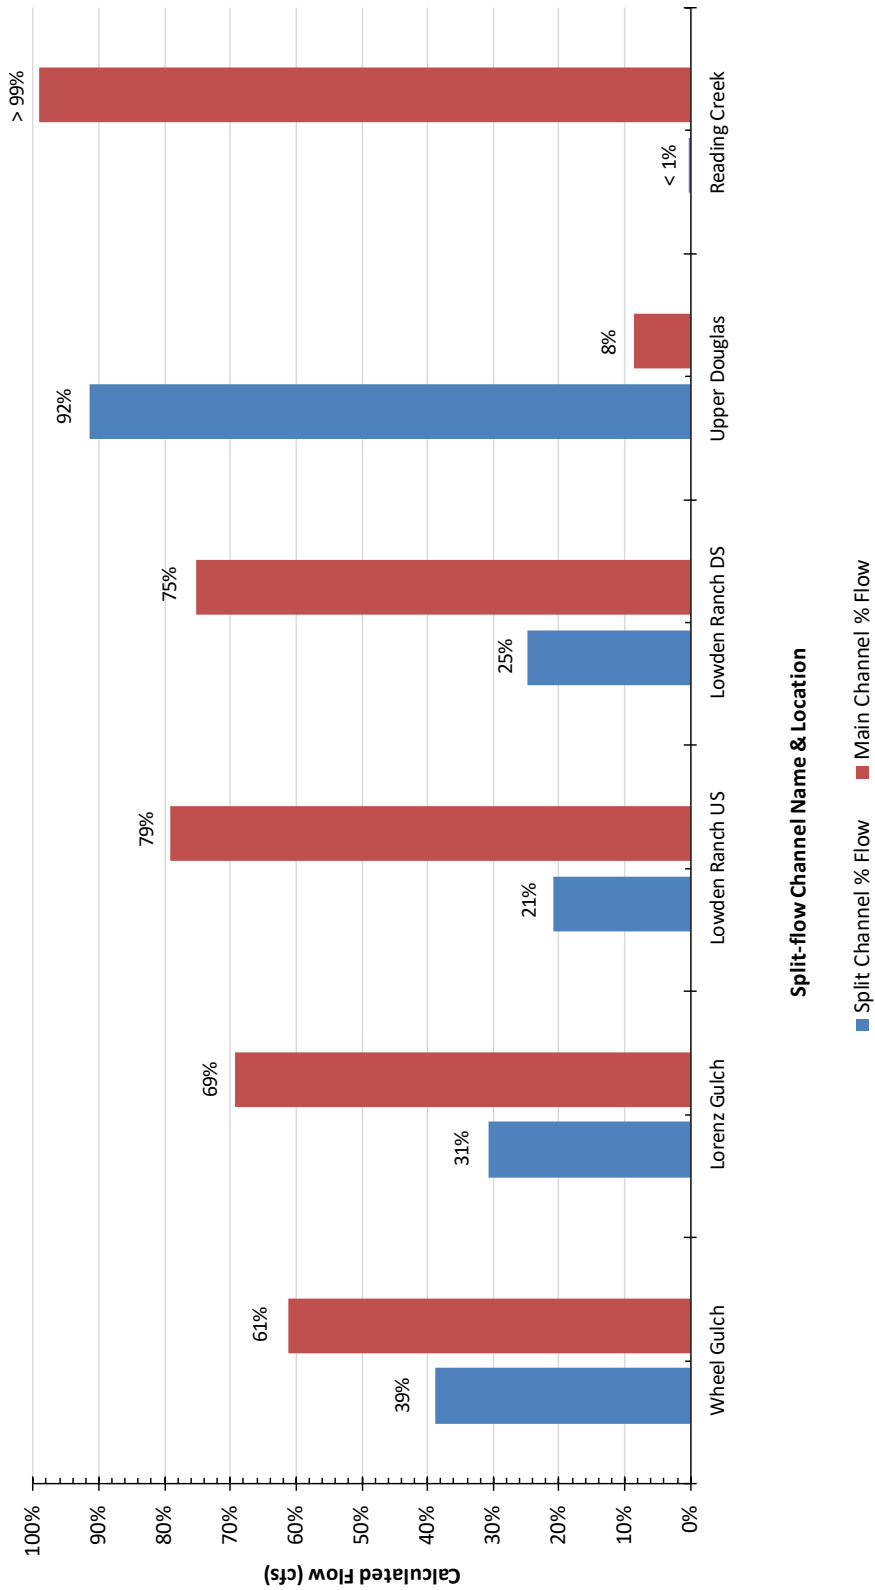
Figure 16. Average flow conveyance at the constructed split-flow channel locations. The reported percentages are the percent of flow in each split at that location. Note that Reading Creek and Upper Douglas City are the only two features where both splits no longer have at least 20% of flow. This could be a result of the severe erosion occurring on the medial bar at these sites.

Figure 17. Flow conveyance in each channel at the naturally occurring split-flow channel locations. Note that five of the eight naturally occurring split-flow locations have at least 20% of the flow in each channel, which is similar to the ratio of constructed split-flow channels where each channel has at least 20% of flow (Figure 16).

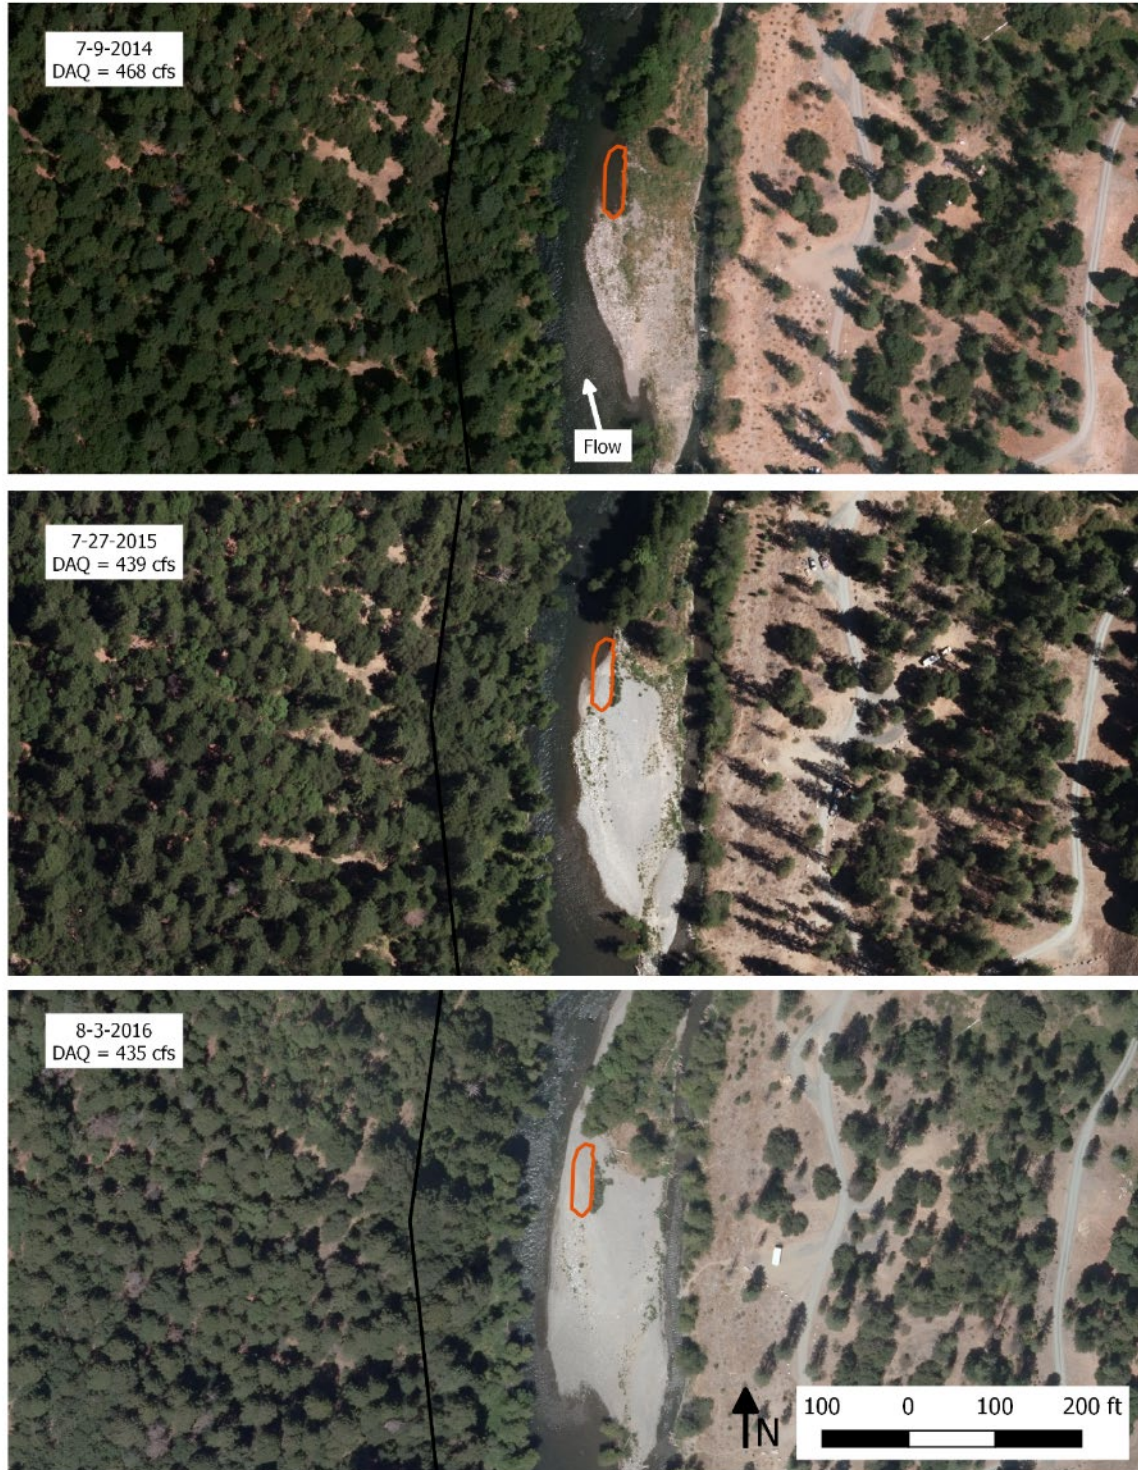
Figure 18. Lower Steiner Flat example of an alcove constructed at the downstream end of an unvegetated gravel bar, which continued migrating downstream and filled the alcove within three years. The alcove footprint is shown in orange. Additional sites with alcoves constructed in a depositional setting such as this one that also filled with sediment in the first few years include: Pear Tree, Elkhorn, Valdor Gulch, Wheel Gulch, and Sawmill. The reported flows are from the USGS Trinity River at Douglas City CA (gage # 11525854).

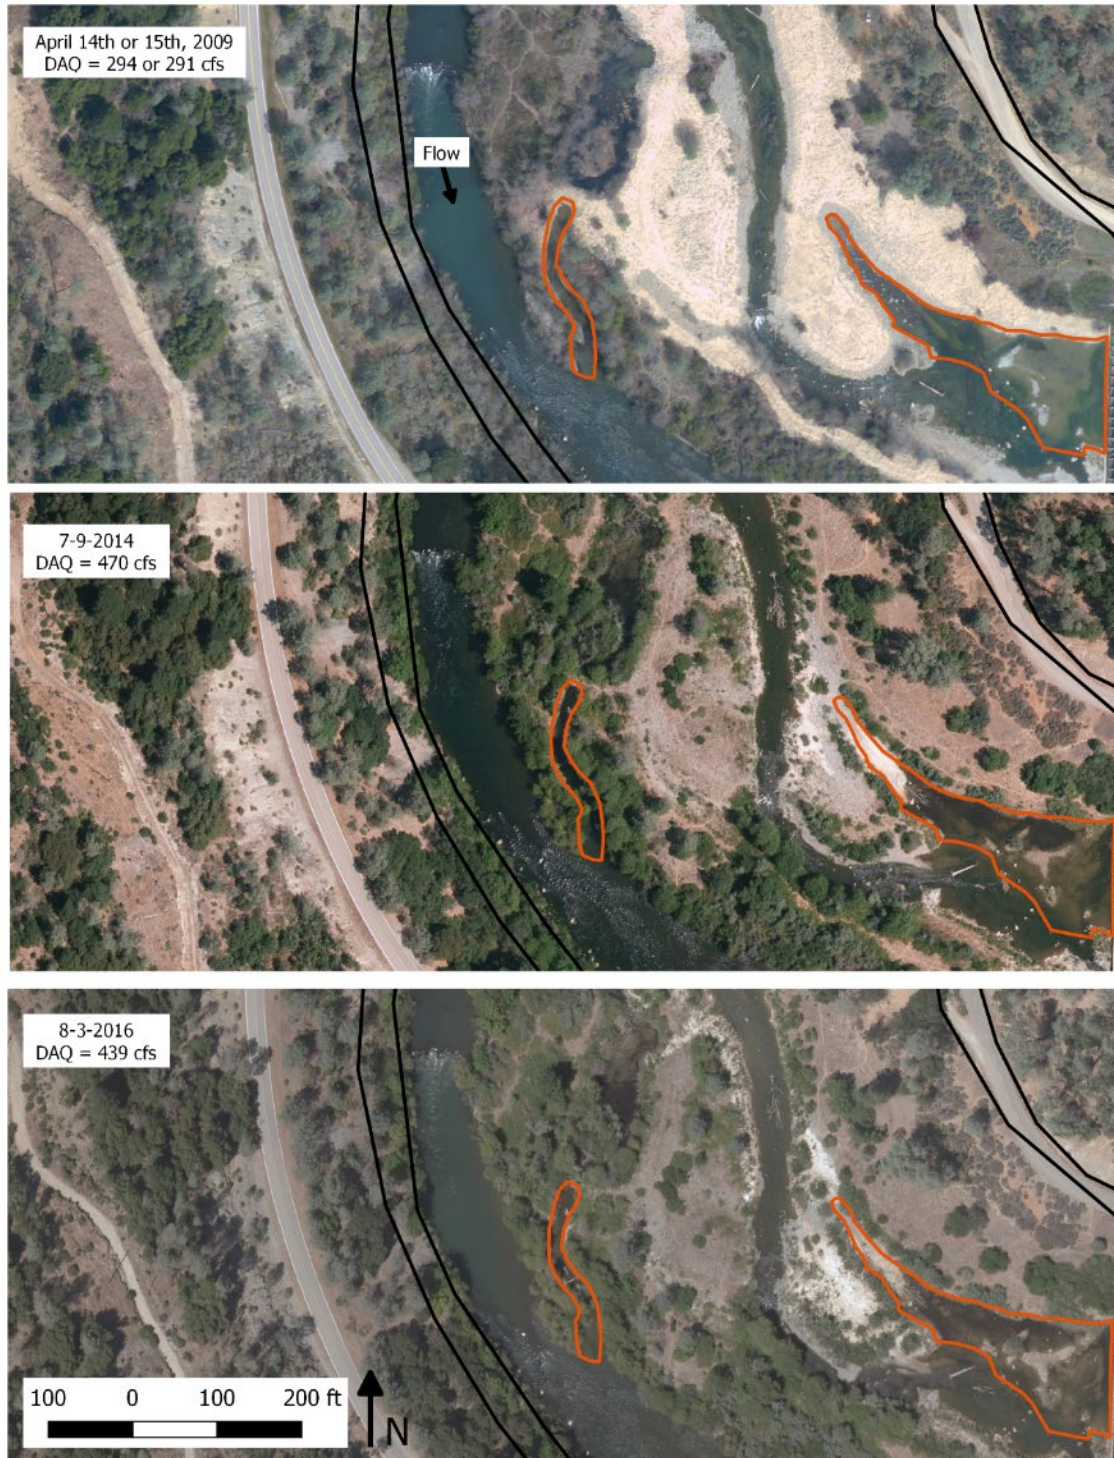
Figure 19. Aerial photographs showing two alcoves at the Sven Olbertson site constructed in 2008. The most successful alcove at this site, and one of the oldest functioning alcoves on the river, is shown in the center of each photograph. The GCD analysis and aerial photographs suggest that there has been no deposition in this alcove through time. This alcove is unique compared to others because it is surrounded by thick vegetation on all sides. The lack of sediment supply upstream of the alcove, the narrow mainstem channel width, and dense vegetation on the banks is likely why it has not aggraded. The Sven Olbertson site is the first downstream of the dam, so sediment input is limited. The reported flows are from the USGS Trinity River at Lewiston gage (gage # 11525500).

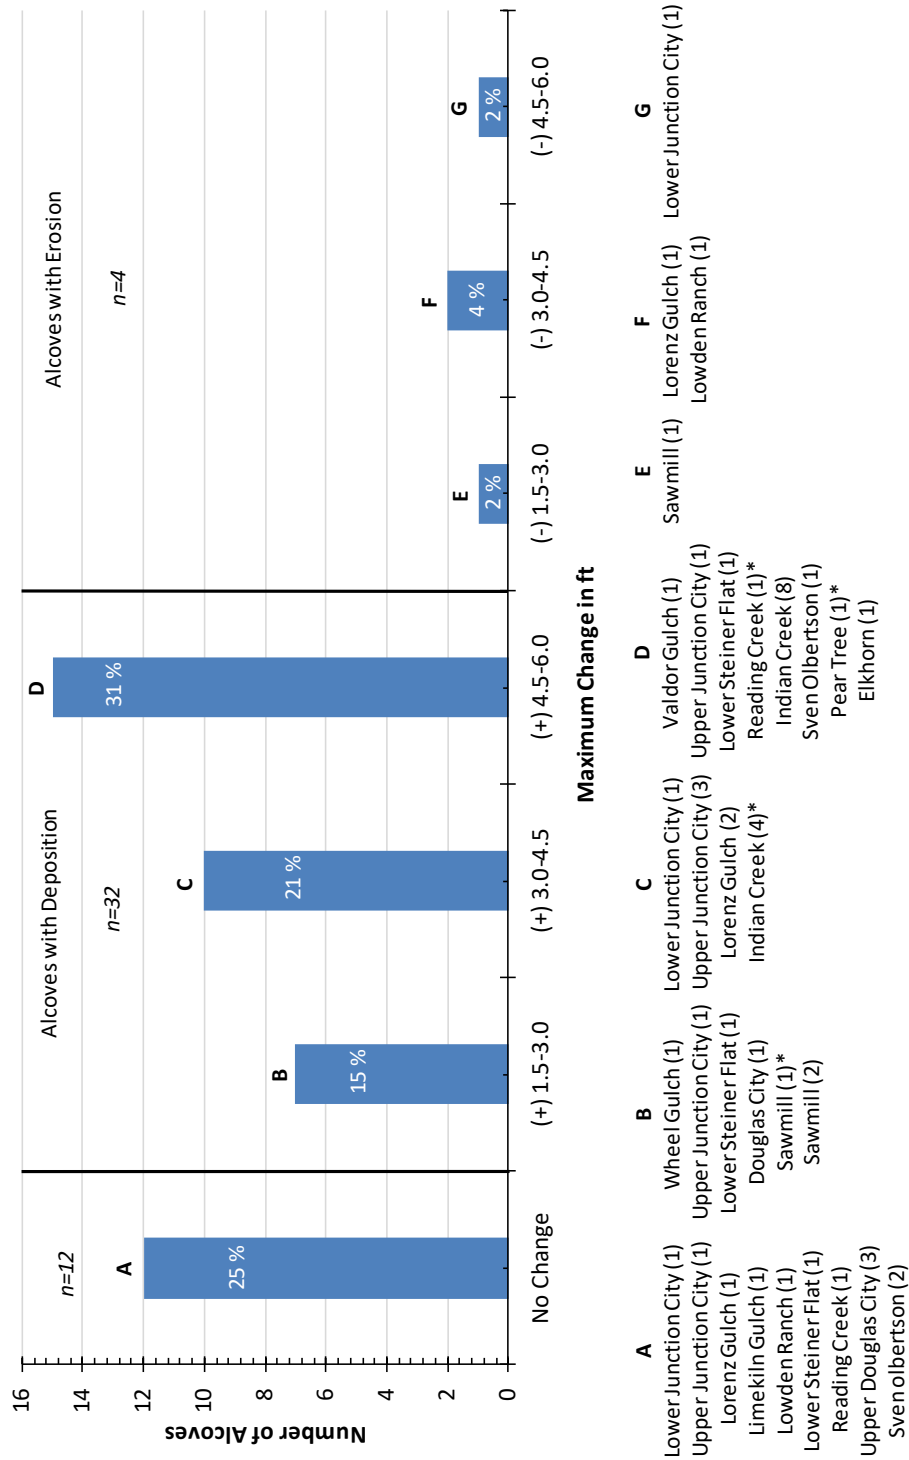
Figure 20. GCD results for maximum topographic change in the 48 alcoves that were evaluated. The graph is split into three sections to show the alcoves that had no change, alcoves with deposition, and alcoves with erosion. The alcoves were grouped based on the GCD “bins,” which register topographic change in increments of 1.5 ft. The percentage that each group makes up in the total population is shown within each bar. Below the graph, the sites and numbers of alcoves are listed for each group. Some sites have many alcoves, therefore individual feature names are not listed. Instead, the site name is listed and then in parenthesis the number of alcoves at that site that belong in that group is listed. The total number of alcoves at each site is shown in Table 7.

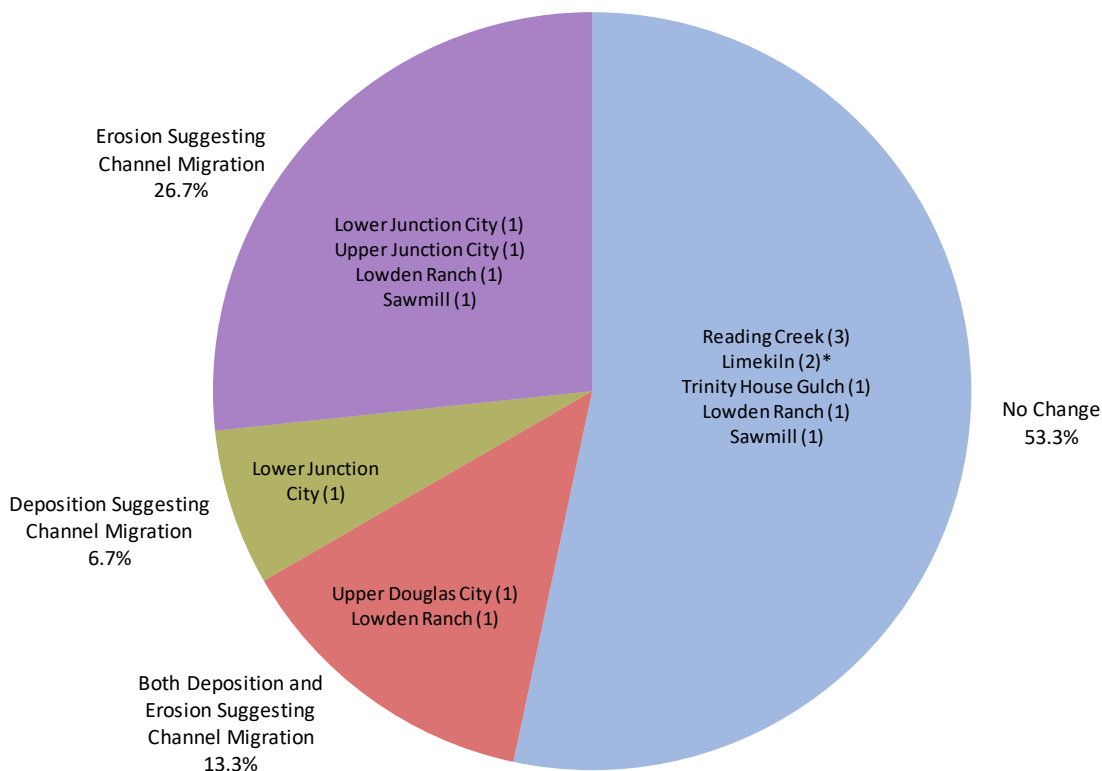
Figure 21. GCD results for 15 channel migration features. The two large, constructed meanders at Upper Douglas City and Lowden Ranch are considered to be the most effective migration features because erosion is occurring on the outside of the meander bend as it erodes into the bank, and deposition is occurring on bars on the inside bend of the meanders, completing the migration process. Because there is more than one migration feature at some sites, the number in parentheses notes how many migration features at that site fall into that group. *Note: Limekiln shows no change, but that could be due to only 1 year being evaluated.

Detailed descriptions of the GCD results for channel meander features can be found in Appendix 9: Channel Meander Results. Both the GCD and aerial photographs were used to evaluate the scale of deposition and erosion and to make observations about how the meanders are changing through time (Figure 21).

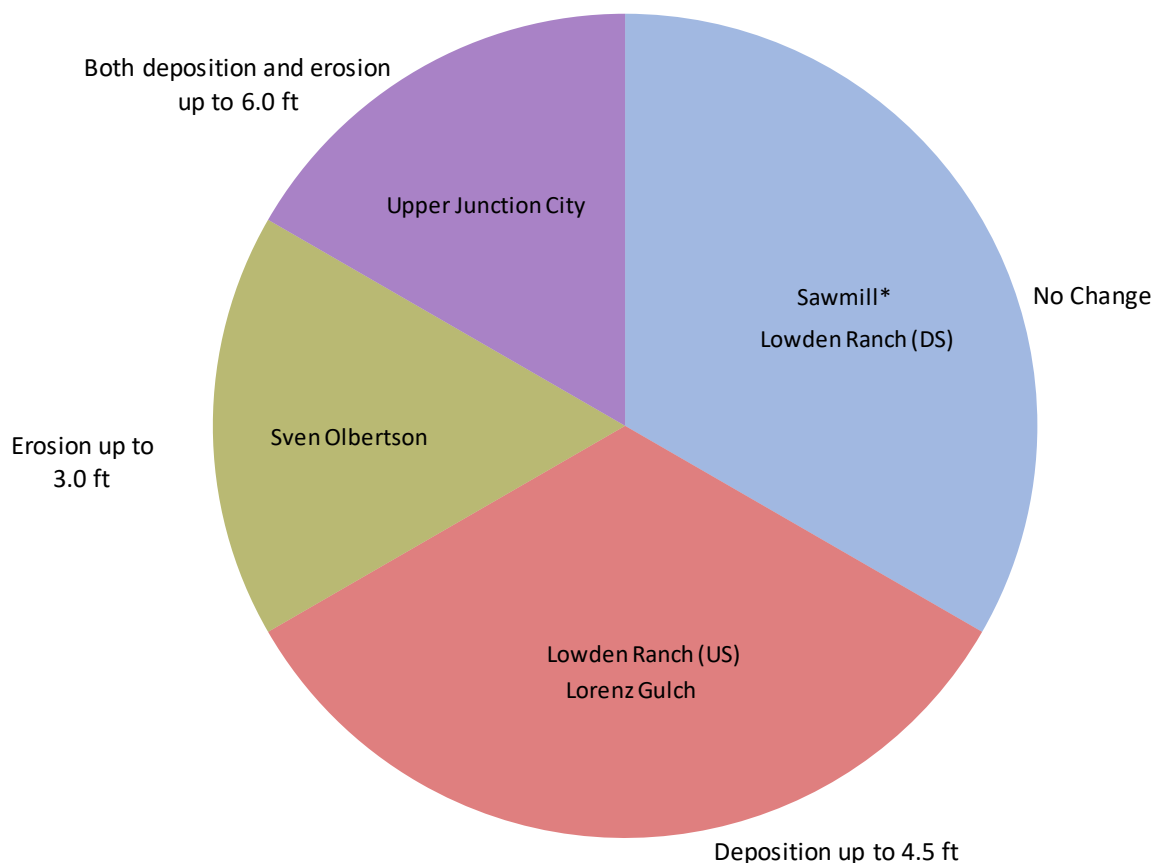
Figure 22. GCD results for the six off-channel wetland features. The group percentages are not calculated due to the low number of wetland features. Note that the “DS” and “US” next to Lowden Ranch indicate whether it is the downstream or upstream feature. Sawmill is shown with an asterisk because the post-construction survey was taken three years after construction, and therefore the GCD does not capture deposition or erosion that happened in between the end of construction and the post-construction survey.

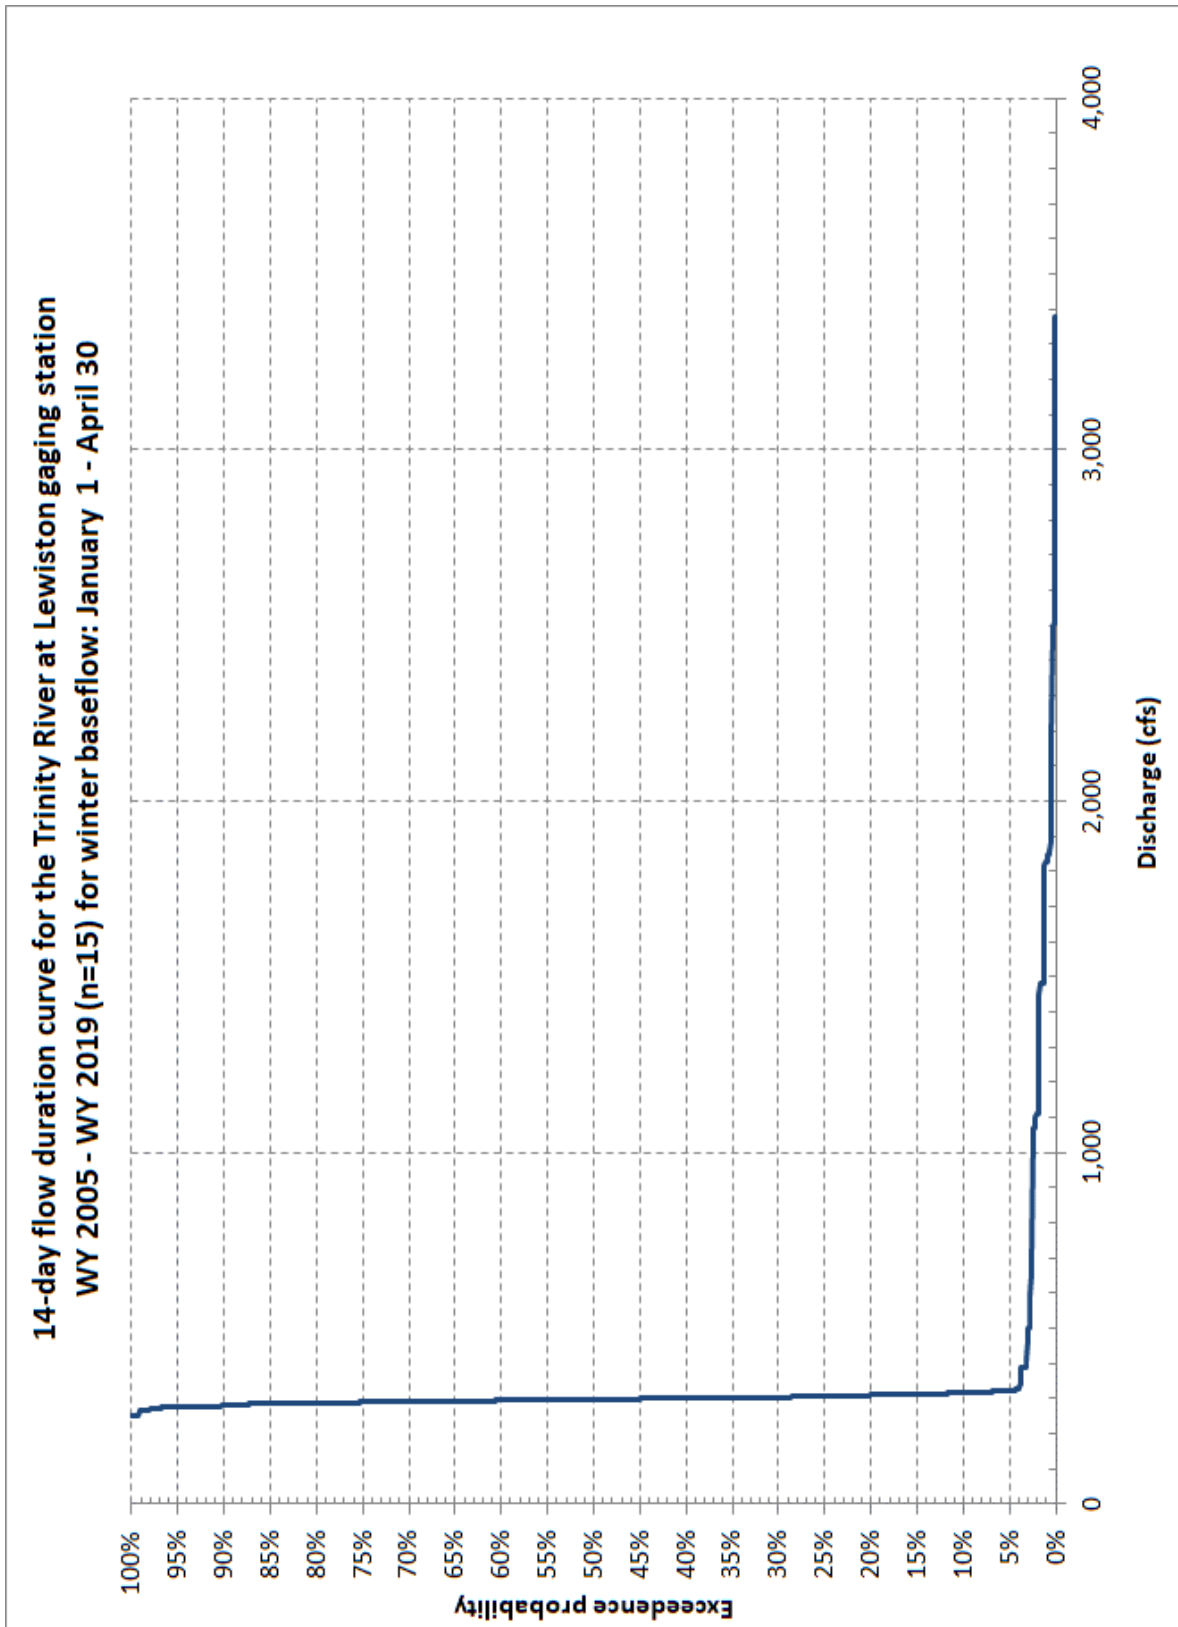
Figure 5-1. 14-Day flow duration curve for the Trinity River at the USGS Lewiston gaging station.

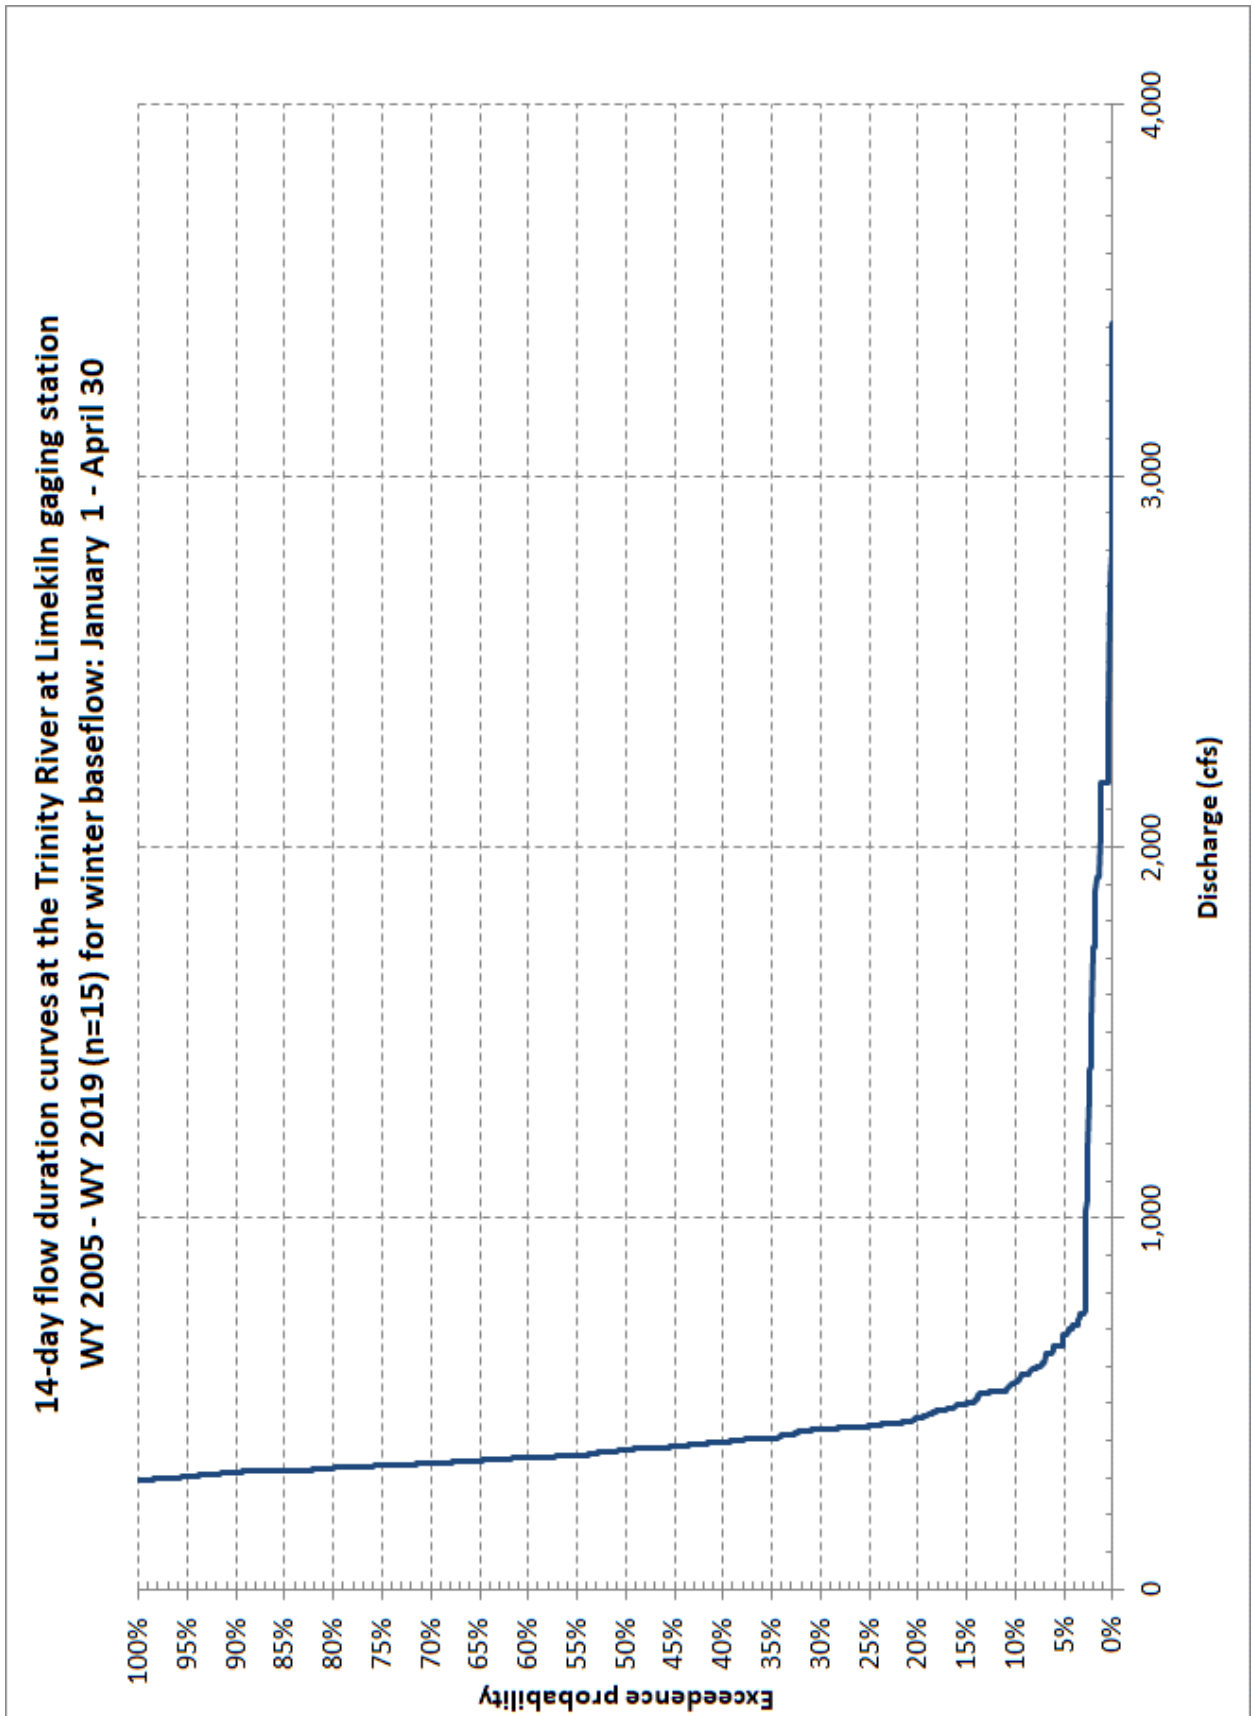
Figure 5-2. 14-day flow duration curve for the Trinity River at the USGS Limekiln gaging station.

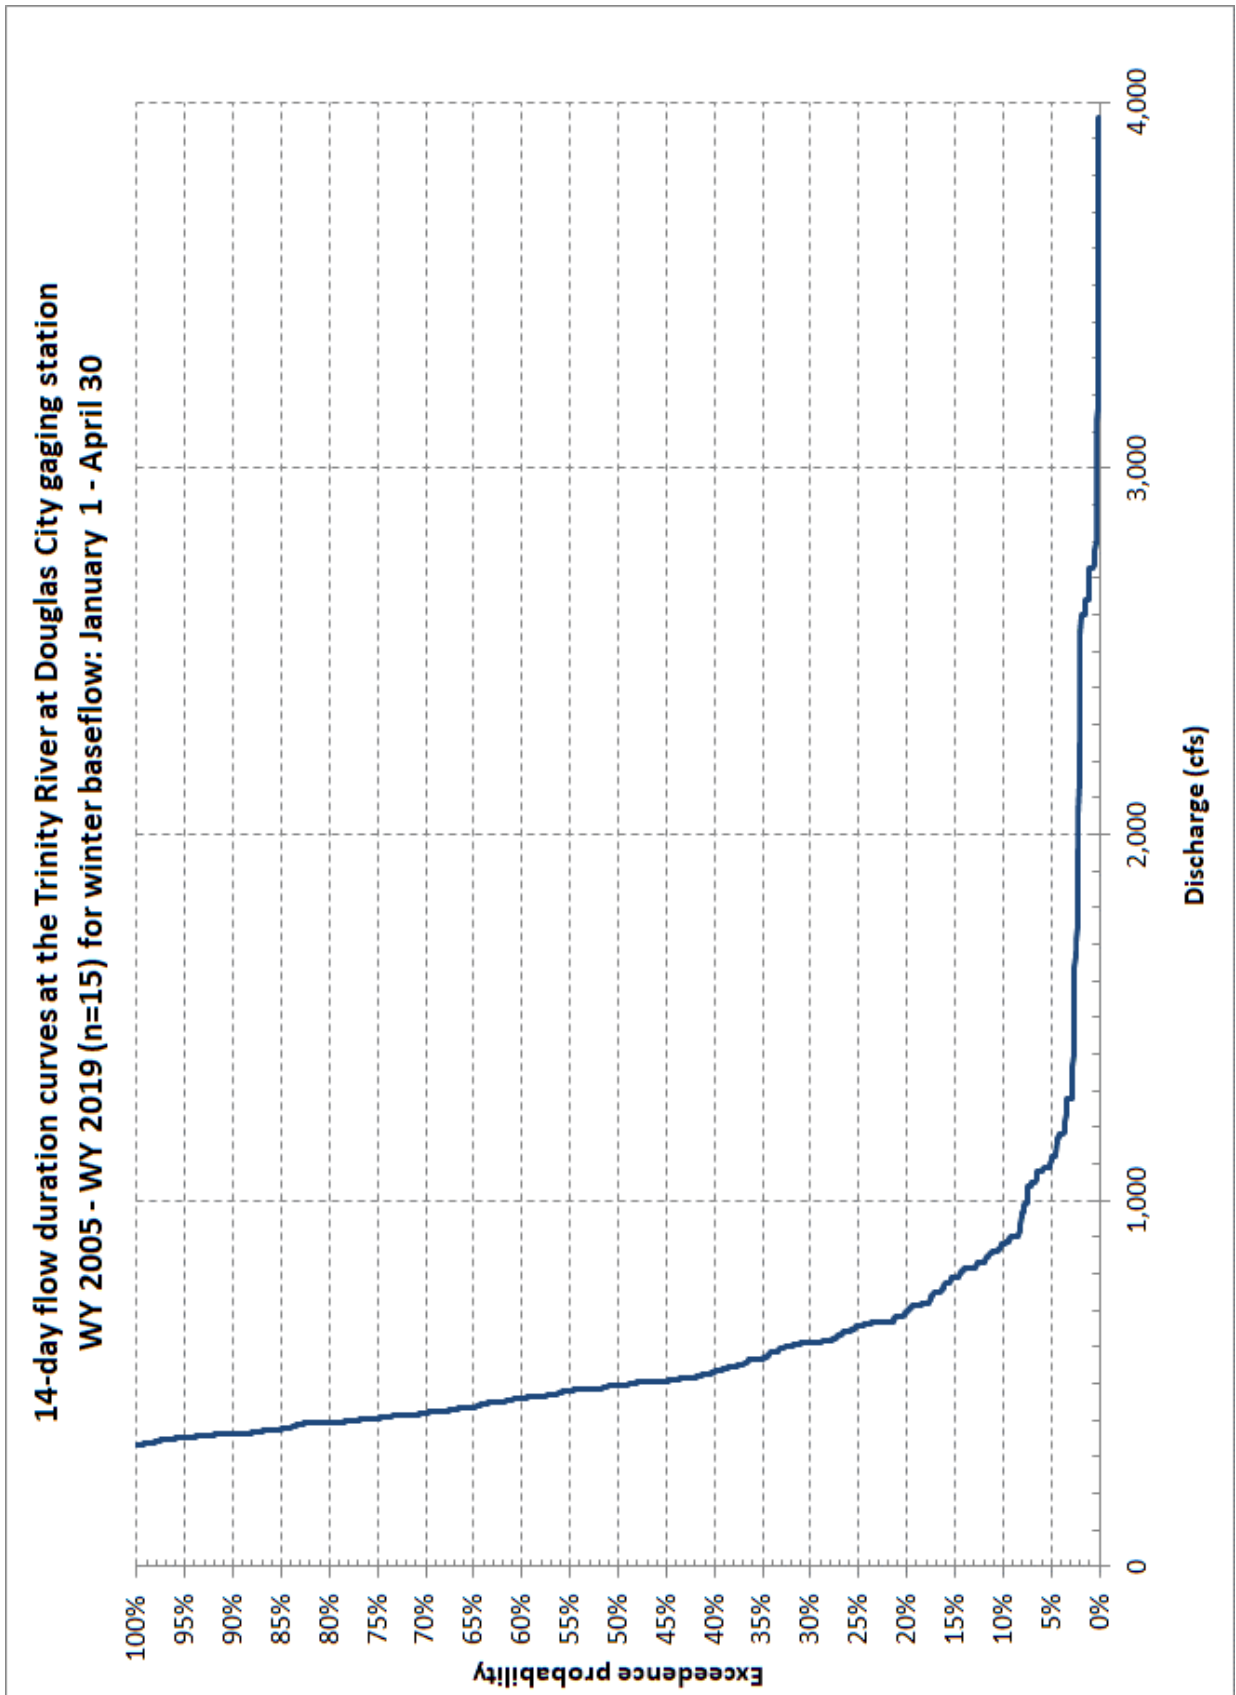
Figure 5-3. 14-day flow duration curve for the Trinity River at the USGS Douglas City gaging station.

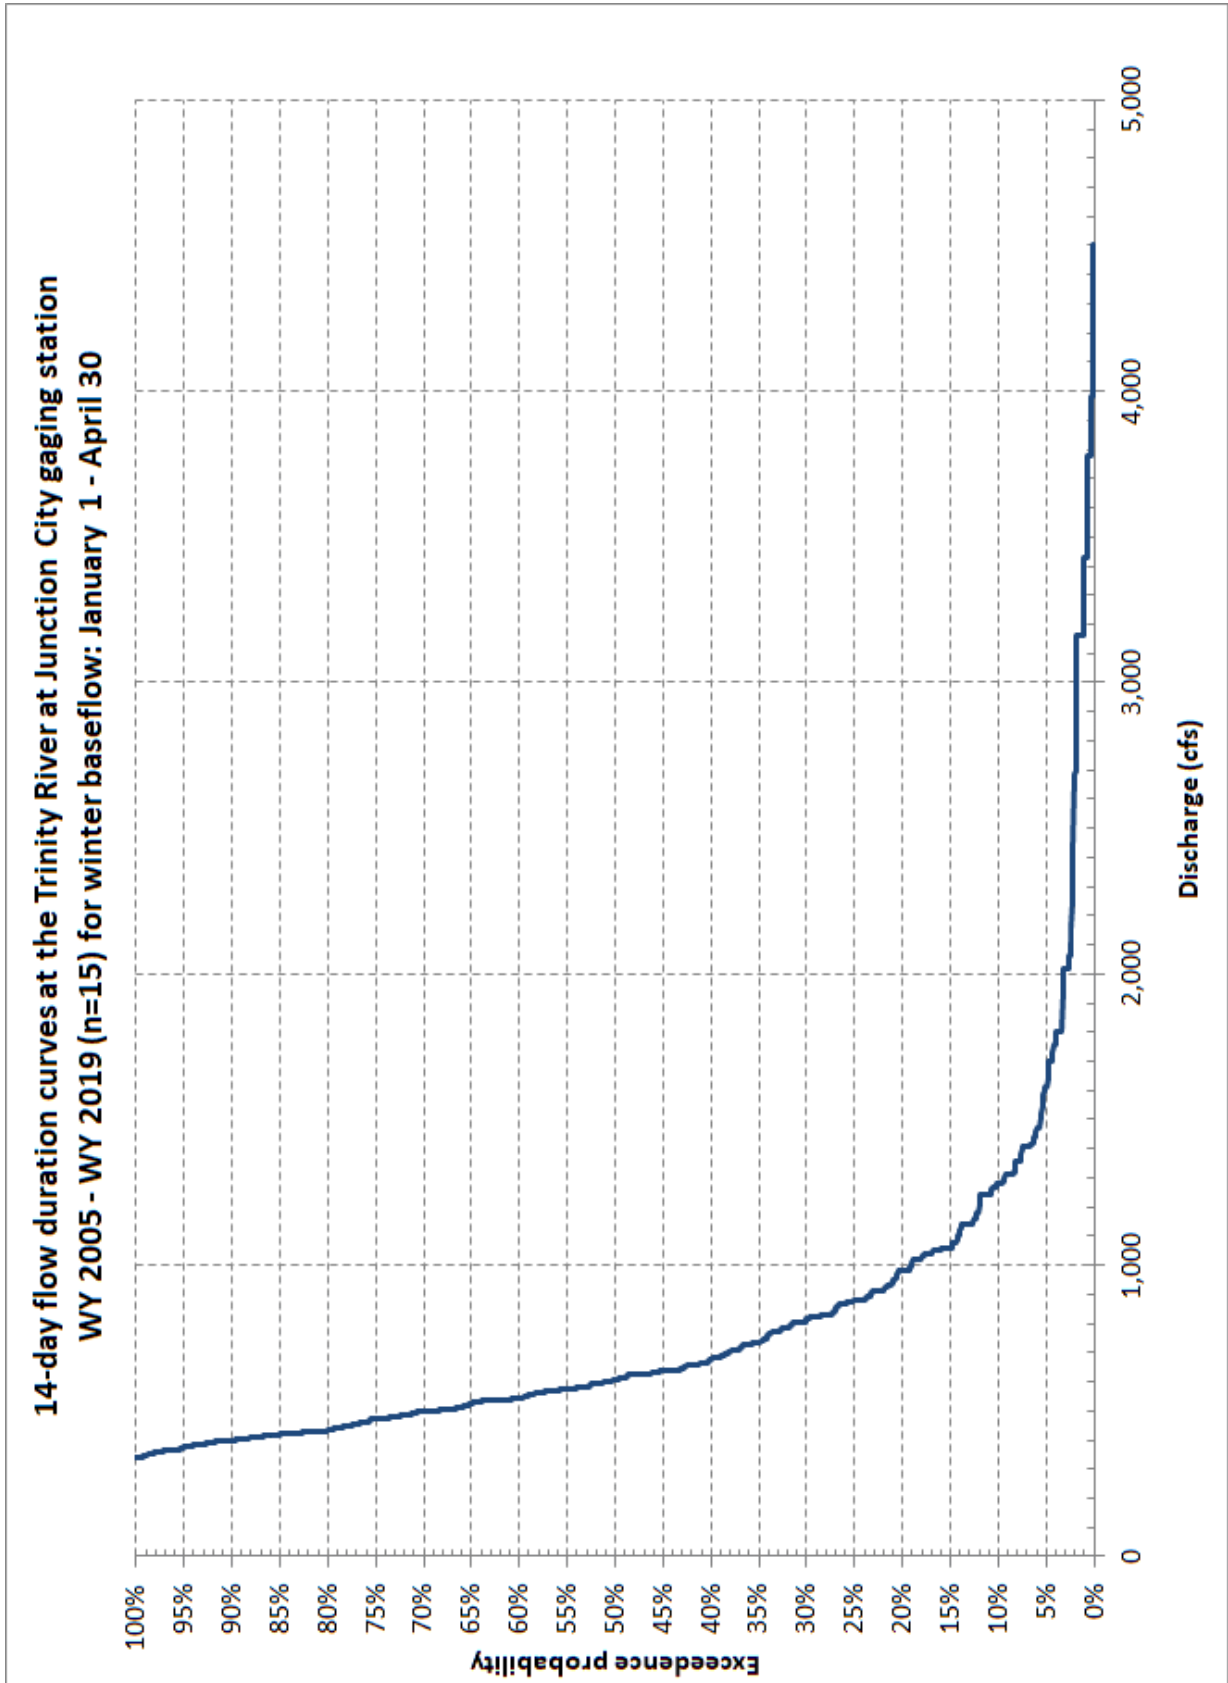
Figure 5-4. 14-day flow duration curve for the Trinity River at the USGS Junction City gaging station.

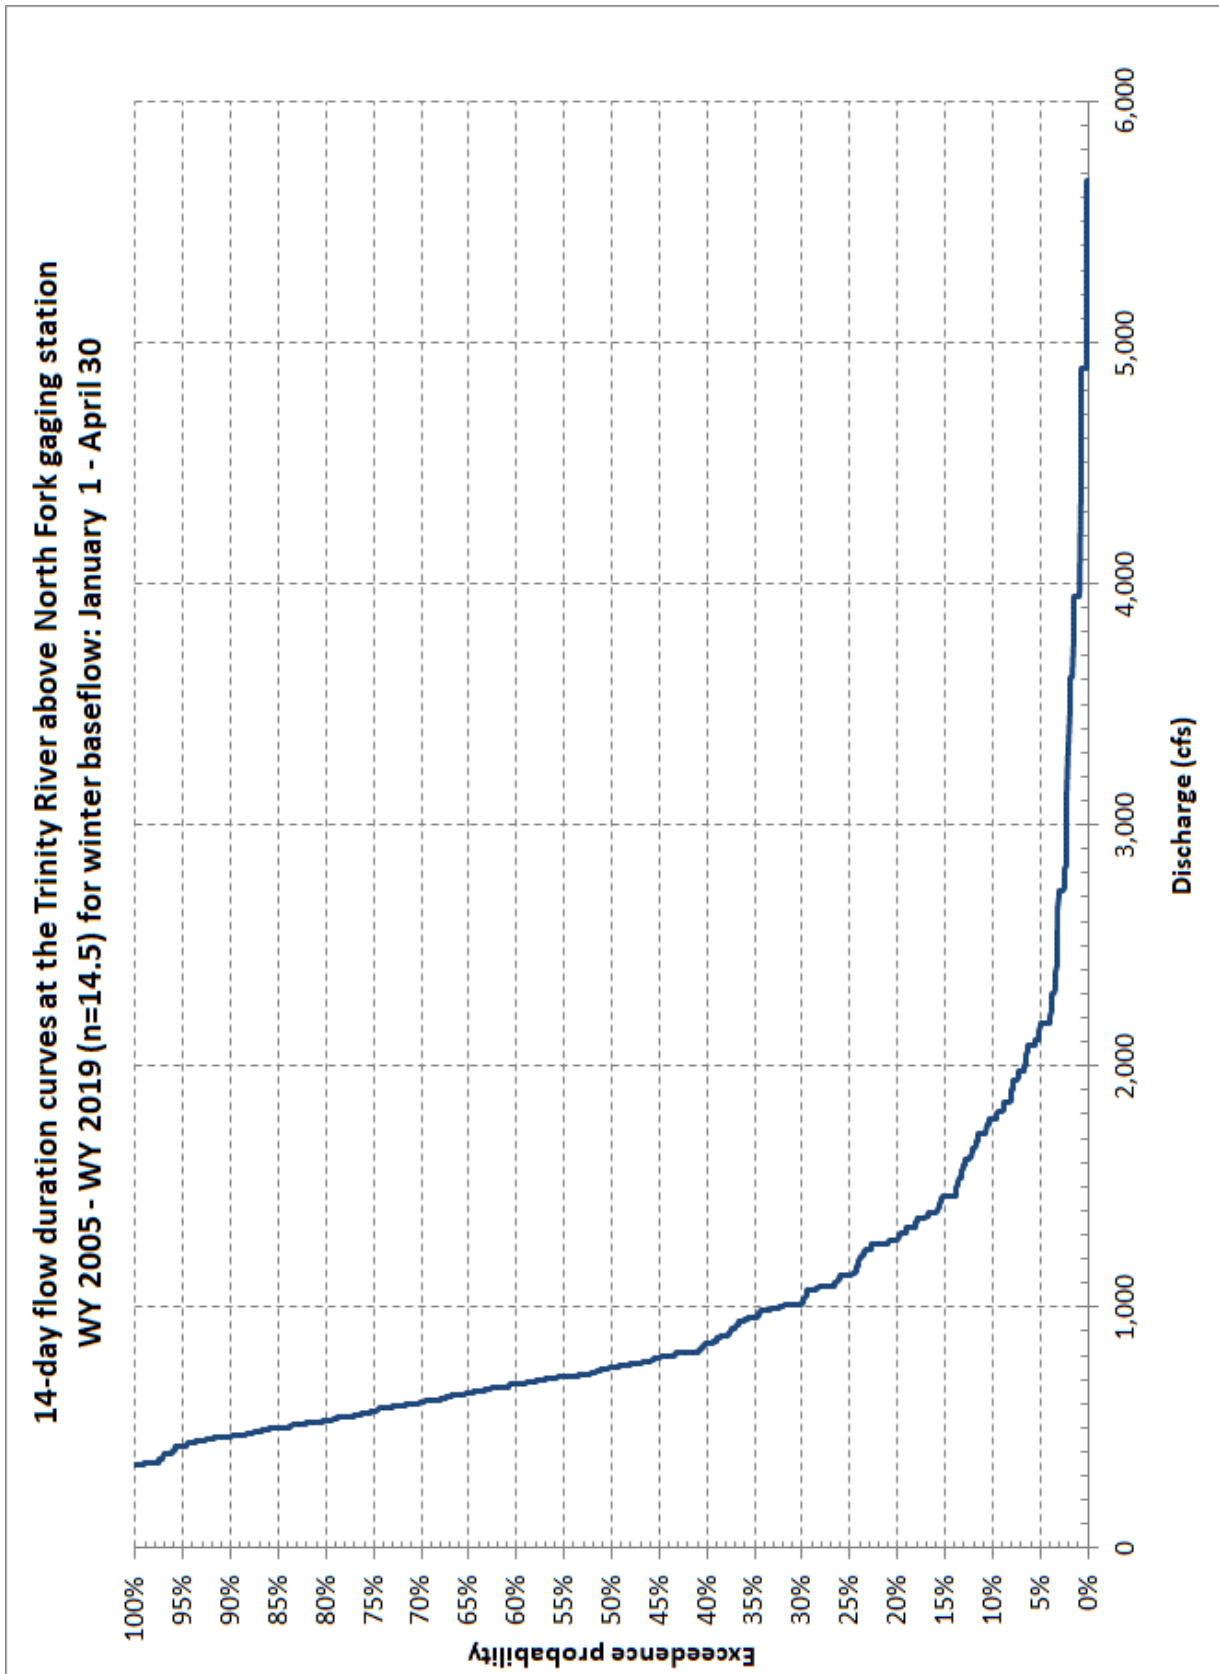
Figure 5-5. 14-day flow duration curve for the Trinity River at the USGS Trinity River above North Fork gaging station.
