**Final Report**  
East Weaver Creek Dam Intake  
Relocation & Dam Removal  
Project &  
McKnight Ditch Water  
Conservation Project

East Weaver Creek Watershed

Trinity River Restoration Program,  
US Bureau of Reclamation  
US Department of Interior

Grant Number: R18AP00075

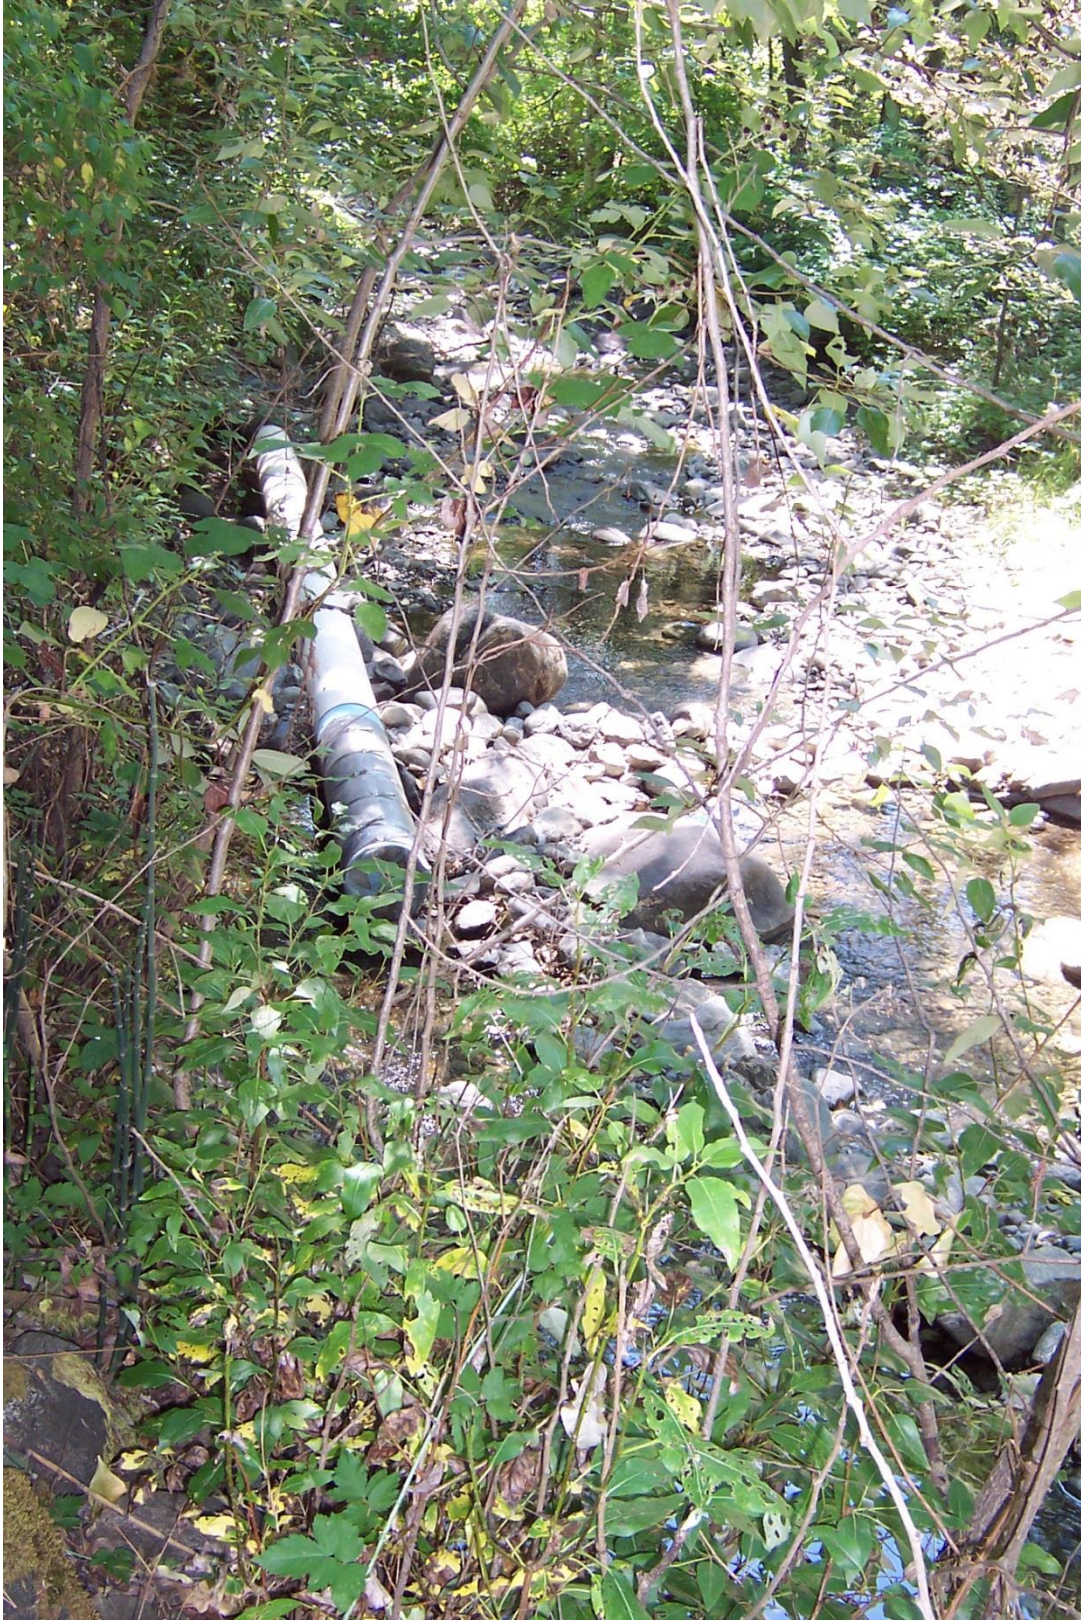
**Figure 4: Existing East Weaver Creek Intake Structure had deteriorating pipe and materials.**

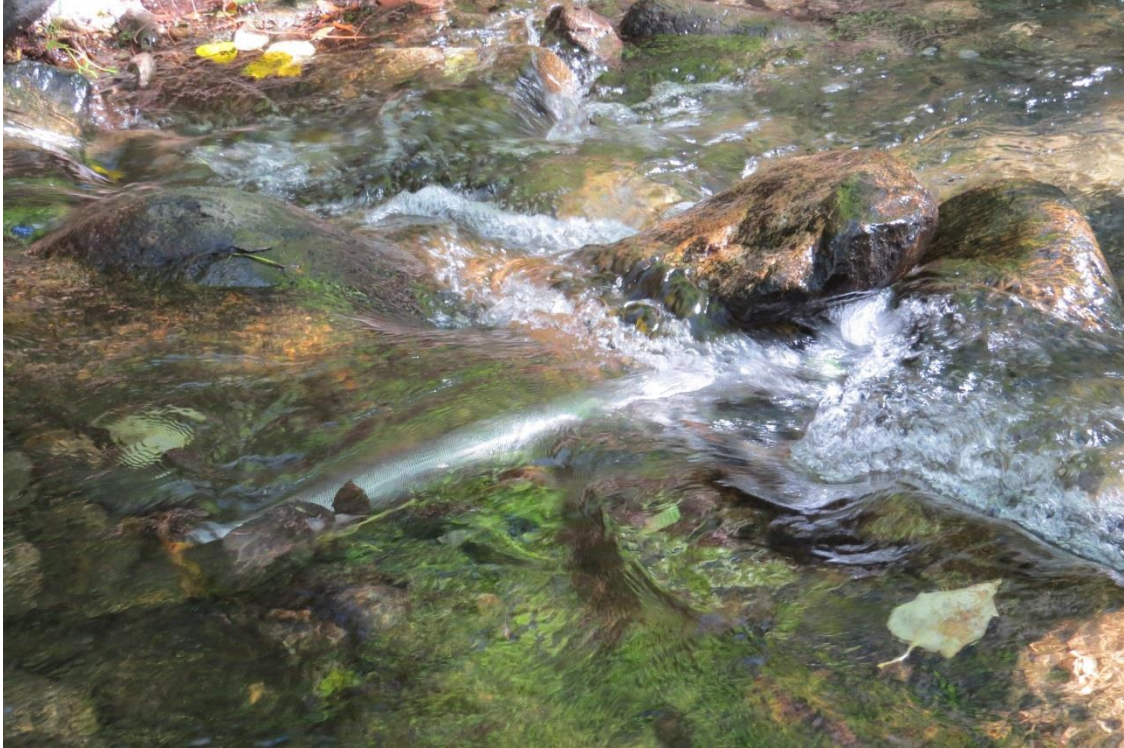
**Figure 5: New intake structure equipped with 20 gauge perforated stainless steel screen with 0.075" screen openings and low entrance velocity design to minimize vortices and debris accumulation. This is a non self-cleaning, passive screen with no moving parts to maintain or replace.**

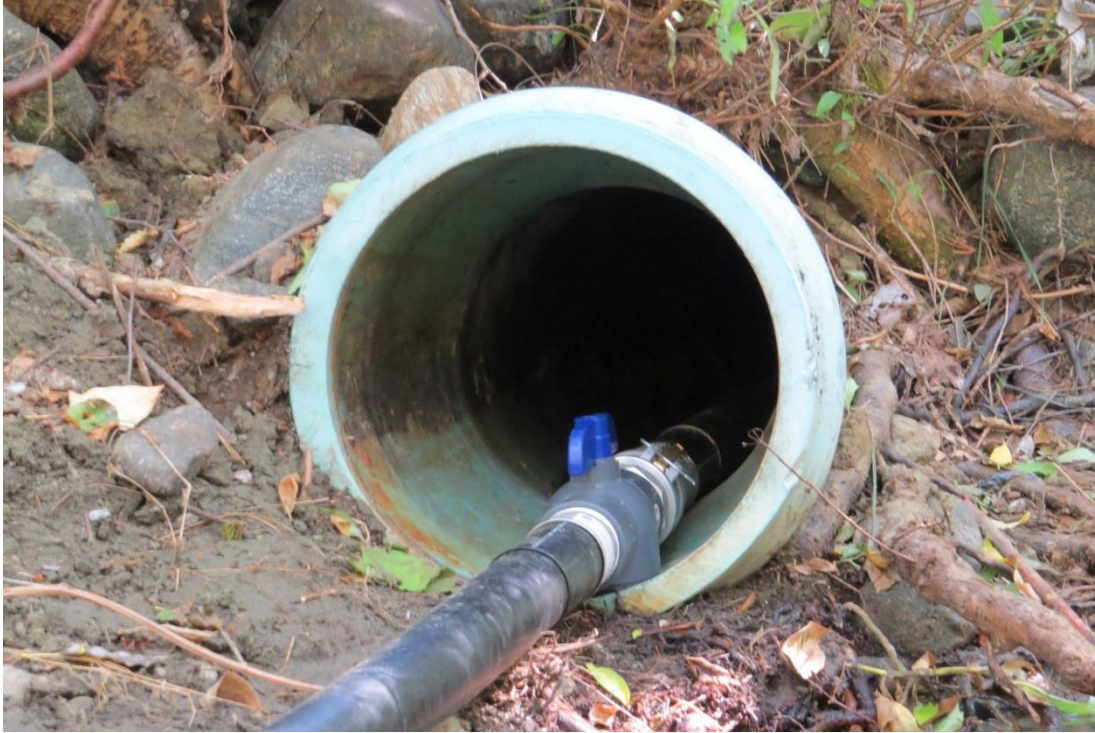
**Figure 61: New HDPE Butt-fusion intake pipe with quick-disconnect cam-lock fitting and shutoff valve utilizes portions of the existing East Weaver Creek Intake Structure thus minimizing disturbance to the streambed and bank.**

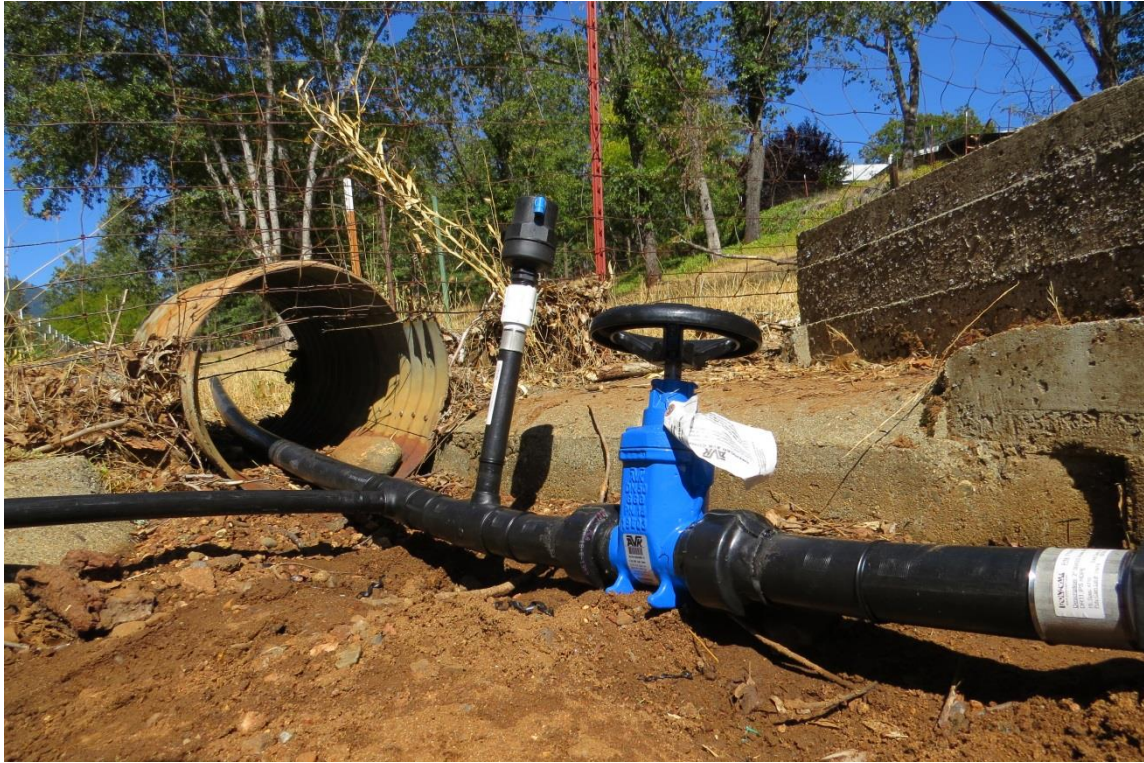
**Figure 7: Gate Valve with HDPE fusible ends and Netafim 1" Combination Air/Vacuum and Continuous Acting Air Vent installed at existing overflow structure. Vents allow for discharge and intake of large volumes of air along mains and at the end of mainlines and provide continuous air release at high points in pipe network or upstream of manifolds.**

Once the line was installed it failed to sustain consistent flows. A process of elimination determined that the issue was with air vent valves that were not sufficiently closing to create and/or maintain a vacuum within the line. The underlying issue was determined to be that flow within the pipe was not fully developed, nor sufficient to create suction necessary to maintain a steady flowrate. A combination of valve replacements- with manually operated valves- resulted in improved flow.

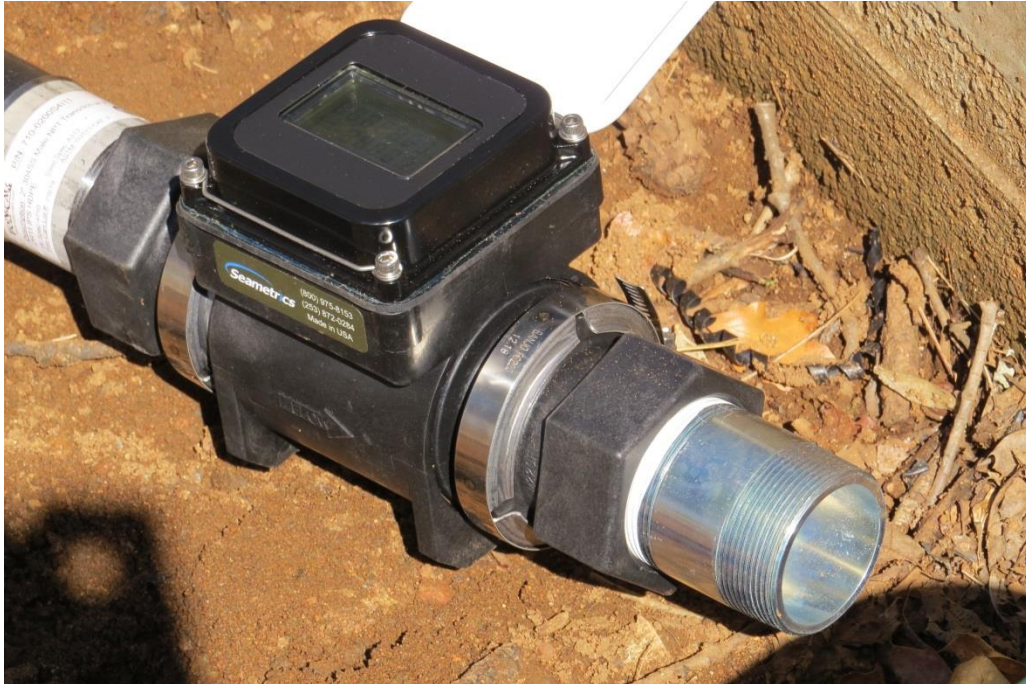
**Figure 82: Seametrics Magnetic flow meter (2-inch) and flow regulating Dole valve. Plastic-bodied and battery-powered magmeter irrigation flow meter with digital display functions with no moving parts for unobstructed flow and minimal flow disturbances. Meter allows the user to easily read instantaneous flowrate in GPM and Total volume in gallons. System ensures durable fluid measurement**

Once flows were fully established after installation, monitoring of daily water delivery was done to verify that the Dole Valve flow limiter was properly functioning and that the magnetic flow meter was working correctly for each Water Right holder. The lines were tested and found to be performing to standards on November 1 but in order to complete the test (before the intake had to be removed) lines were left above ground from Butlers to Powers property. With the system functioning properly the final construction elements of the Powers water line were installed. This included disconnecting the Powers 1" HDPE water line and running the new waterline inside the underground portion of the pre-existing 6" pipeline (acting as a conduit for the new line). Due to a number of bends and root blockages in the existing line it had to be dug up to clear obstructions.
