# **TRINITY RIVER WATERSHED Five Counties Road Erosion Inventory**

## **Final Report**

**For State Water Resources Control Board  
Proposition 204 Program**

Prepared By  
Trinity County Planning Department - Natural Resources Division

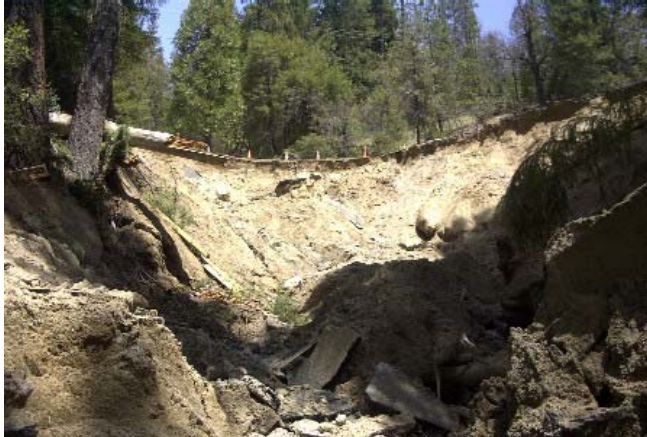
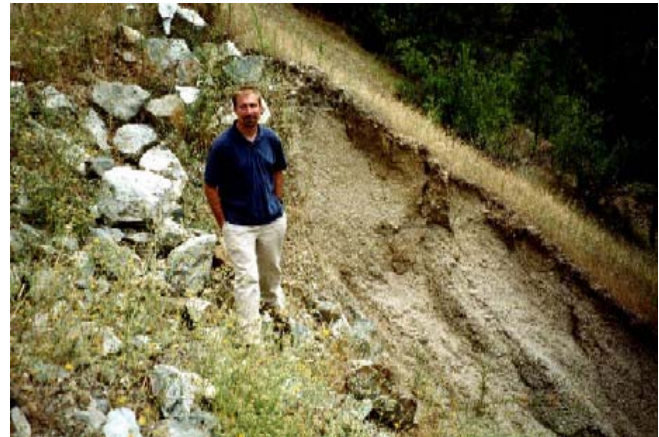
design standards. Many fill slopes on these roads cross small drainages with undersized culverts. The highly erodible soils have buried culvert inlets. Stand pipes, some more than 20' tall, have been added as sediment accumulates at the inlets. In these instances, the watercourse or drainage runoff typically saturates the decomposed granitic soils and permeates through the road fills or is diverted to an alternate culvert crossing. In normal stormflows, water can pond or pool on the upslope side of the roads without risk of overtopping the roads. However, fill saturation can result in increased risk of failure (Photos A & B).

Photo A (Upper left). Trinity Alps Road fill failure in May 2003. The combination of decomposed granitic soils and saturated fill resulted in the fill failure at this Class III stream crossing. Photo B (Upper right). Trinity Dam Boulevard showing fill erosion in May 2003 from diverted road surface runoff.

While this report includes the theoretical potential volumes for these crossings, the program manager estimates the actual potential delivery volume for crossings larger than 1,000 yd<sup>3</sup> to be ~ 50% of these reported volumes. The reduced sediment volume for these roads reflects the sheer size and depth of the fills compared to the size of their watercourses and the total stormflow within the channels. It is the program management's opinion that the slope failures would tend to be relatively vertical, outside of the flood channel width, rather than the typical angle of repose of 1:1½ for most soils in the area. It is not inconsistent with decomposed granite soil characteristics to retain a near vertical angle following channel downcutting, at least initially. Assuming that the sites would be treated within a reasonable time following the failure, the downcutting and slope erosion would be controlled. For many of these crossings, the installation of an overflow culvert placed high in the fill and the placement of a downspout along the length of the fill slope, or the placement of culverts to prevent water from pooling, should minimize the potential for catastrophic failure of the fill crossings.

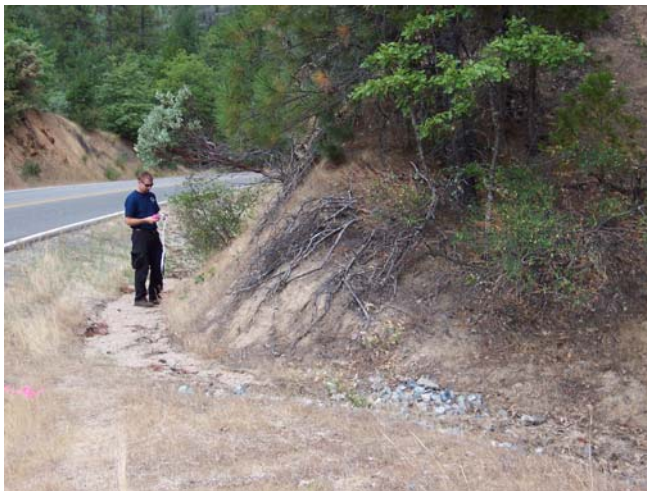
Photo C (Lower left). Trinity Dam Boulevard showing cutbank sediment delivery to a ditch.

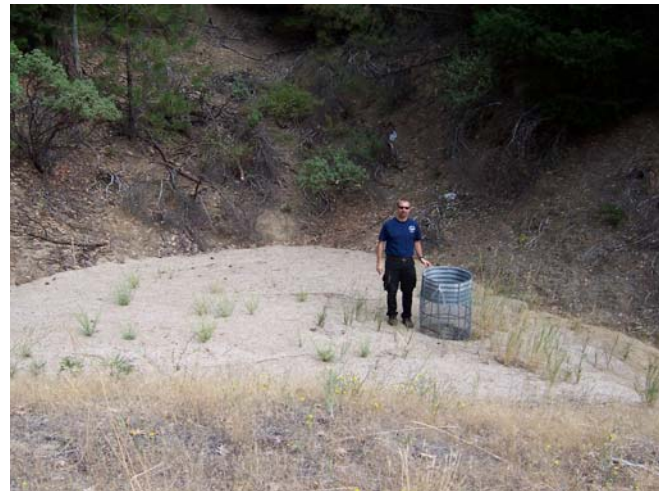
Photo D (Lower right) showing sediment delivery from a ditch to a sediment basin and a culvert inlet. Periodic removal of sediment from basins can reduce delivery to streams.

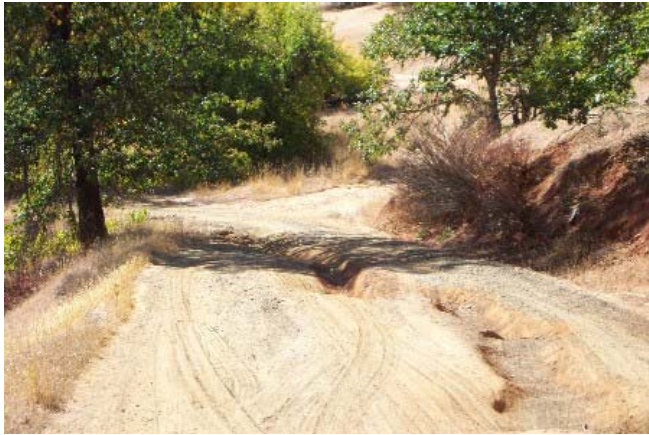
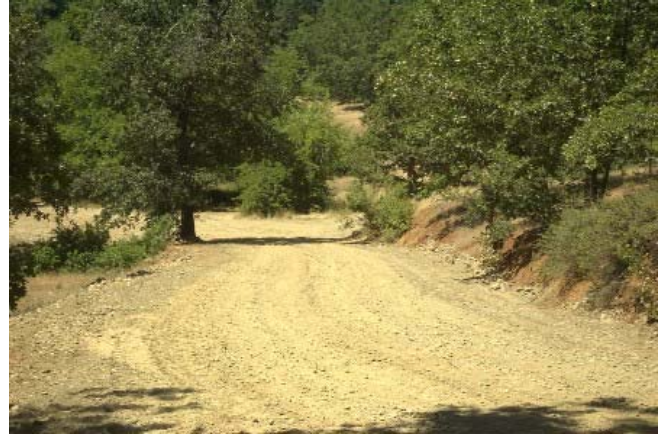
Photo E (Upper left). Dutch Creek Road showing diverted ditch flow down road. Photo F (Upper right). Same location after the road was outsloped with rolling dips and rock surfacing.

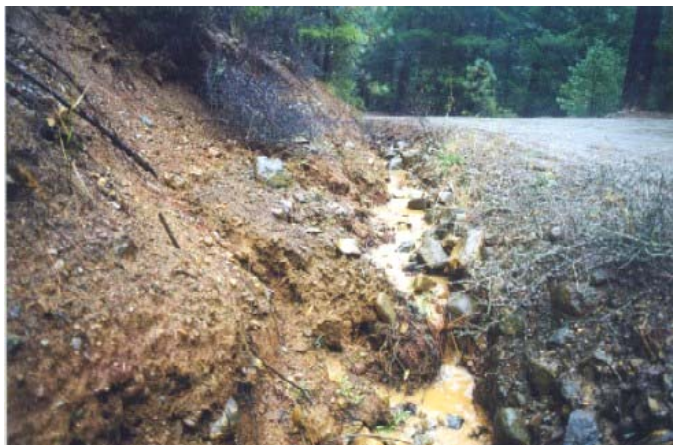
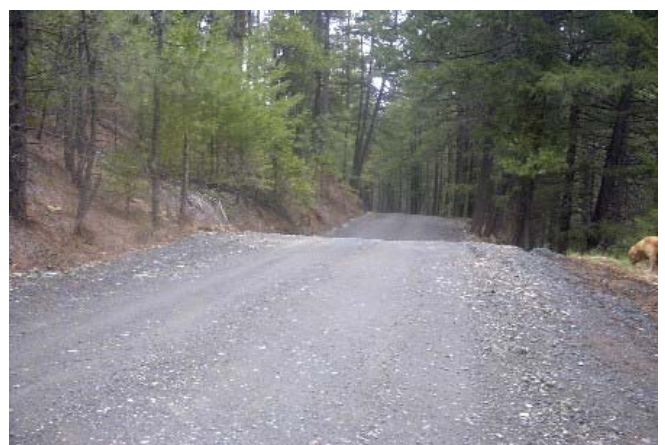
Photo G (Lower left). China Gulch Road showing both ditch and cutbank erosion. Photo H (Lower right). China Gulch Road after ditch removal showing outslope and exaggerated rolling dip. The exaggerated dips were used due to the cutbank slides on and low vehicle use of the road.

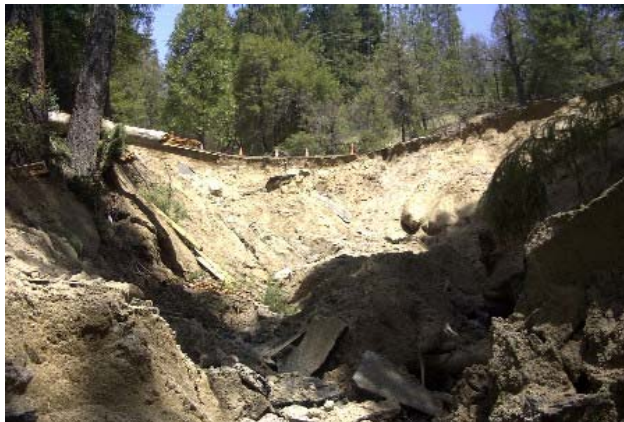
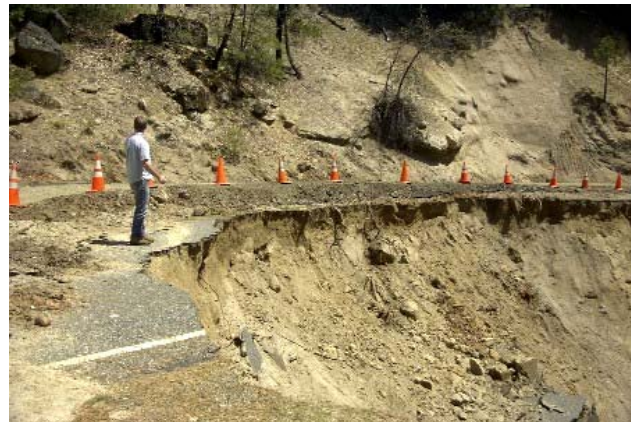
Photo 1 and 2. Trinity Alps Resort Road fill failure in decomposed granite soils. May 2003

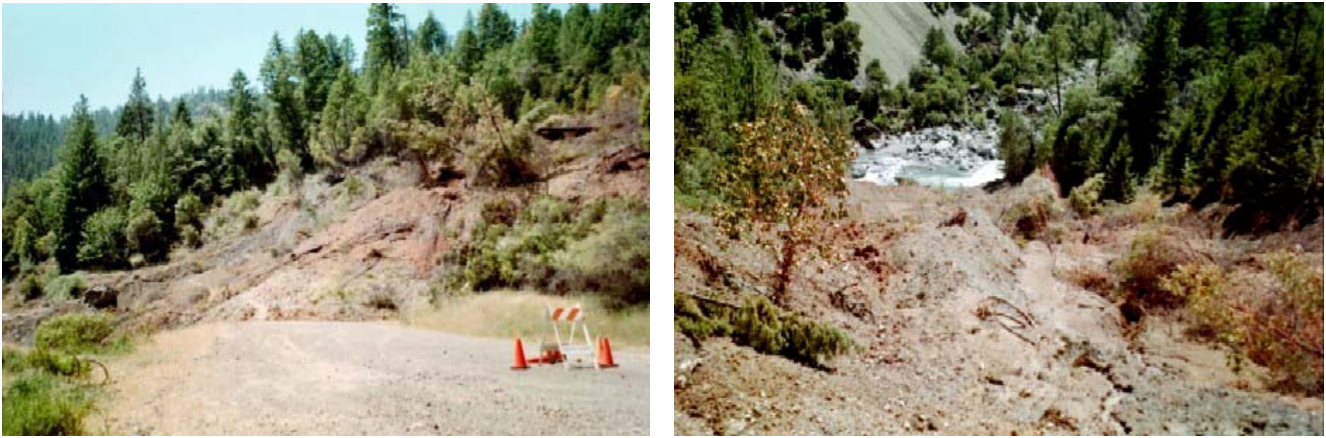
Big Slide on Lower South Fork Road in Hyampom above the South Fork of the Trinity River. Road crews have been removing material as part of their efforts to re-open the road. The failure volume of the most recent event was estimated at  $\sim 231,000 \text{ yd}^3$  – much higher than that originally projected ( $1,952 \text{ yd}^3$ ). Of that  $\sim 45,000 \text{ yd}^3$  is thought to have delivered to the South Fork Trinity River. (Figures obtained from USDA Forest Service “Big Slide near Hyampom Mass Failure Report, January 24, 2003.”)
