# Riding the adaptive management loop: habitat assessment informs restoration

Josh Boyce, Damon Goodman (USFWS) ● Aaron Martin, Kyle Hopkins (YTFD) ● Justin Alvarez (HVTFD)

# Why monitor salmon rearing habitat?

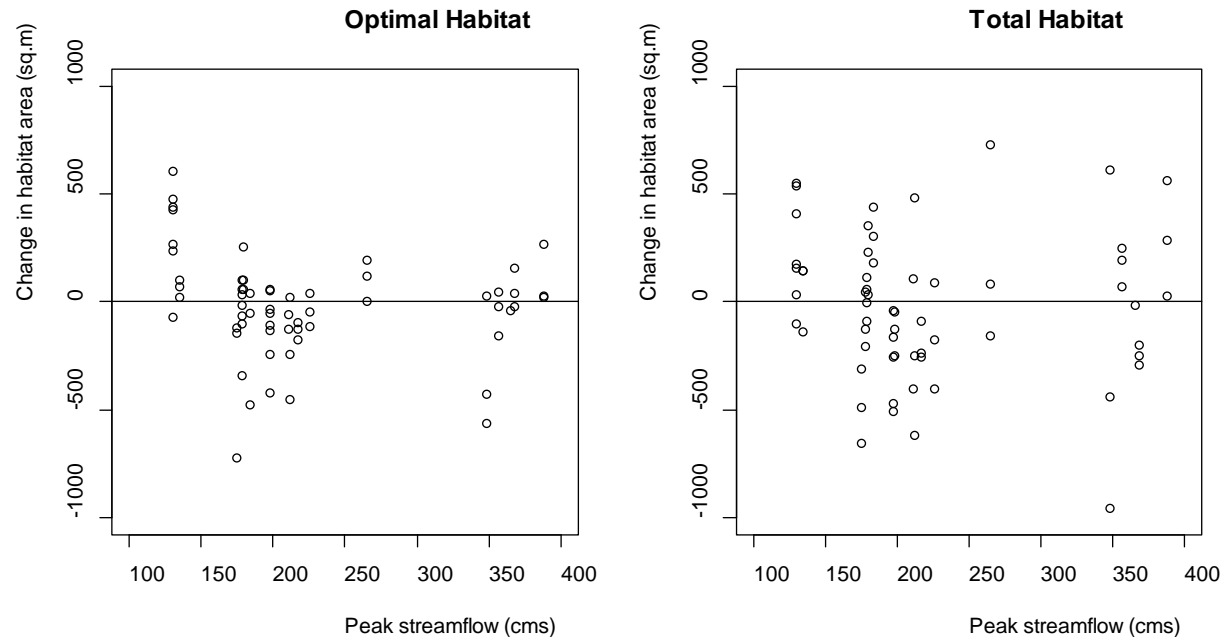
# Systemic Scale: Habitat availability at summer base streamflow 450 cfs

## Results:

annual variation in habitat area by site  
(increases and decreases)

larger annual peak streamflows did not relate to  
greater improvements or more variation in habitat area

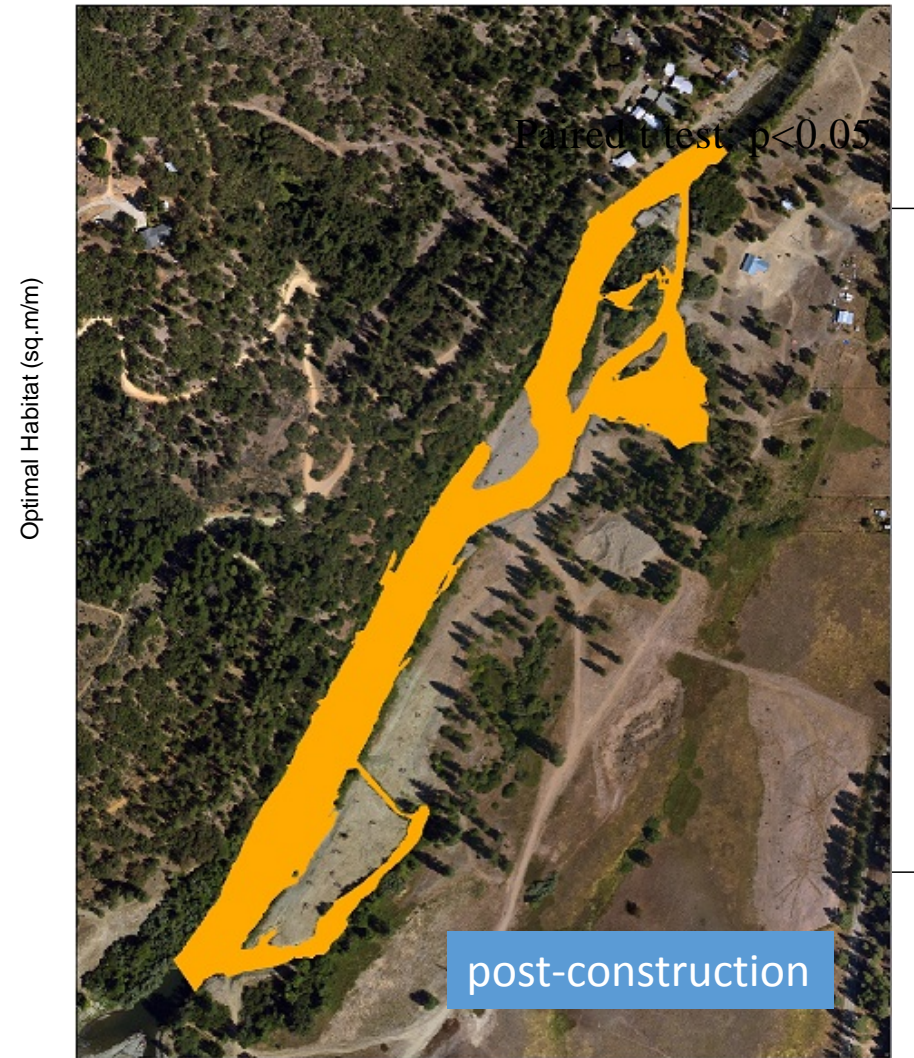
# Site scale: habitat availability at rehabilitation sites at **450 cfs**

n=13 sites

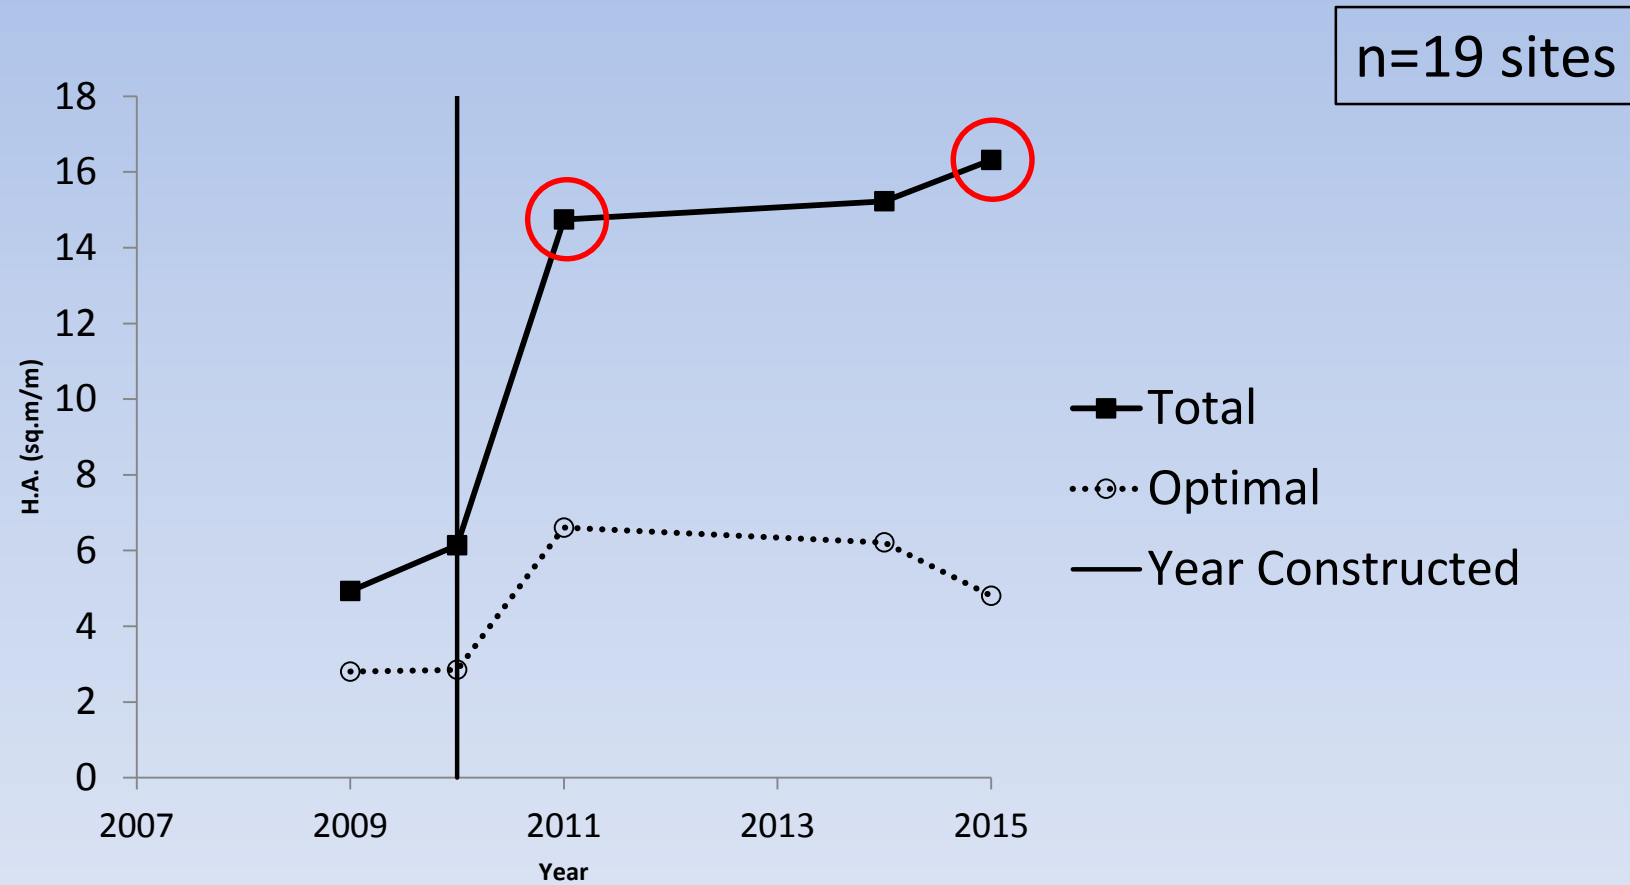
## Site scale: trends in rearing habitat at 450 cfs

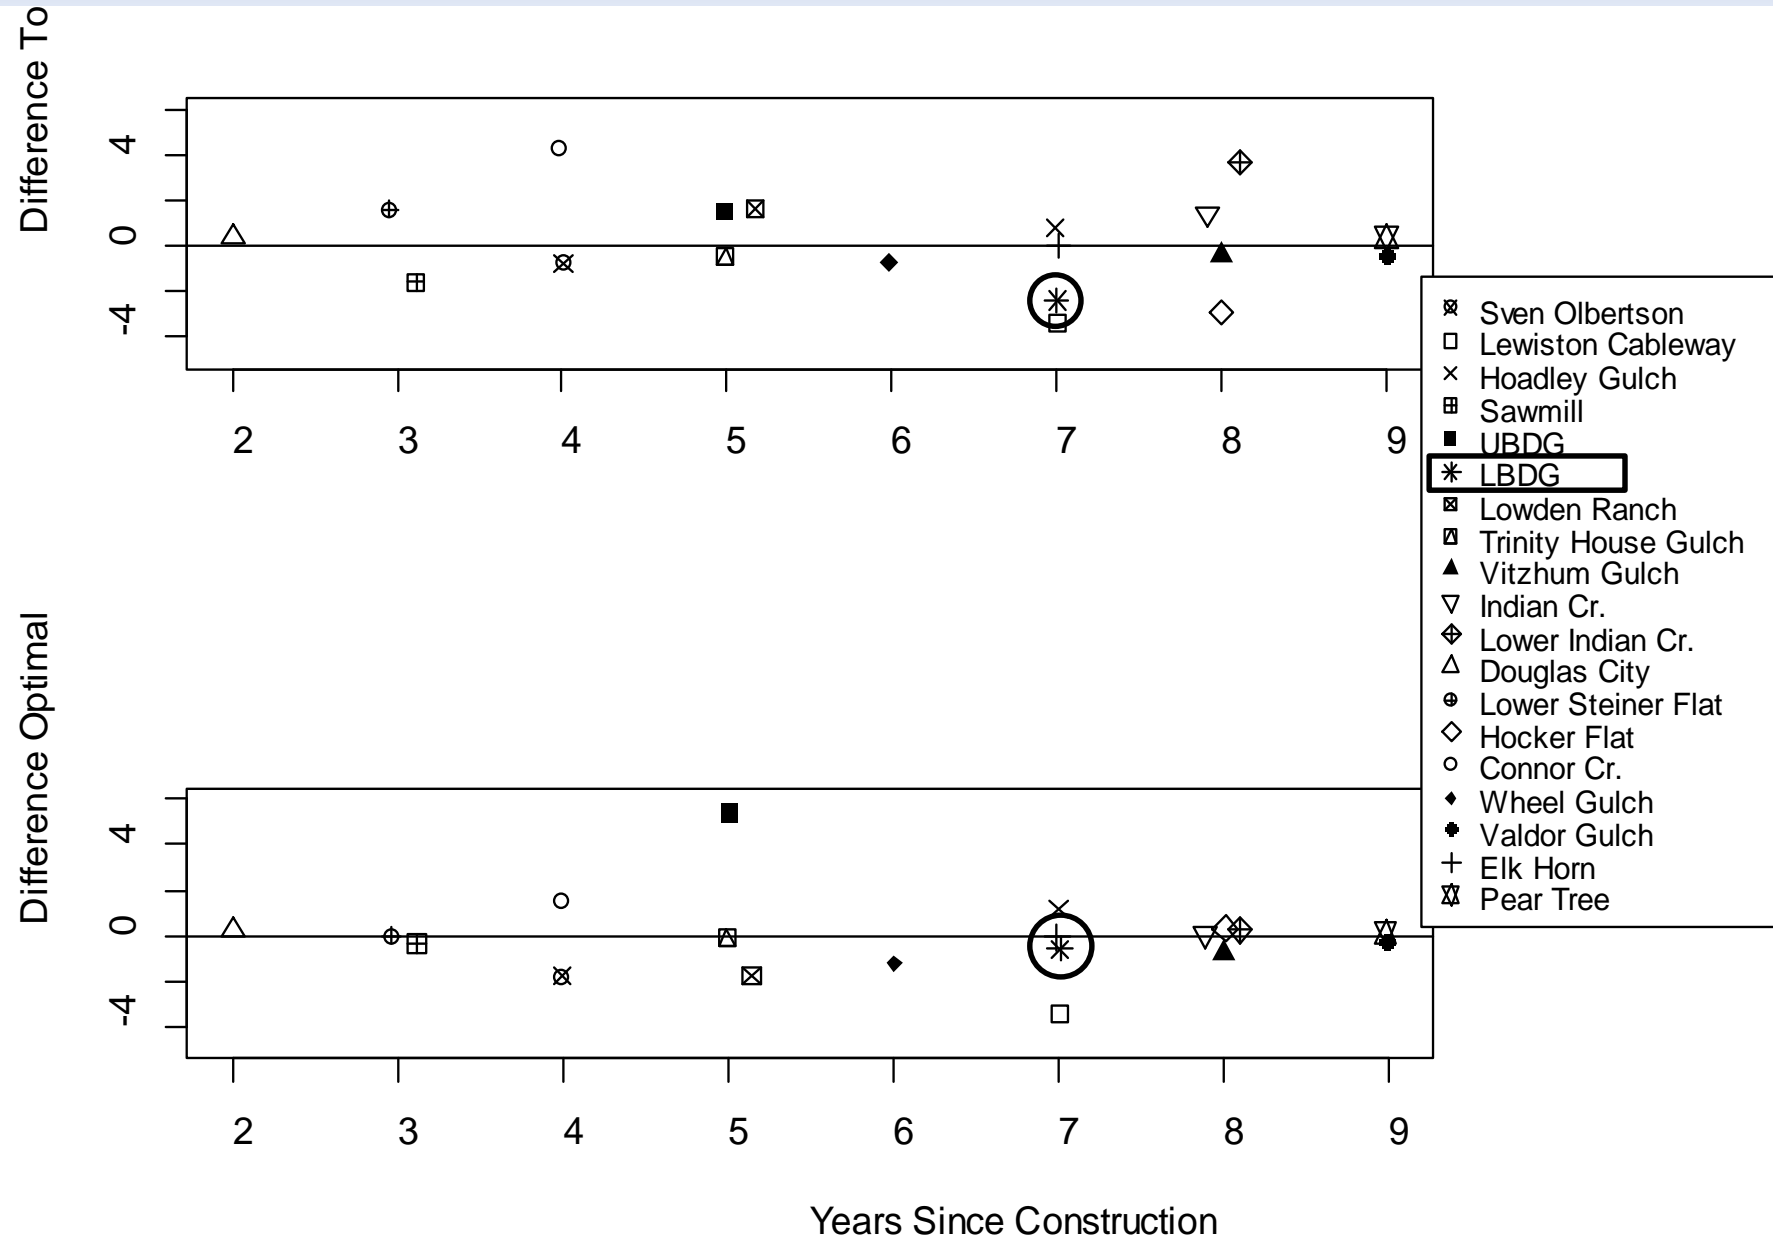
# Site scale: $\sim 50\%$ of sites had more habitat at most recent survey

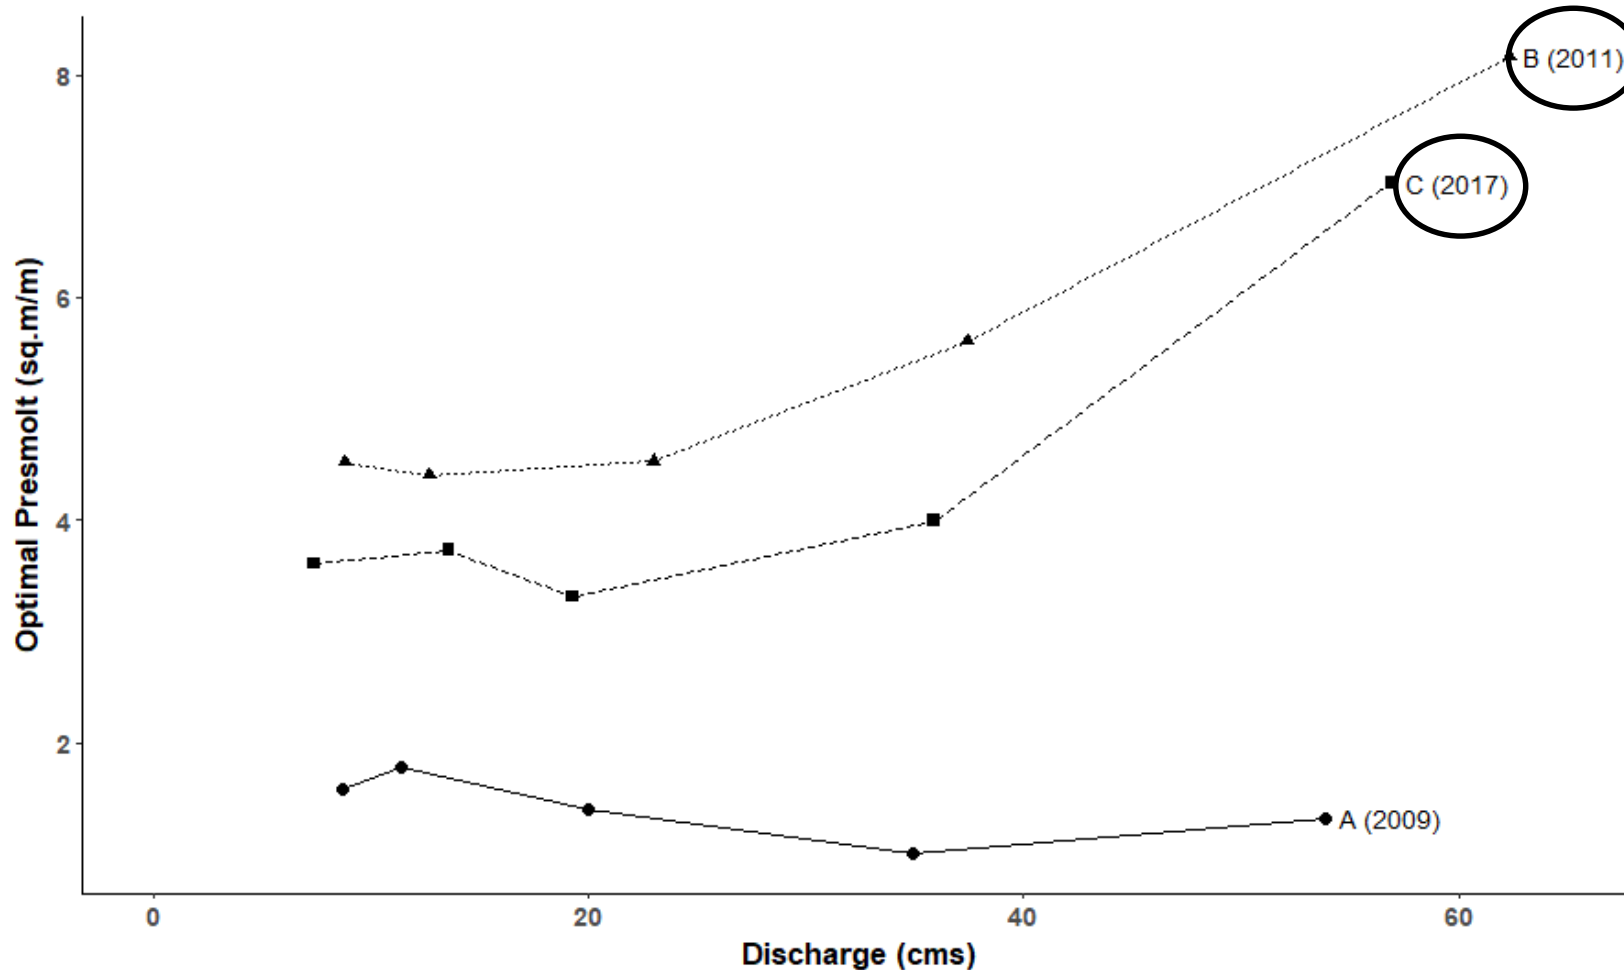
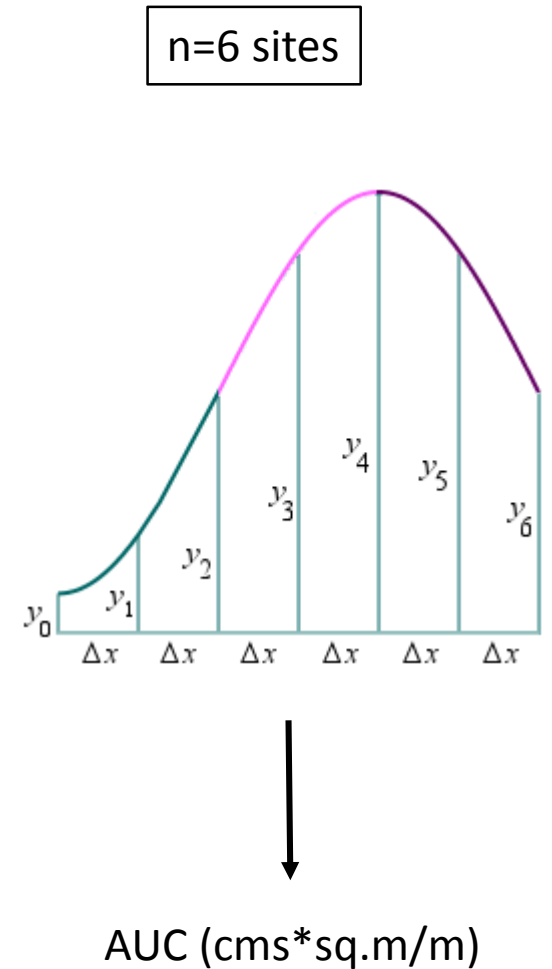
# Site scale: trends in the streamflow to habitat relationship (synthesis report in preparation)

(300-2,000 cfs)

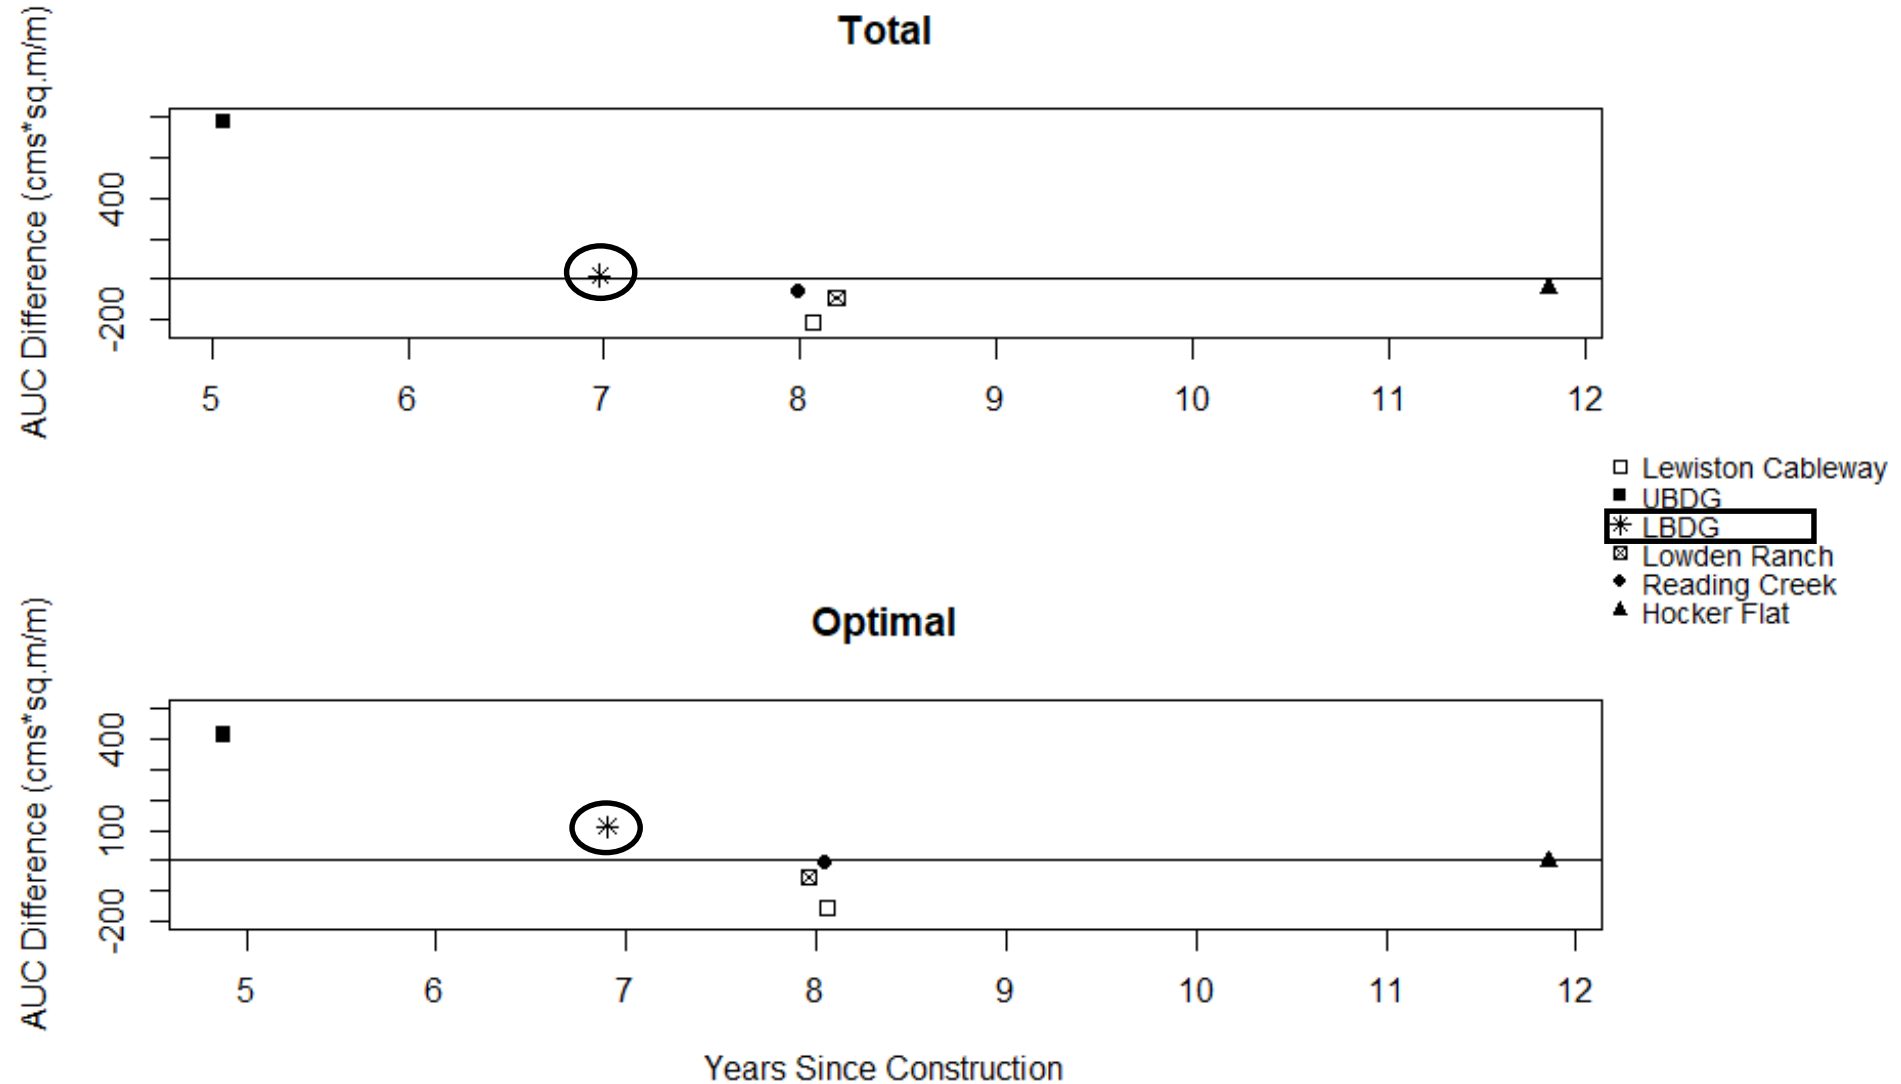
# Site scale: Two of six sites had higher AUC values at most recent survey

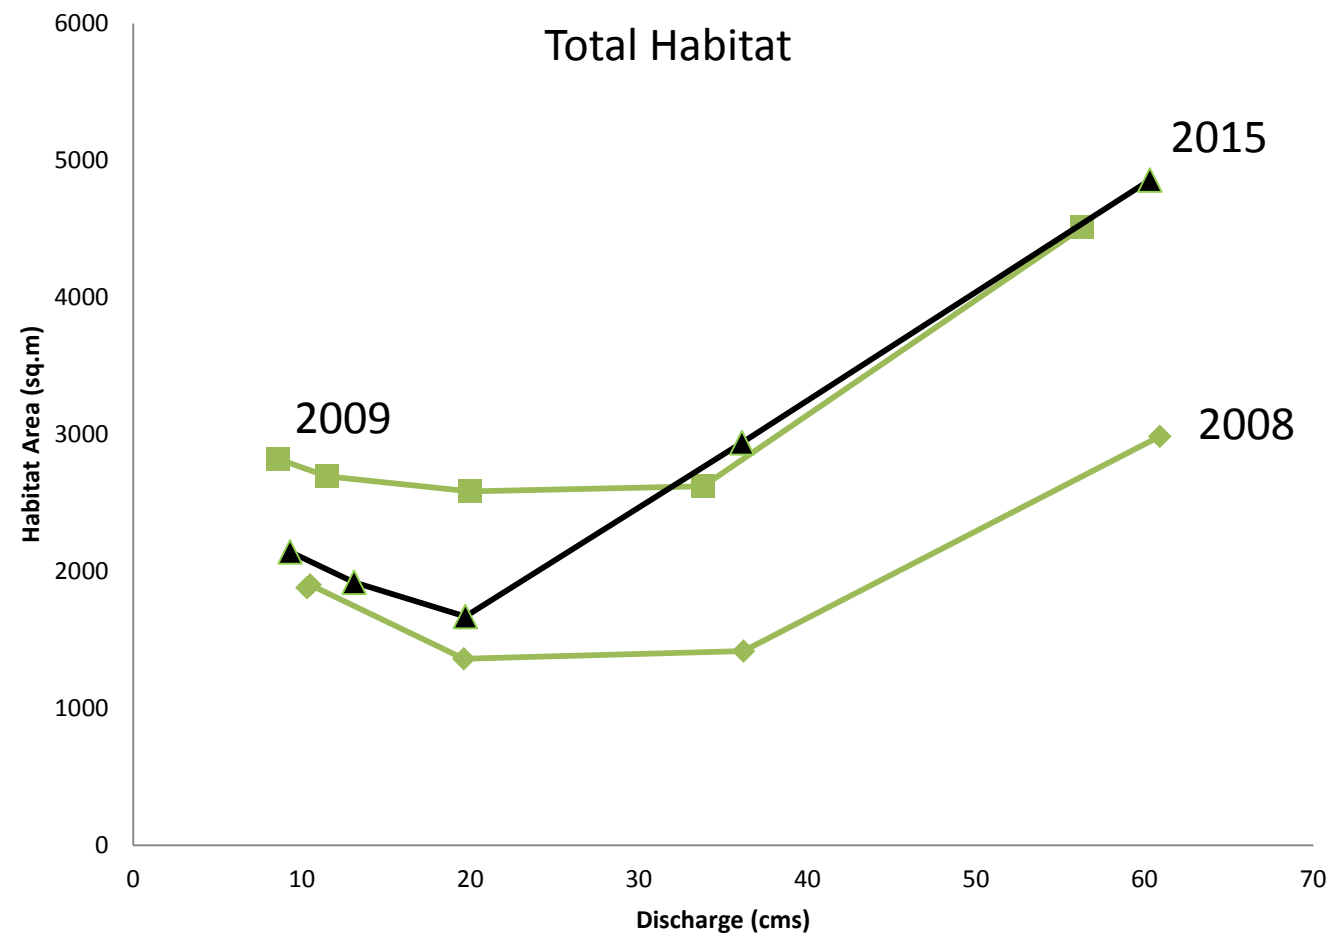
# Lower Bucktail-Dark Gulch

habitat losses  
side channel aggradation  
negligible topographic change

reconstruction 2016

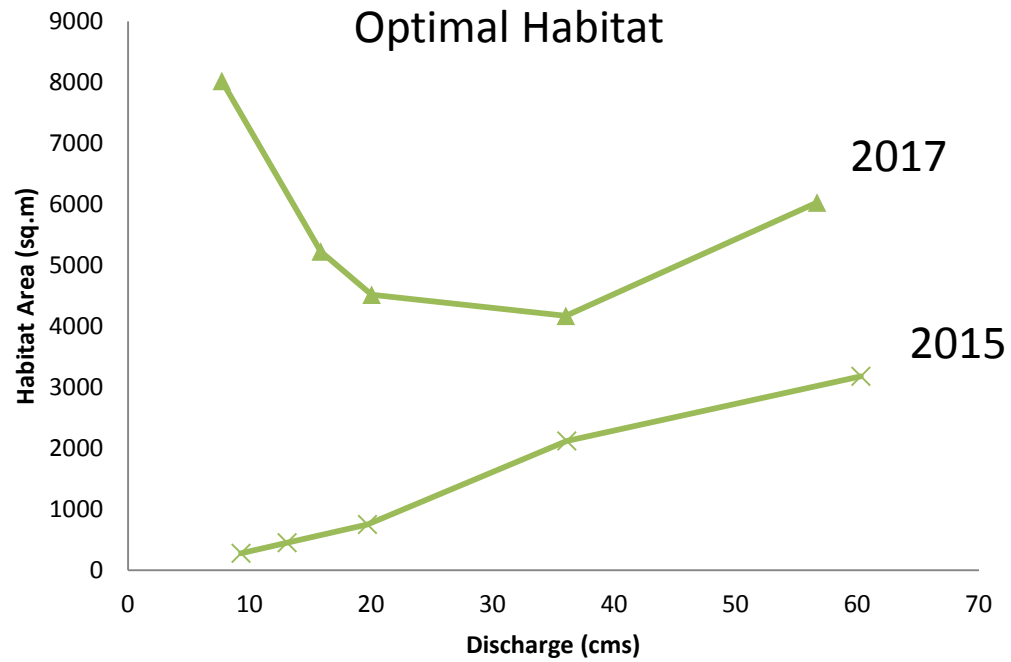
## 2015-2017

**increases 90% to 2,799%**

post-construction “dip” at intermediate flows

Reconstruction increased habitat at all flows (more than doubled)

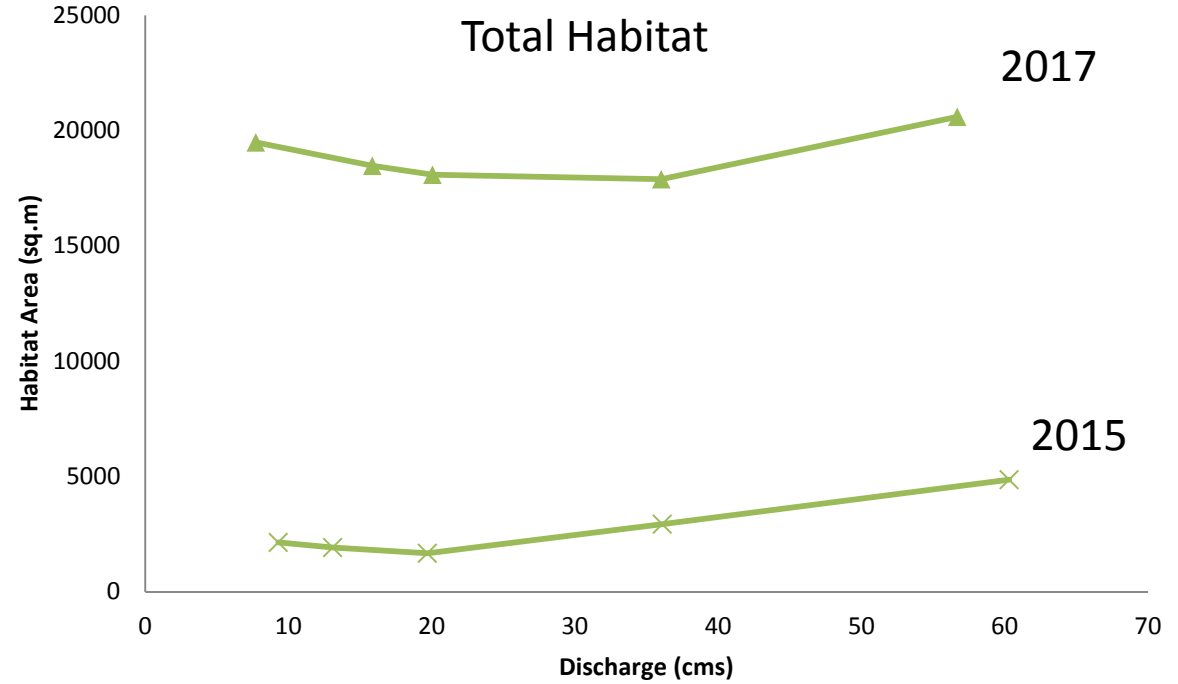
**increases 324% to 984%**

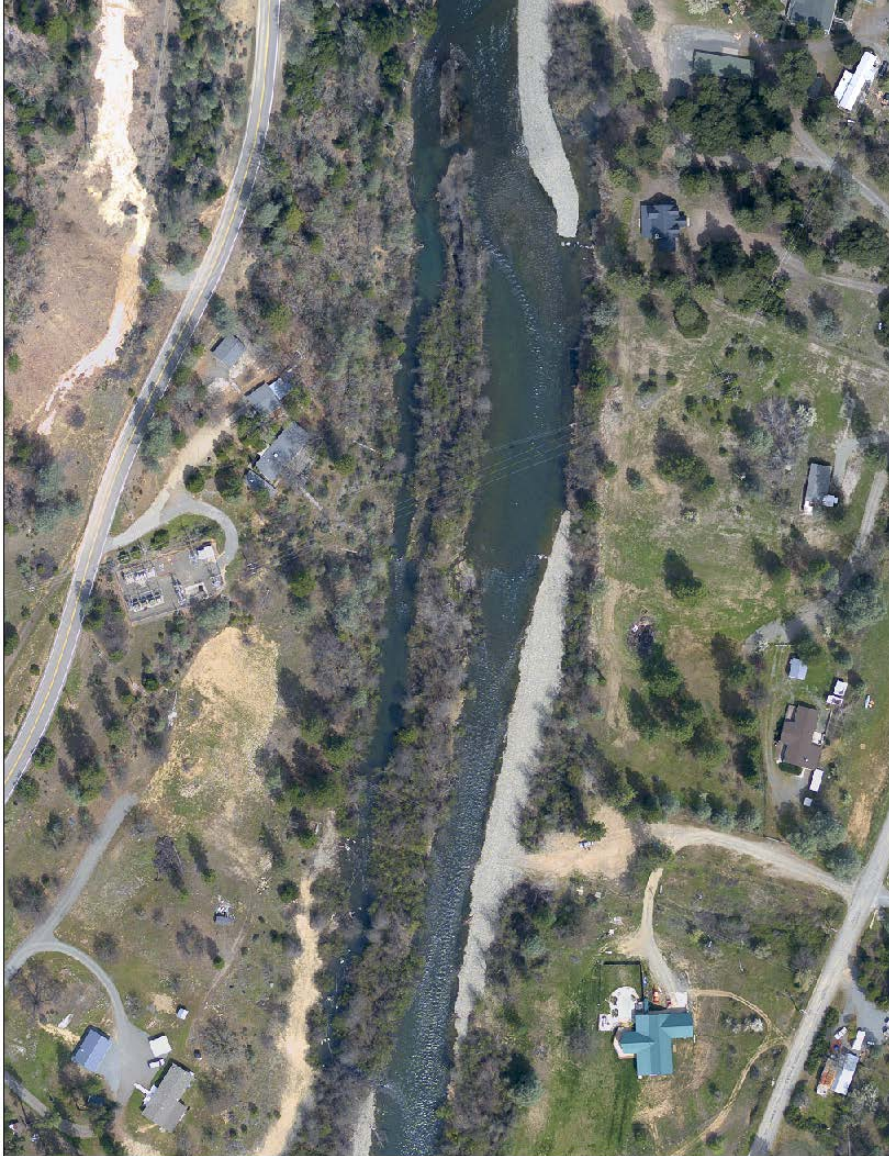
Compare natural and TRRP constructed side channels, 2005-2015

Performance = mainstem connectivity?

Aerial photographs

Natural	TRRP
Disconnected	12% (3/25)	31% (4/13)
Reconnected	2	0

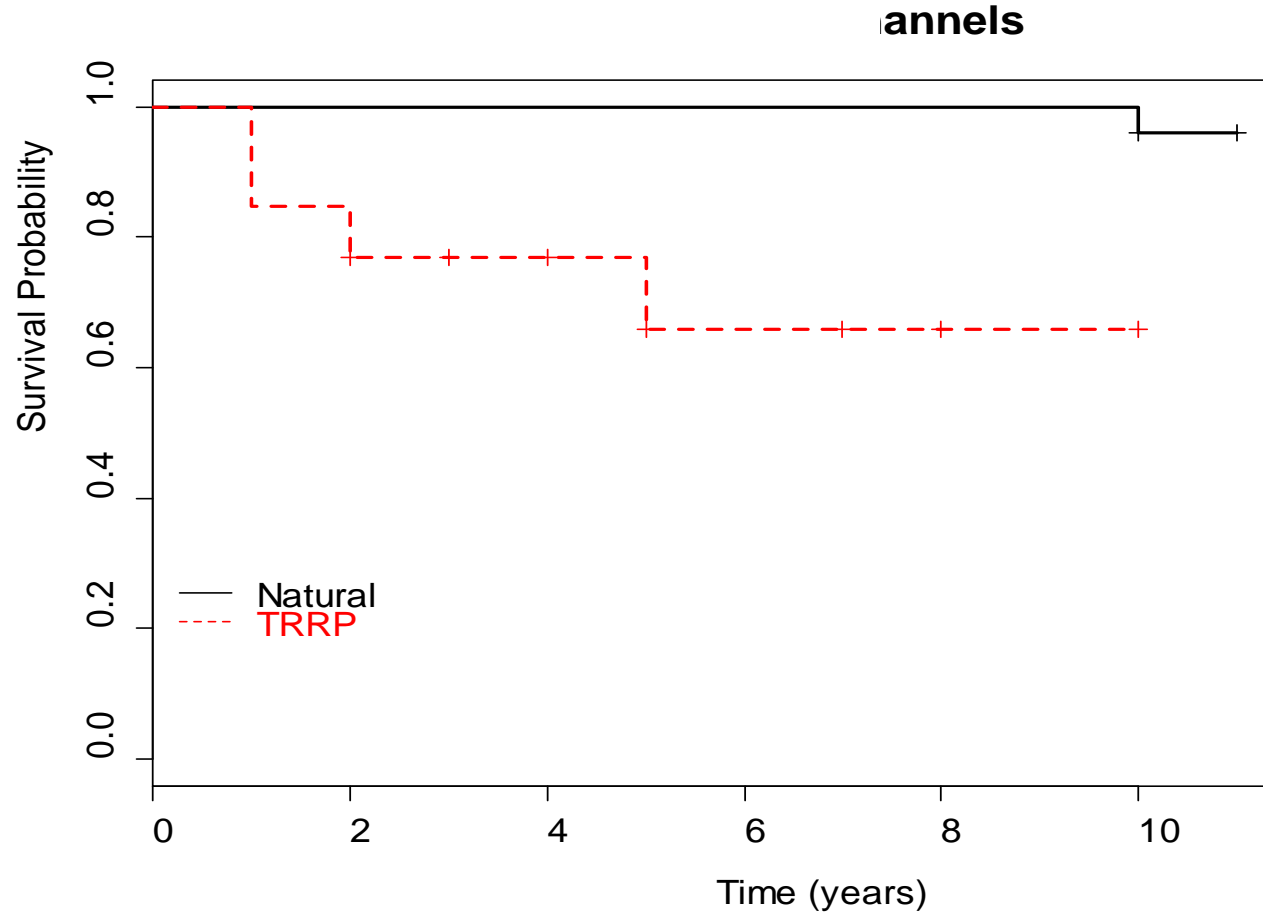
# Natural side channels have a higher survival rate than constructed side channels

Log Rank Test  
( $\chi^2 = 3.5$ ,  $df = 1$ ,  $P = 0.003$ )

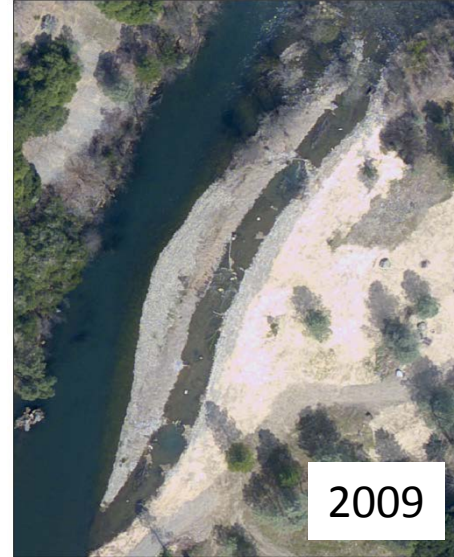
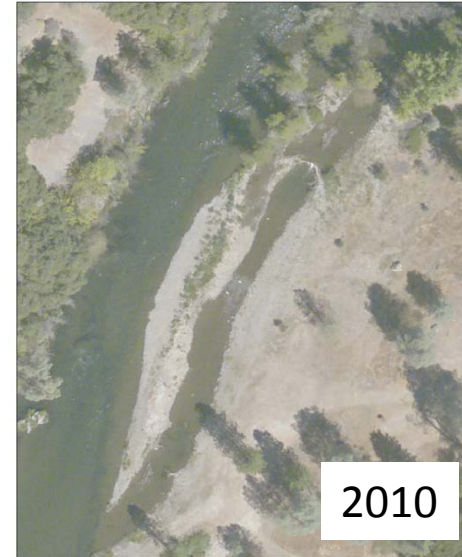
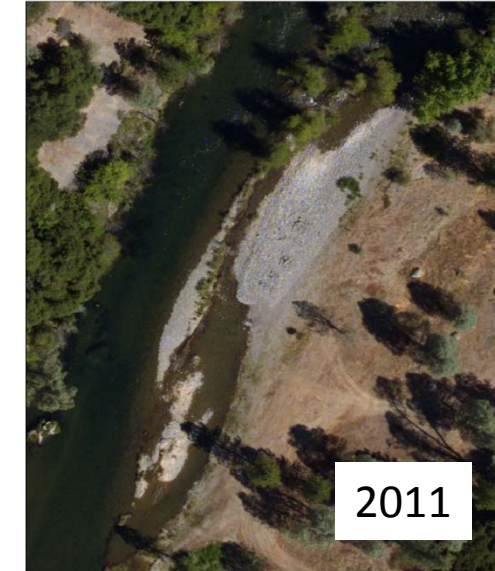
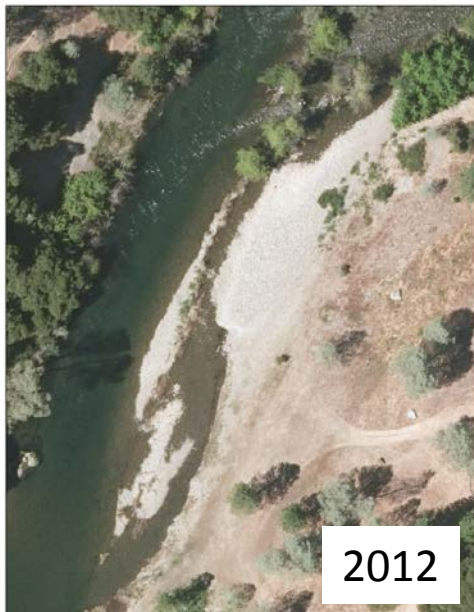
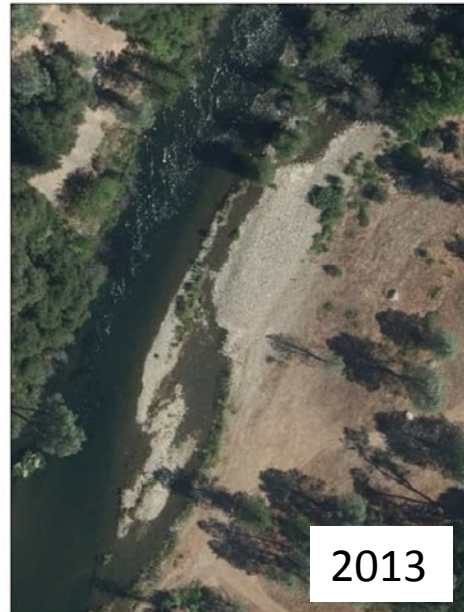
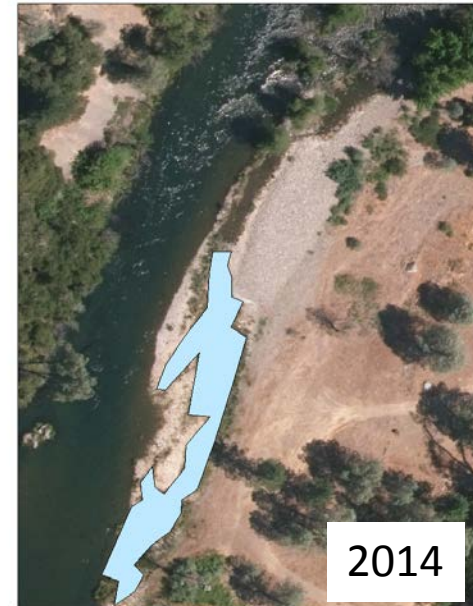
Deadwood Creek

# Aggraded side channels convert to high flow channels/alcoves

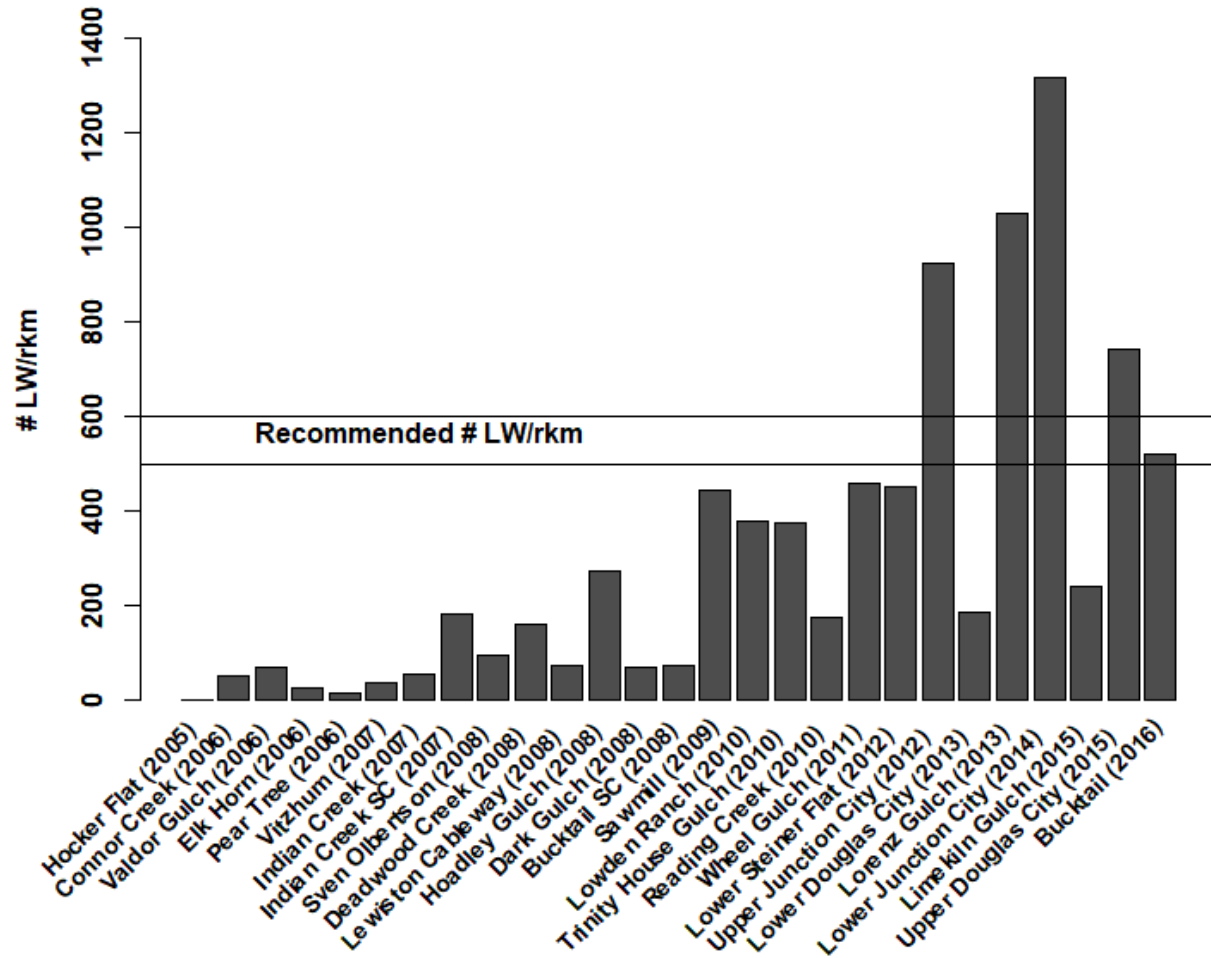
# TRRP has increased large wood placement over time
