# ***Trinity River Restoration Program***

# Chapman Ranch Channel Rehabilitation Site: Phase A

Justin Alvarez, HVTF and Fred Meyer, McBain Associates

April 4 2017

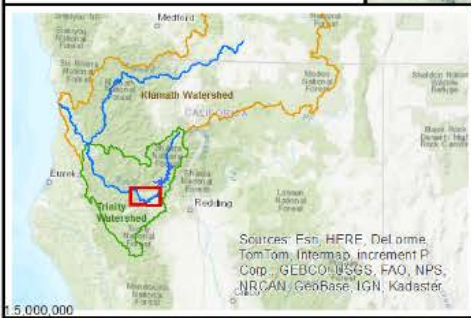
**TRRP Channel Rehabilitation and Gravel Augmentation Sites**  
January 2018

**Environmental Study Limits (ESLs)**

- Rehabilitation during 2005-2014
  - TRRP Channel Rehabilitation Phase 1
  - TRRP Channel Rehabilitation Phase 2
  - TRRP Restoration - Other
- Gravel Augmentation**
- TRRP Augmentation Site

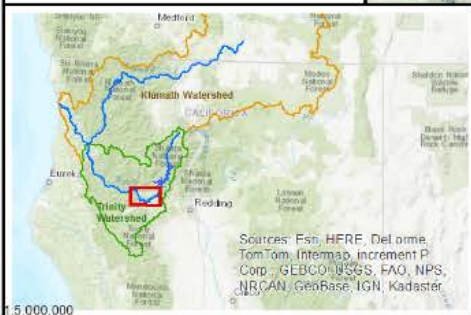
## Chapman Ranch

*Description:* Heavily altered; large tailings and mine terrace

- Hydraulic mine debris washed into valley bottom
- Valley bottom was dredged, eliminating or reconfiguring the natural channel
- Juvenile salmon habitat decreases with flow

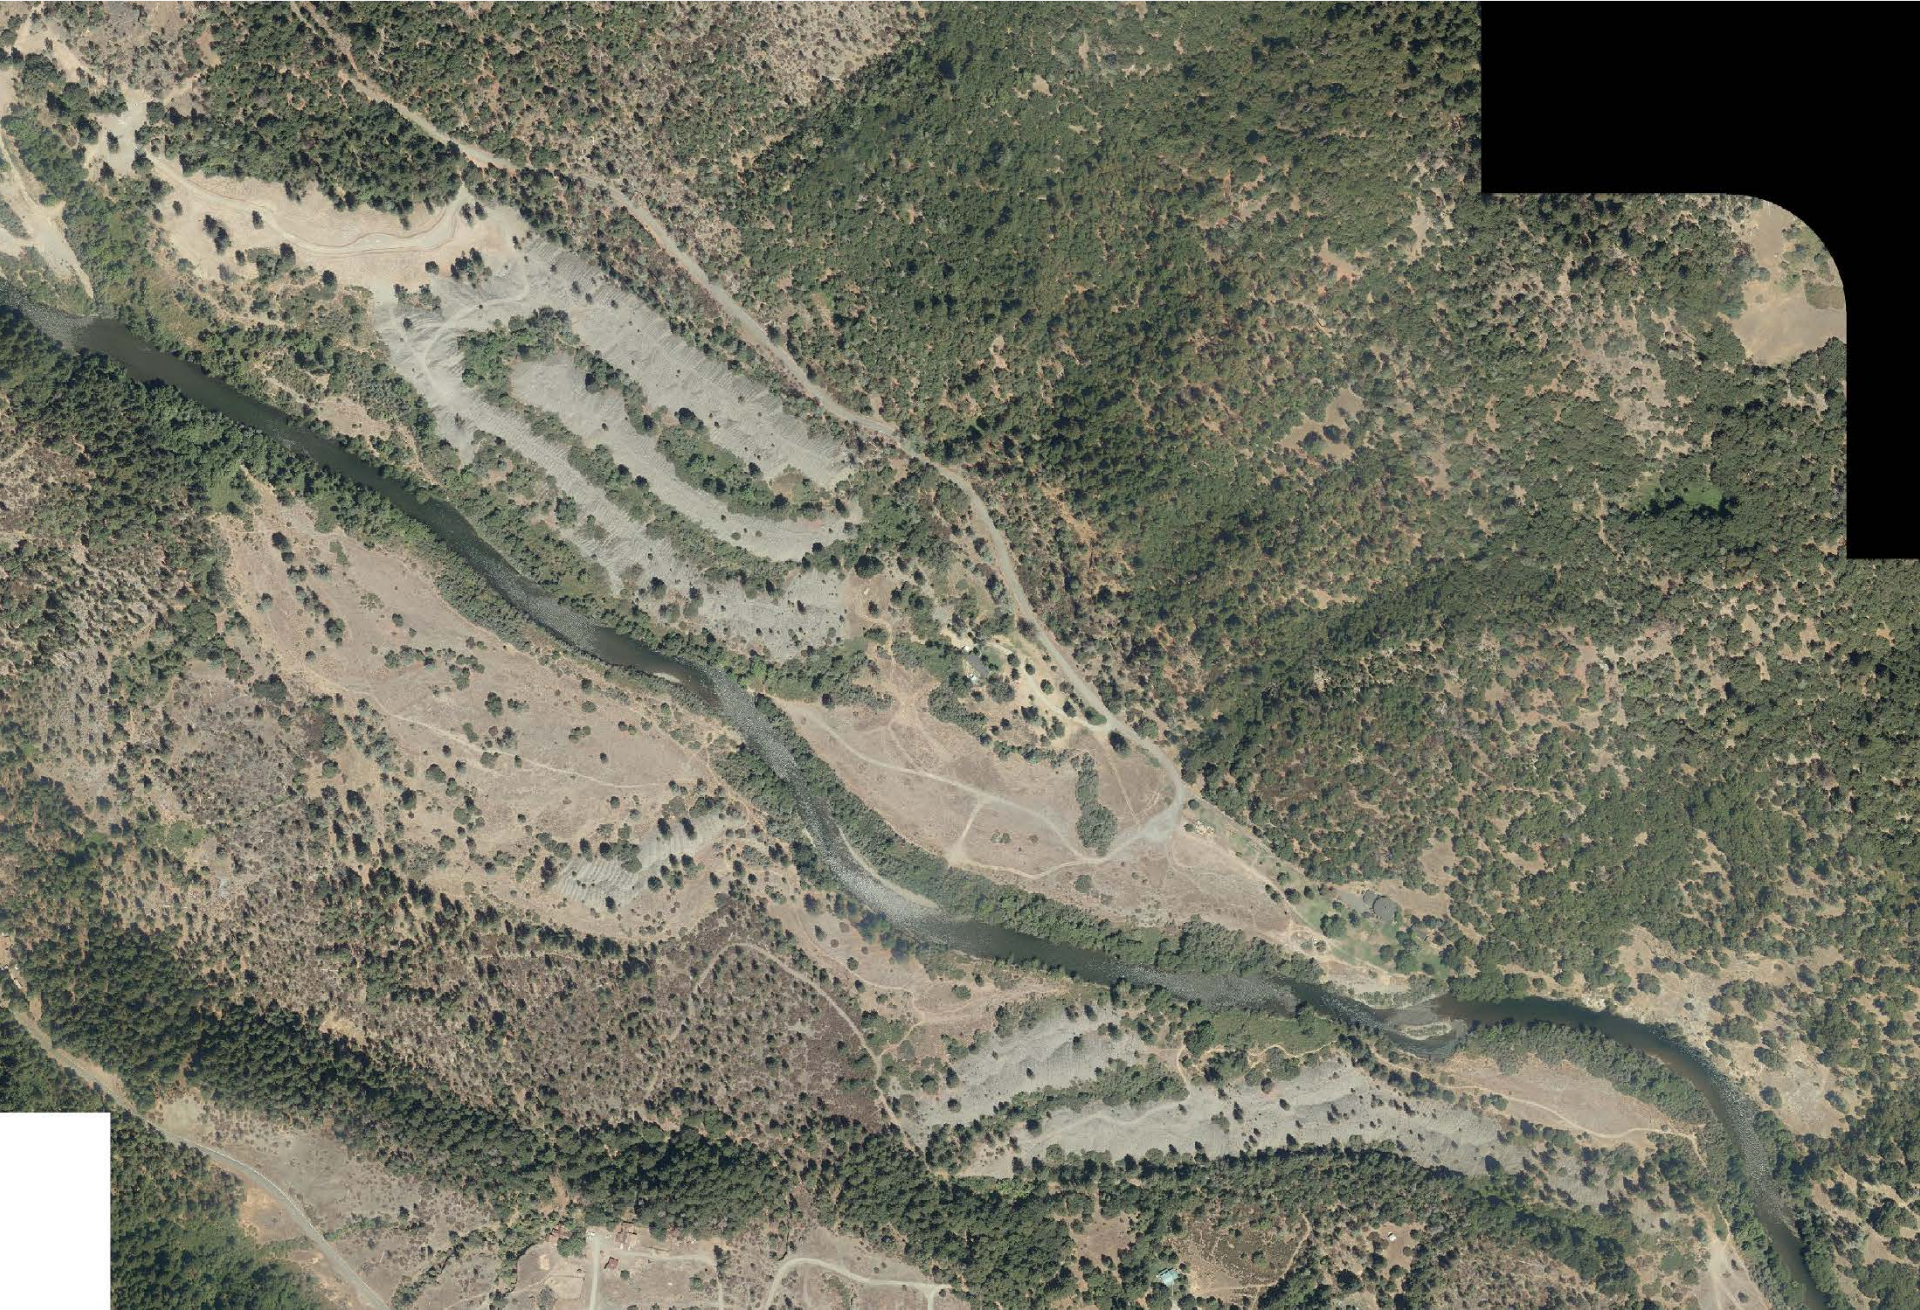
# Chapman Ranch Rendering

Background photo: Artists rendering of Chapman Ranch Phase A, five to ten years after construction.
