Design Team Workgroup Notes

27 February 2017

Age-0 Chinook and Coho Salmon Rearing Habitat Observations, Upper Douglas City Rehabilitation Site, 2016, Upper Trinity River, CA

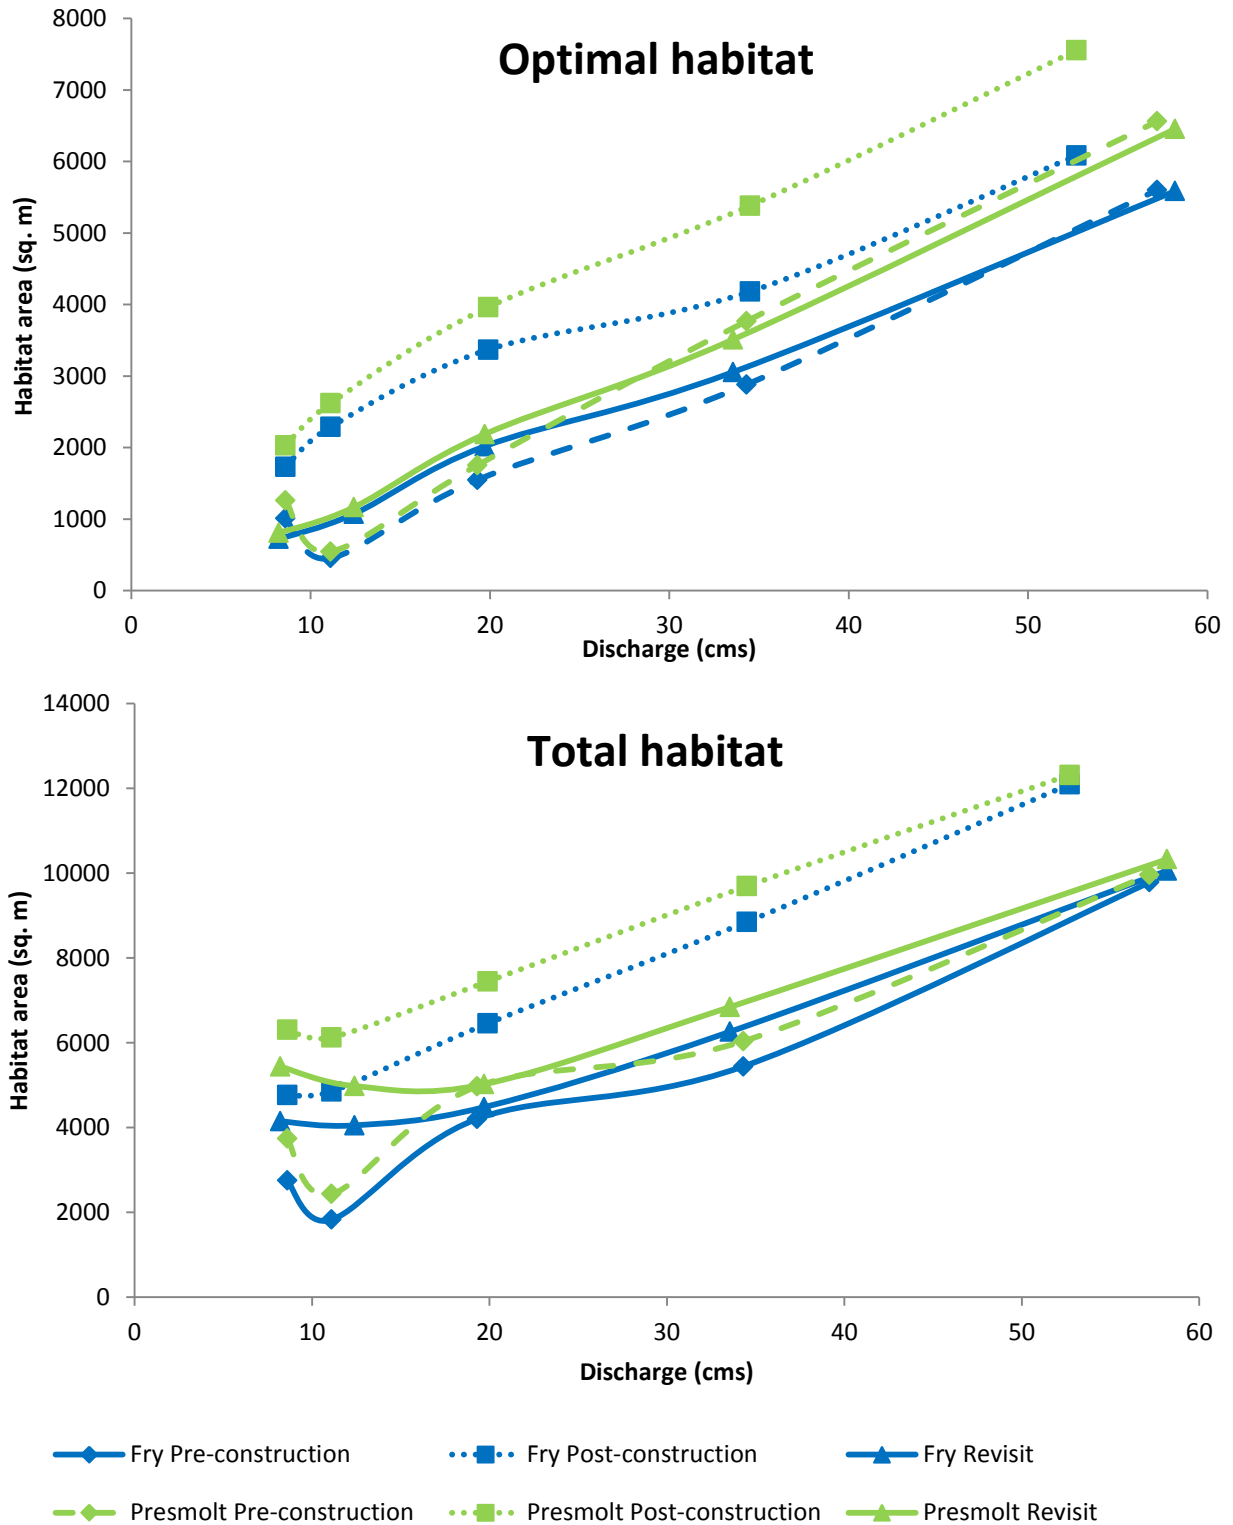
Figure 1. Optimal and total habitat area for Chinook and Coho Salmon fry and presmolt at the Cableway restoration site during pre-construction (2008), post-construction (2009), and revisit (2016). Habitat categories correspond to combinations of depth/velocity (DV) and in-water escape cover (C) criteria.
